Effects of Different Lasers and Particle Abrasion on Surface Characteristics of Zirconia Ceramics

Journal of Dentistry, Tehran University of Medical Sciences, Tehran, Iran (2014; Vol. 11, No. 2)

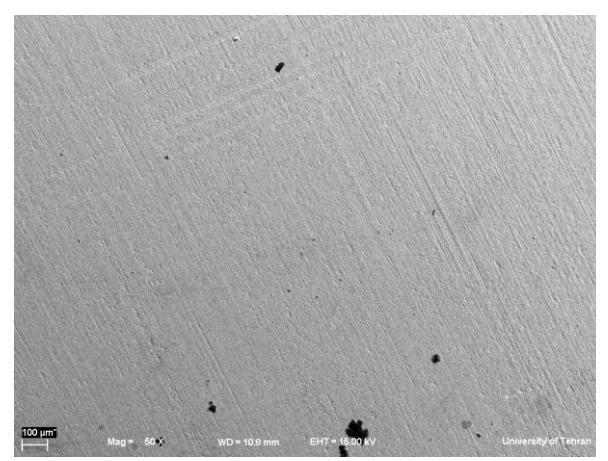
Fig 1. SEM micrographs (magnification 500X) of non-treated Y-TZP surfaces (magnification 60X)

In SEM images, non-treated surfaces of Y-TZP showed grooves and irregularities due to the polishing process (Figure 1). Treated Surfaces by AL_2O_3 air-particle abrasion (50µ) indicated roughness, grooves and irregularities, uniformly throughout the surface (Figure 2).

Air abrasion showed increased surface roughness (Ra) compared to the control group. SEM images of the control group were almost smooth except for some scratch-like lines and small pits that were created by the polishing sandpaper.

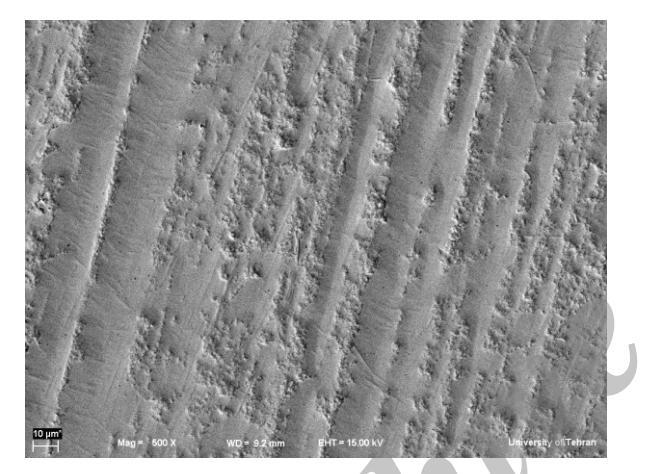
Fig 3a. SEM micrographs of Y-TZP surfaces after Er:YAG laser irradiation (at 1.5W) (magnification 500X(

The Er: YAG laser with power of 1.5W created a rough surface with irregularities (Figure 3a). Surface roughness increased by enhancing output power to 2W; also, the surface became more uniform (Figure 3b). The Er:YAG laser irradiation at power of 2.5W reduced surface roughness and depth of irregularities (Figure 3c). Treated surfaces by CO_2 laser with power of 3W showed several fine and wide crack lines (Figure 4a). In addition, the circular shape prominences could be seen over the surface produced by the motion of laser irradiation. With increasing power, the rate of irregularities and surface roughness increased (Figures 4b and 4c). Treating samples by Nd: YAG laser at a power of 1.5W created surface microcracks, prominences and porosities; moreover, some areas were partially melted (Figure 5a). Nd:YAG laser irradiation at 2 and

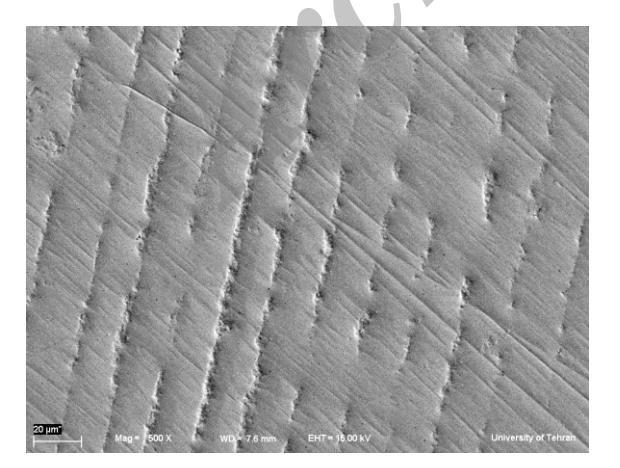
Fig 3c. SEM micrographs of Y-TZP surfaces after Er:YAG laser irradiation (at 2.5W) (magnification 500X)

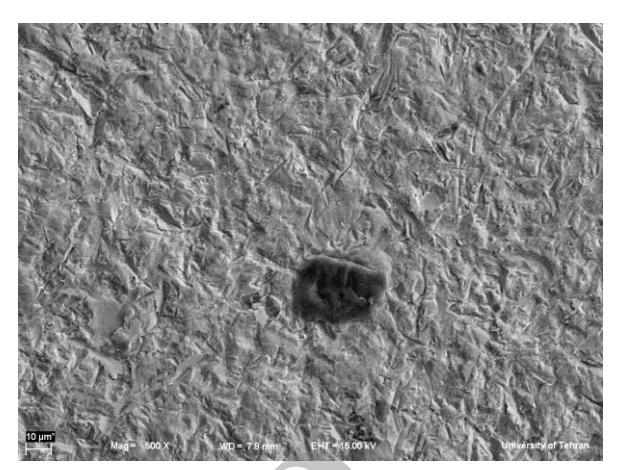
Fig 2. :SEM micrographs of air abraded Y-TZP surfaces (magnification 500X)

In this study, SEM micrographs showed that the application of air abrasion with AL_2O_3 particles leads to apparent retentive pits and scratches; although, there was no significant difference in Ra between treated surfaces with air-particle abrasion and Er: YAG laser.

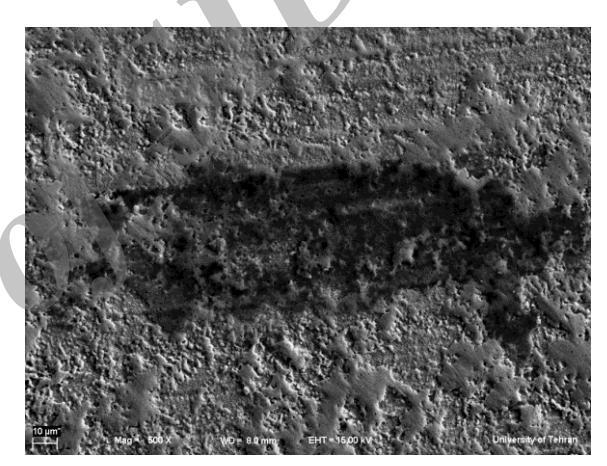
Fig 3b. SEM micrographs of Y-TZP surfaces after Er:YAG laser irradiation (at 2W) (magnification 500X)

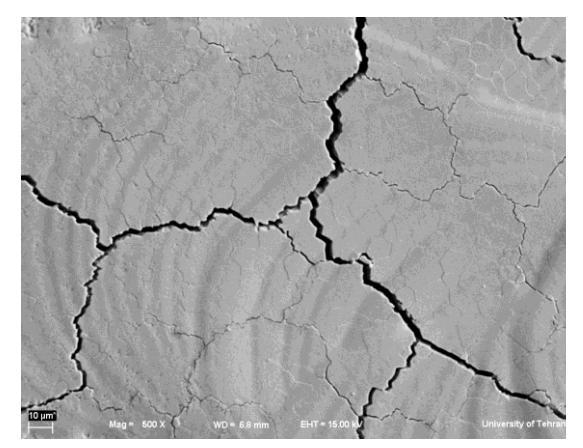
Fig 4a. SEM micrographs of Y-TZP surfaces after C0₂ laser irradiation at 3W (magnification 500X)

In this study, the specimens irradiated with CO_2 laser showed significant superficial changes in SEM observations. The high temperature due to CO_2 laser irradiation effectively facilitates localized surface melting and creates micro-cracks on the surface. Increased Ra values of treated Y-TZP by CO_2 laser in the present study confirm SEM observations. Different reasons are expressed for the formation of these cracks after CO_2 laser irradiation [20].

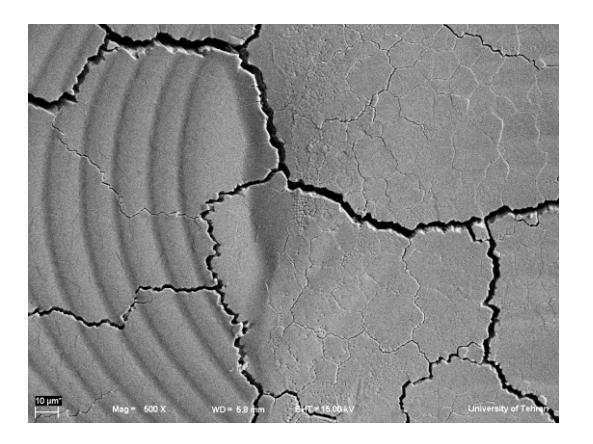
Fig 4b. SEM micrographs of Y-TZP surfaces after CO_2 laser irradiation at 4W (magnification 500X)

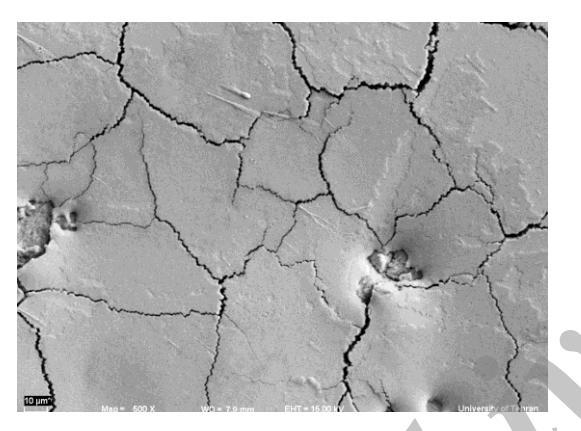
Fig 5a. SEM micrographs of Y-TZP surfaces after Nd:YAG laser irradiation at 1.5W (magnification 500X)

In the present study, results of SEM micrographs and ANOVA confirmed that the treated samples with Nd:YAG laser had higher Ra than the other groups and indicated uniform surface cracks and molten regions. Like the CO₂ laser process, increasing temperature during the laser irradiation can also cause thermal melting of the ceramic surface. Surface expands during melting and immediately contracts during solidification. This stress due to temperature can cause superficial cracks. Another challenge is that Nd:YAG laser treated surfaces are characterized by a carbonized layer with silver pigments [24]. This feature can prevent the use of Nd: YAG laser in the esthetic zones. Cavalcanti et al. evaluated the

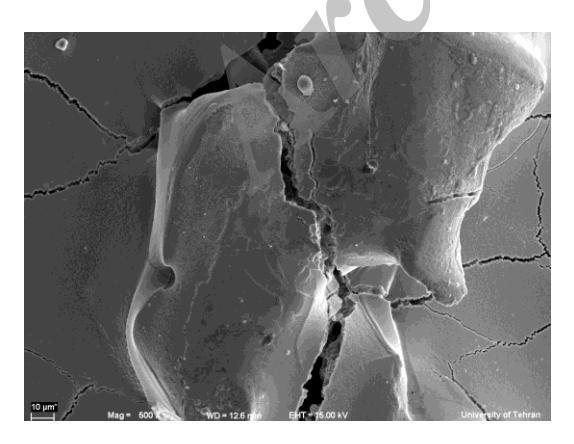
Fig 5c. SEM micrographs of Y-TZP surfaces after Nd:YAG laser irradiation at 2.5W (magnification 500X)

2.5W power increased these changes (Figures 5b and 5c).

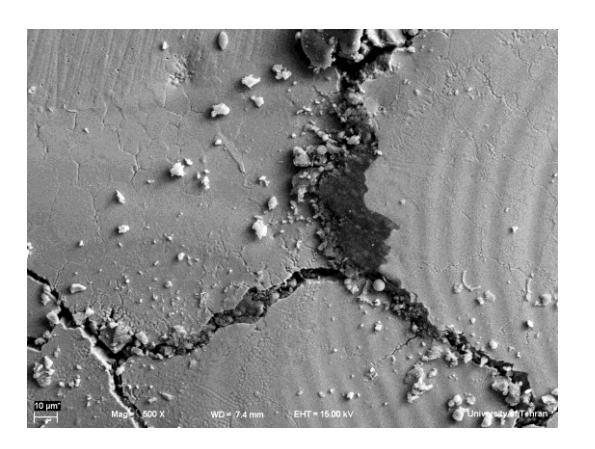
Fig 4c. SEM micrographs of Y-TZP surfaces after CO_2 laser irradiation at 5W (magnification 500X)

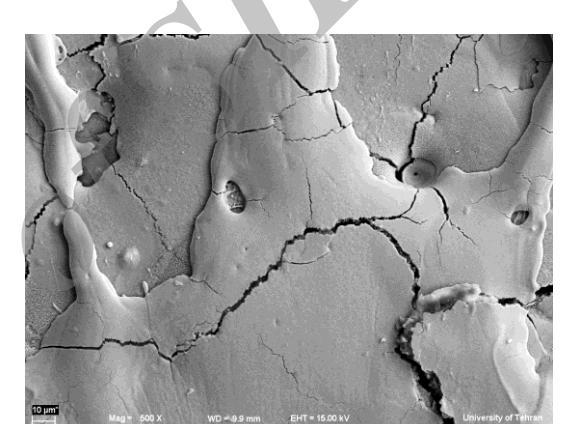
Fig 5b: SEM micrographs of Y-TZP surfaces after Nd:YAG laser irradiation at 2W (magnification 500X)

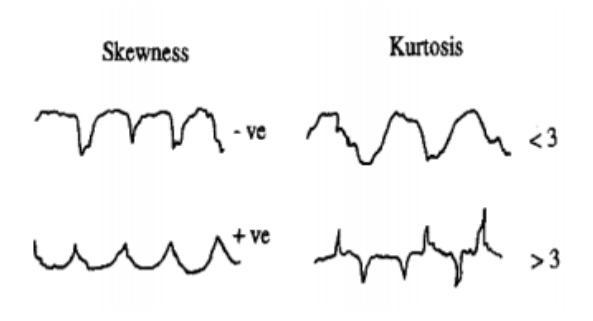
Fig 6. Schematic design of kurtosis and skewness values

Rsk or skewness is the symmetry measure of the profile about the mean line and is characterized as positive or negative. Negative skewness indicates a plateau like profile and positive skewness confirms the peaks (Figure 6). Rsk values were positive in treated samples with Nd:YAG and CO_2 lasers; indicating prominences on the surfaces. But the other groups showed negative Rsk numbers. A plateau-like profile is indicated by a negative skewness value. As the levels of Rsk approach zero, we encounter more normal distribution of peak and plateau-like areas [15].

The next parameter was Rku or kurtosis. This is a measure of the sharpness of the surface profile and takes the value 3 for the normal distribution. Rku >3 indicates that the surface is dominated by sharp peaks (spiky); whereas, the peaks are bumpy if Rku is lower than 3 (Figure 6). The differences in Rku between groups were not statistically significant (P >0.005) and all of them showed Rku >3; indicating sharp prominences and depressions [15]. All the above-mentioned processes rely on increasing the surface area for bonding and creating a stronger and more durable restoration. However, the range of changes on the surface of ceramics depends greatly upon the energy intensity of laser irradiation and type of ceramic.
