ASIAN JOURNAL OF CIVIL ENGINEERING (BUILDING AND HOUSING) VOL. 7, NO. 4 (2006) PAGES 359-368

THE IMPORTANCE OF HISTORICAL DOCUMENTS FOR THE STUDY OF STABILITY IN ANCIENT BUILDINGS: THE FRENCH PANTHÉON CASE STUDY

C. Blasi^{*}, E. Coïsson

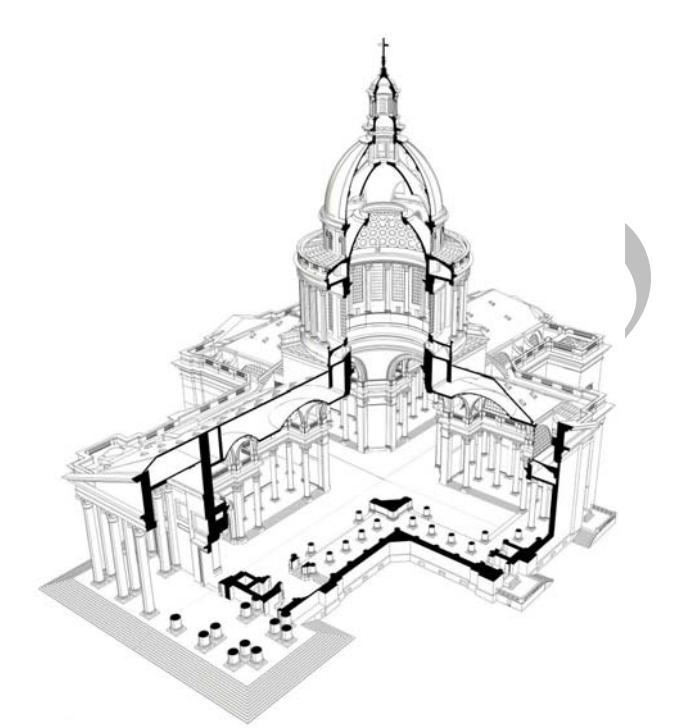
Figure 1. Axonometry of the monument with view of the inside [10].

The French Panthéon (Figure 1), started by Soufflot in 1756 as the biggest church in Paris, dedicated to Sainte Genevieve, patron saint of the town, and finished by Rondelet in 1790, is, probably, the first building to be calculated with modern methods of structural engineering. The need for these calculations was the consequence of the adoption of an innovative building technique (the reinforced stone masonry, see Figure 7) and of the reduced dimensions of wall structures, that did not follow the classical building rules. Still in the design phase, the first objections aroused from the architects linked to the old academic building tradition, particularly from Pierre Patte [6], because the structures did not respect the canonical proportions: pillars too slender, domes masonry too thin, windows too large.

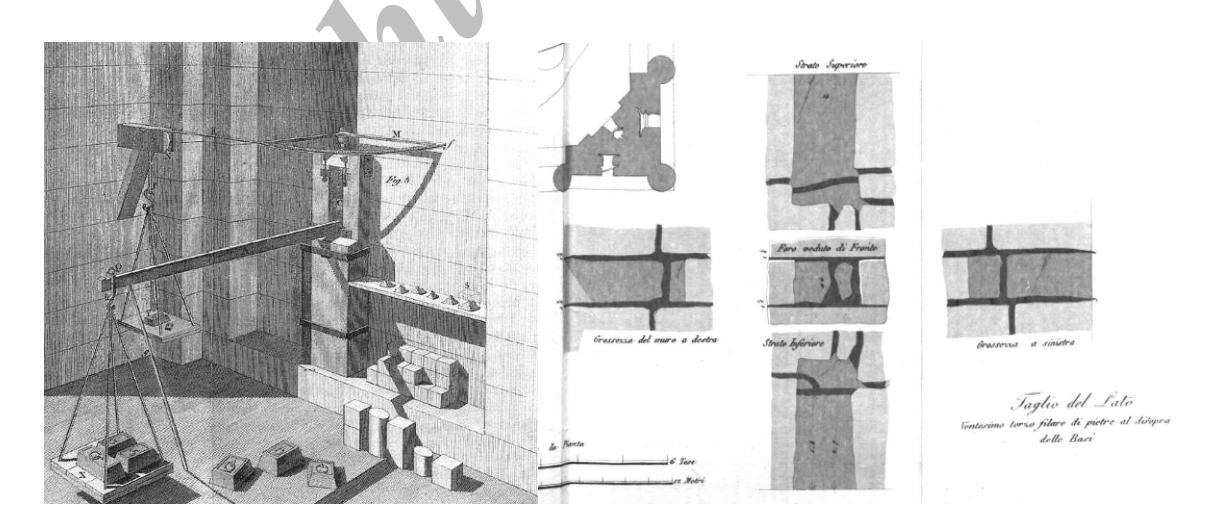
Figure 2. Rondelet's drawing of Gauthey's machine to test stone in compression [4] (on the left) and Rondelet's assays on the pillars [1] (on the right).

To answer this first campaign of polemics, Jacques-Germain Soufflot and Emiland-Marie Gauthey, director of the prestigious "École des ponts et chaussés", carried out the first systematic compression tests on stone specimens and the first calculations [3,5], demonstrating that the pillars had a cross section large enough to sustain the weight of the domes considering a centred load (Figure 2).

Thus, the second phase of the debate concentrated on the eccentricity of the load on the pillars and, as a consequence, on the thrust of the domes and on the possible strengthening systems. The controversy compressed between the opinion of Gauthey [3], who wanted to oppose the domes thrust with new buttresses, and the opinion of Rondelet [2], who thought that the domes did not thrust, thanks to the many metal rings in the stone of the dome and that the cause of the fractures in the pillars was to be searched in the bad execution of the pillars masonry. The assays made by Rondelet showed that the thickness of mortar beds was few millimetres on the external surfaces, while it was some centimetres on the inside. The whole load weighted thus only on the boundary of the pillars (Figure 2).

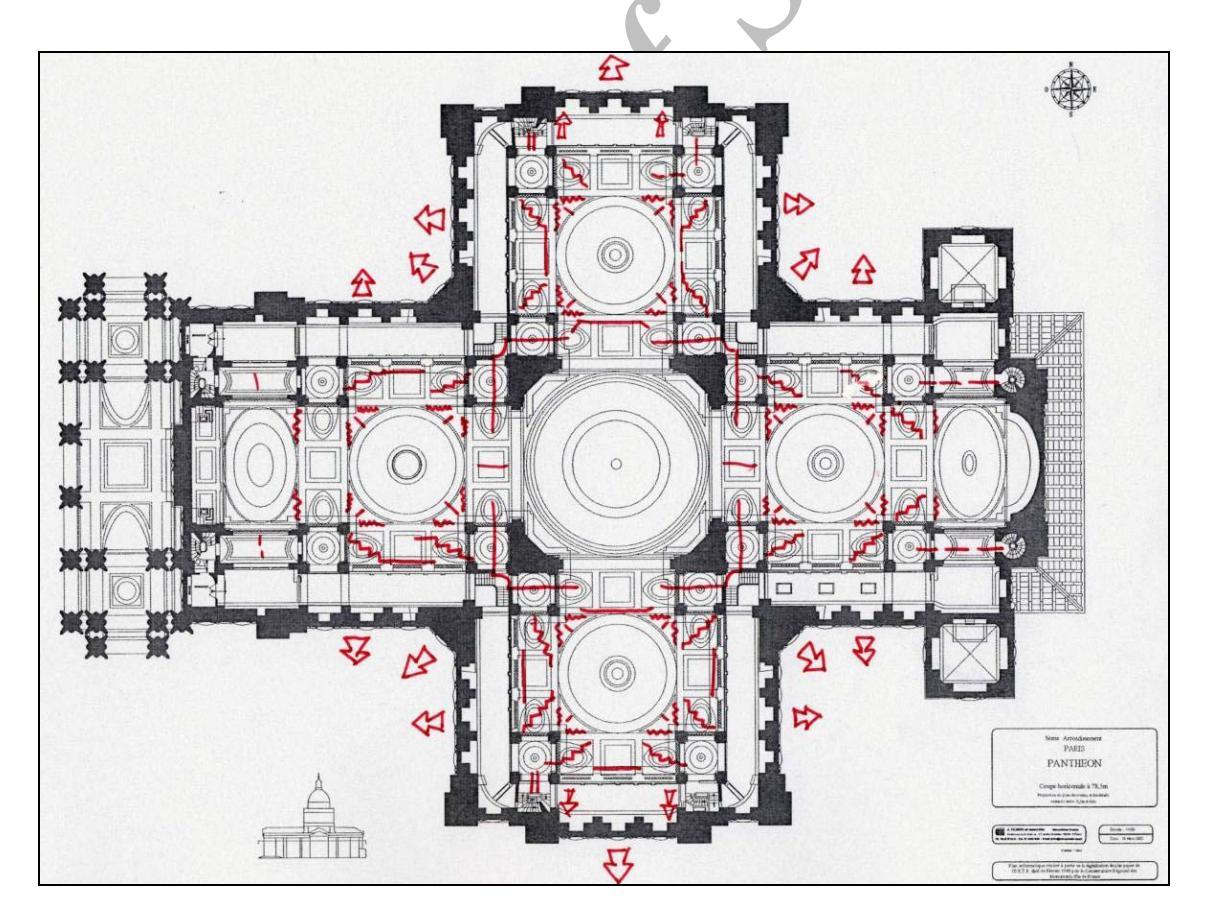
Figure 3. Schematic survey of the main crack systems (position and global interpretation) [1]

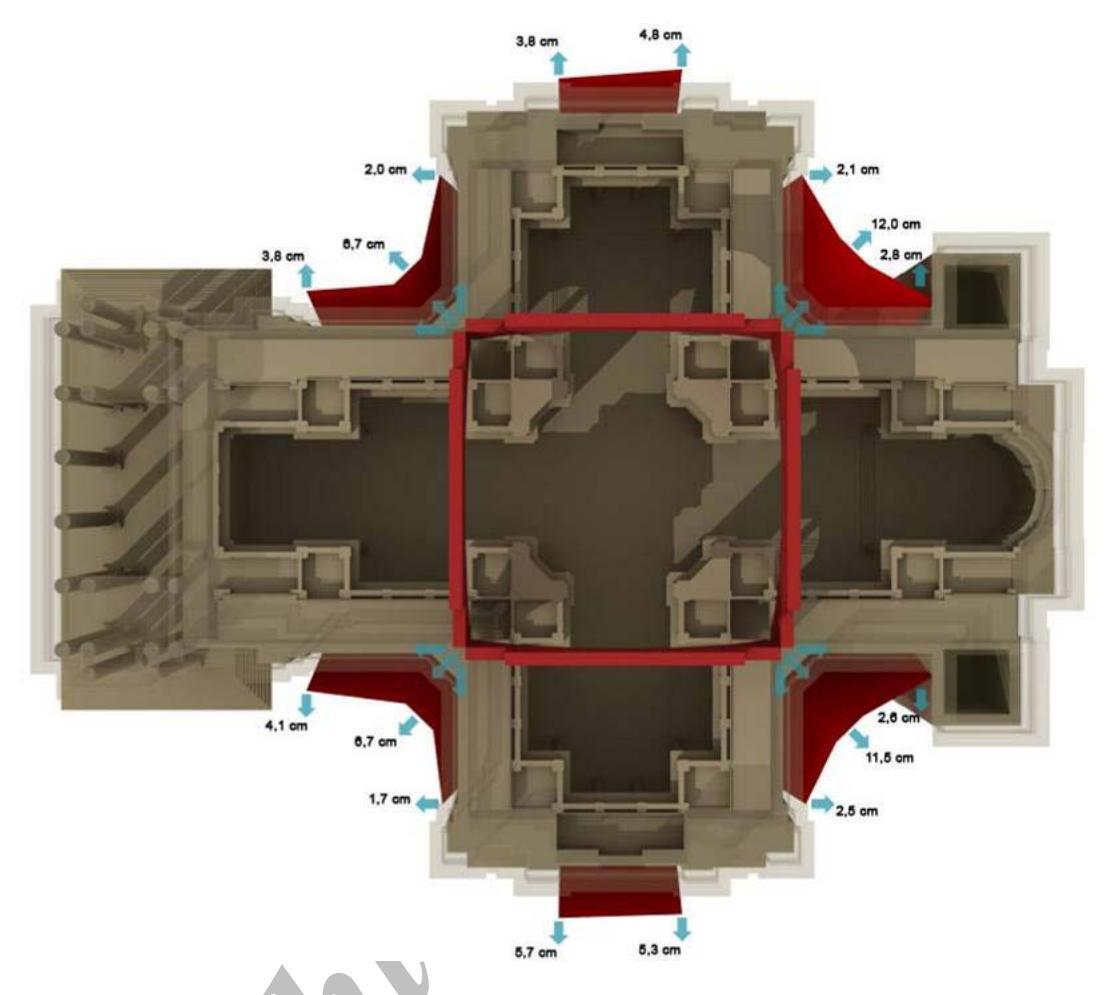
Figure 4. Survey of the rotation of the external walls [1]

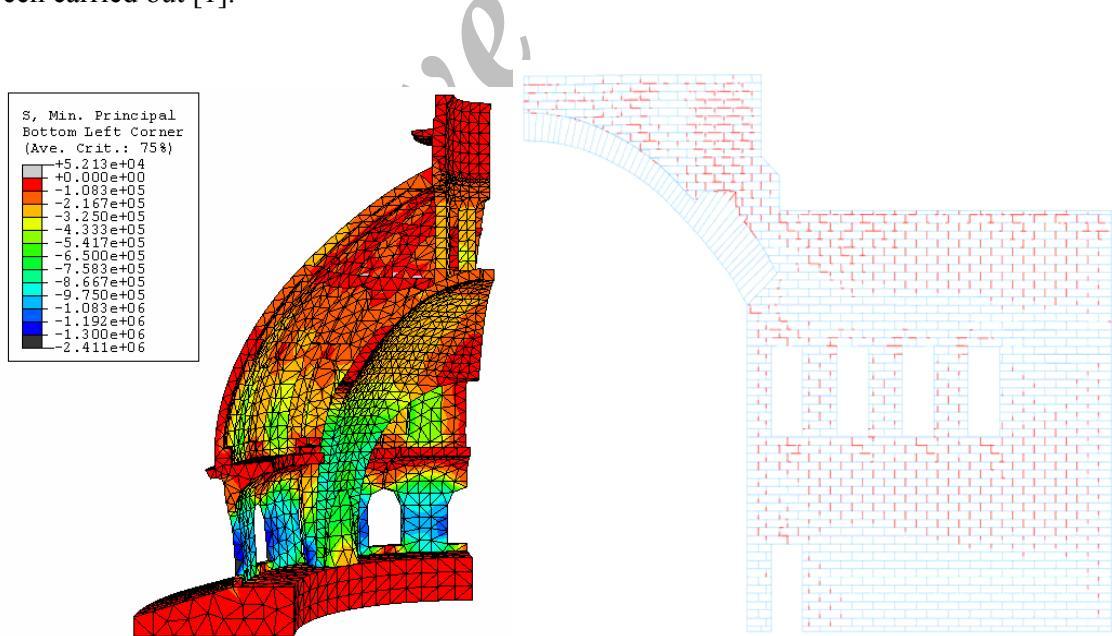
Figure 5. Finite element modelling of the two outer domes (left) and distinct element model of a great arch, that exactly reproduces the crack openings in the external walls (right) [1]

In particular, non linear finite elements analyses have been carried out to model the static and thermal behaviour of domes and "plafonds", non linear distinct elements analysis have been used in the reconstruction of the disorders in the great arches that sustain the external colonnade of the dome (Figure 5) and a variational model of quasi-static crack evolution have been adopted to understand the typical crack pattern found in the stones of the Panthéon (Figure 6). Moreover, a closed form solution for the deformation of pillars have been carried out [1].

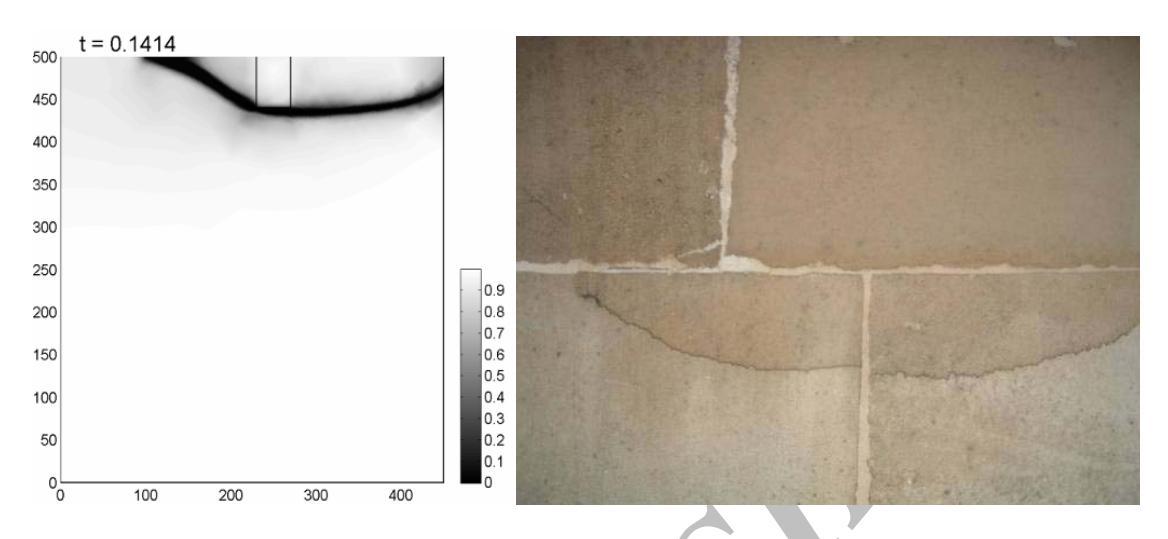
Figure 6. Comparison between the non linear numerical modelling of cracks due to traction phenomena in the iron clamps and a typical real crack [1].

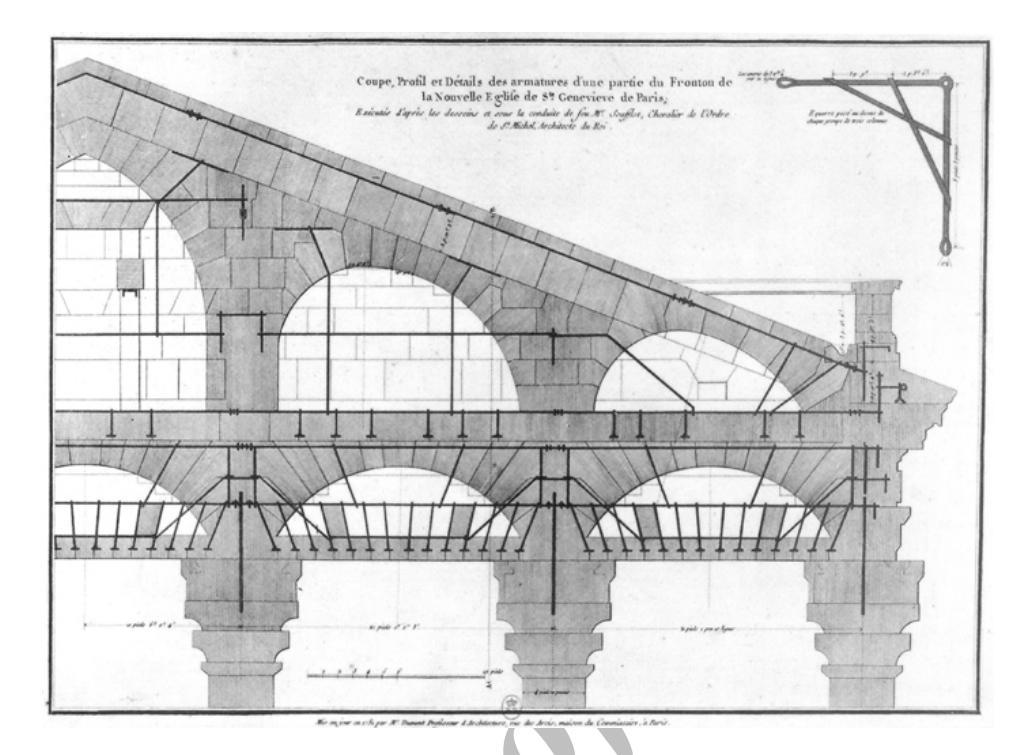
Figure 7. The drawing depicting the iron clamps in the flat arches clearly recalls reinforced concrete trusses [4]

The reinforced stone masonry was a building technique completely new at the time of the construction of the Panthéon. It was made possible by the spreading of iron due to the technological development at the beginning of the industrial era. This new technique allowed Soufflot to realize very slender structures, comparable only with the structures that one century later will be made with reinforced concrete. Indeed, looking at the drawings depicting the iron clamps in the flat arches, it seems to look at drawings of reinforced concrete trusses (Figure 7). Soufflot has developed his design basing only upon his structural intuition and also the calculations made by his friends and co-workers Gauthey and Rondelet are little compared to the complexity of the problems posed by the new structures.

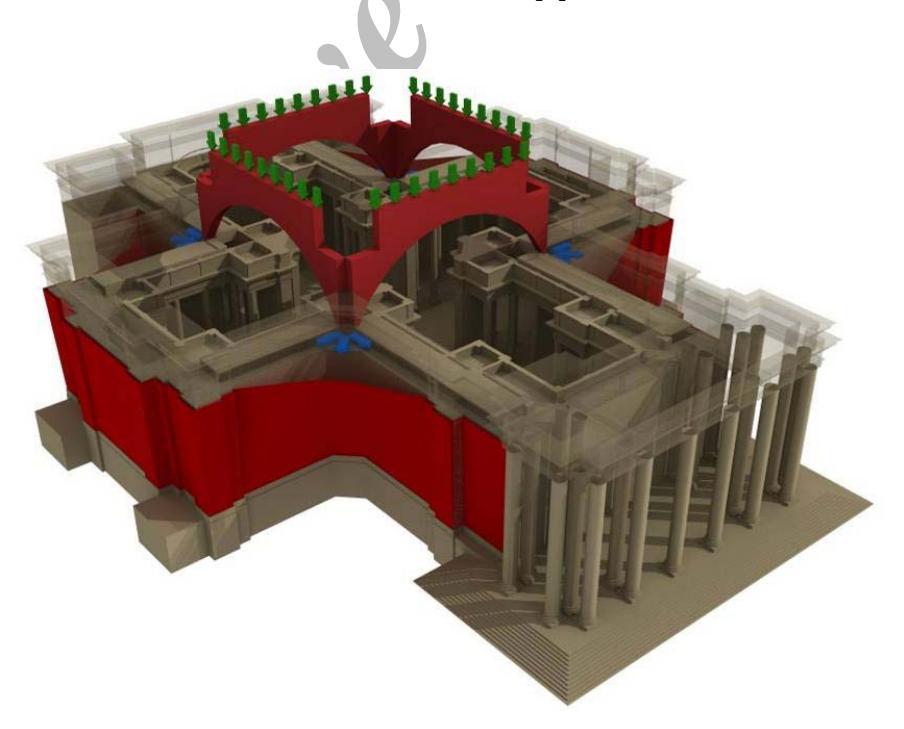
Figure 8. Scheme of the deformations and mechanisms that are at the origin of disorders in external walls (rotations and settlements) [1].

The slenderness of the structures, together with the real long time deformability of the masonry (2000 MPa) has, however, produced large deformations on structures, unpreviewed and non congruous with the fragility of reinforced stone masonry. The presence of iron clamps, indeed, produces, under long time loads, stress concentrations in the stone and consequent fractures. The characteristic shape of the cracks in the stones due to the presence of the iron clamps was exactly recreated with numerical crack models. In brief it was demonstrated as the cause of fractures, repeated in a perfectly symmetric way in the whole building, is to be traced back in the global deformability of the masonry, associated with the local fragility of connections [1]. In particular, the structural elements that mainly show problems and deformations are the four great arches, with a span of over 30 metres, that sustain the external colonnade of the tambour. These arches thrust on the boundary walls both with high static horizontal forces (about 3300 kN) and with dynamic actions caused by the wind.
