ASIAN JOURNAL OF CIVIL ENGINEERING (BUILDING AND HOUSING) VOL. 7, NO. 4 (2006) PAGES 429-452

ON THREE-STAGE MITIGATION OF LIQUEFACTION-INDUCED HAZARDS

I. Towhata* Department of Civil Engineering, University of Tokyo, 7-3-1, Hongo Bunkyo-Ku, Tokyo 113-8656, JAPAN

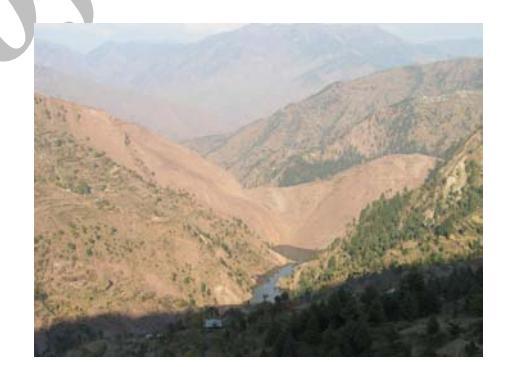
Figure 2. Slope failure and natural dam near Chakar in Pakistan during the Kashmir earthquake in 2005

Firstly, the section compares the conventional kind of earthquake damage. Figures 1 and 2 illustrate the consequence of earthquake in 2005 which hit Kashmir region, northern Pakistan. It can be seen that shaking completely destroyed the shape and function of structures. Most traditional structures, inclusive of natural slopes, have brittle nature which induces total failure once yielding occurs. Restoration requires removal of debris and reconstruction which require long time and cost.

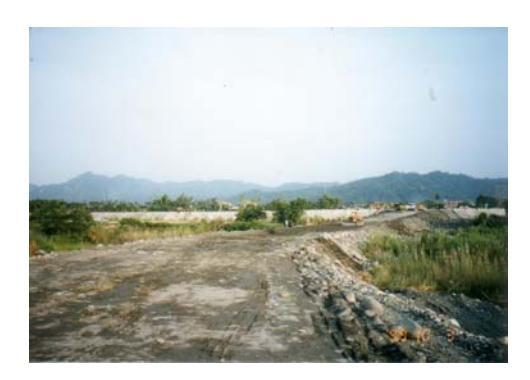
Figure 3. Quick construction of detour road after 1999 ChiChi earthquake in Taiwan

There is, however, a situation in which geotechnical structure has an advantage over other kinds of structure. Figure 3 illustrates a quick construction of emergency road after the 1999 ChiChi earthquake in Taiwan. In this earthquake, fault movement destroyed many bridges, and, in the site of this figure, emergency transportation was made possible by constructing this detour road. Thus, earth structure has this advantage of quick construction / restoration. Figure 4 demonstrates a collapse of road embankment. Although the previous section proposed an idea of network for cost-efficient principle, the 2004 Niigata-Chuetsu earthquake destroyed all the roads in the epicentral area, and the idea of network did not work properly. This adverse situation made extremely difficult and delayed the restoration

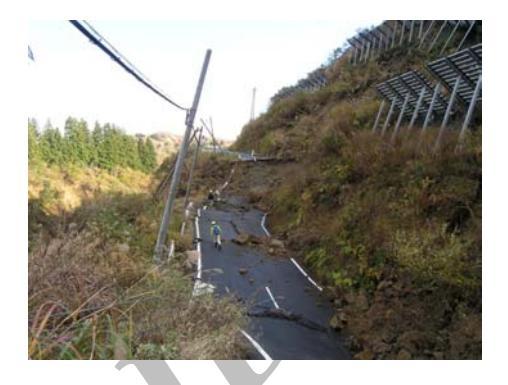
Figure 4. Fatal collapse of rural road after 2004 Chuetsu earthquake in Japan

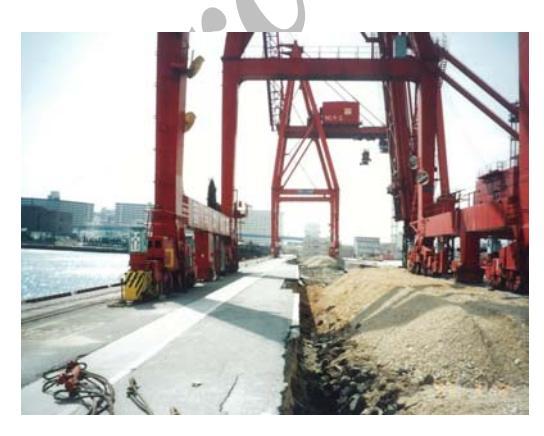
Figure 5. Heavy distortion of quay wall in

Kobe Harbor in 1995

Figure 5 illustrates the significant distortion of a gravity quay wall in Kobe Harbor which was induced by a combined effect of strong shaking (inertial force) and development of pore water pressure in the foundation as well as in the backfill. The significant displacement (several meters) and tilting of the wall made the crane get derailed and backfill surface subside. This situation stopped the function of the harbor for many months. Since the idea of quick restoration did not work, the harbor client went to other harbors and hardly came back. Another example of unacceptable deformation due to liquefaction is shown in Figure 6 in which a manhole of sewage system floated. Thus, service to local sanitary environment was intervened by liquefaction.

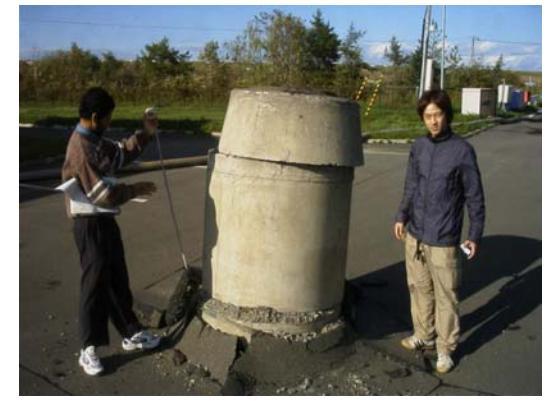
Figure 6. Significant floating of sewage

manhole at 2004 Tokachi-oki earthquake

The last example of an underground wall concerns floating of an embedded structure. In addition to floating of sewage manhole (Figure 6), a bigger water treatment tank floated during the 1964 Niigata earthquake and also in 2004 Niigata-Chuetsu earthquake. In this regard, the author carried out 1-G shaking model tests on mitigation of a bigger structure such as underground parking lot, shopping mall, subway, and highway. Figure 34 illustrates the configuration of the model. The configuration after shaking (Figure 34b) clearly indicates that the floating was accompanied by the inward movement of liquefied subsoil under the structure and that the structure was pushed upwards by this sand movement. It is therefore inferred that floating may be mitigated by preventing soil movement by installation of underground walls beside the structure.

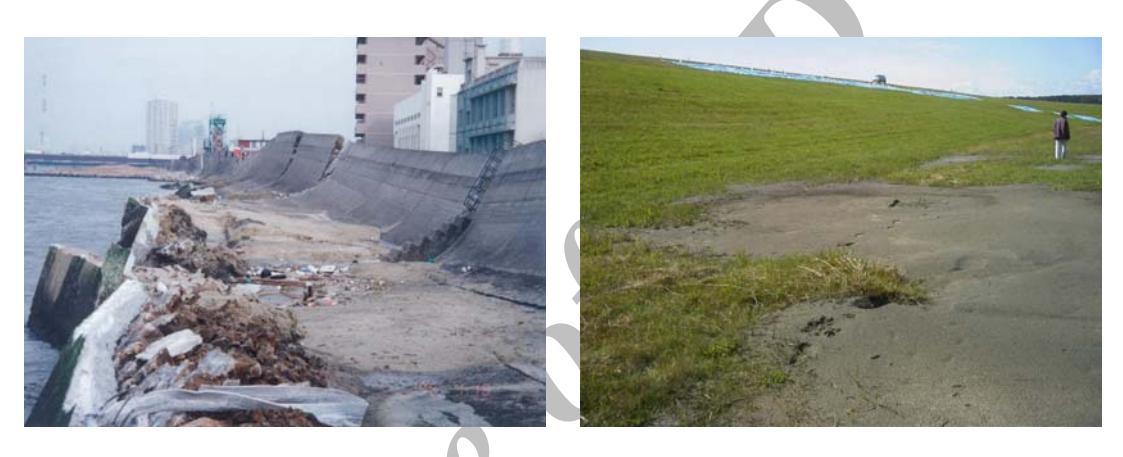
Figure 7. Significant subsidence of Yodo River dike in 1995 (Ministry of Construction)

Figure 8. Minor liquefaction near dike of Tokachi river in 2004. earthquake

Figure 7 illustrates another example of unallowable deformation. The subsidence and slope failure of Yodo River dike in Osaka City made flooding of the back area very likely. Since the main function of river dikes is to prevent flooding, significant subsidence may be fatal, while minor subsidence is not serious and can be restored within a reasonably short time (Figure 8). Thus, the essence of liquefaction-induced damage lies in the extent of residual deformation/displacement and its significance is evaluated in terms of impacts on social and economic issues. Note that liquefaction has hardly killed people except the collapse of tailing dam at El Cobre of Chile in 1960s.

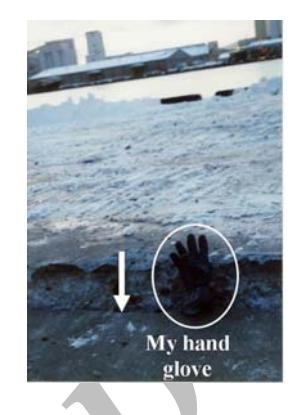
Figure 10. Minor subsidence in Kushiro Harbor in 1993 in spite of heavy seismic shaking

While the main aim of liquefaction-mitigation measure is to reduce the residual deformation to an allowable extent, the conventional approach has been more effective. Compaction of sand or installation of drains aimed at preventing onset of liquefaction under design earthquake motion. Past earthquakes verified the reliability of those measures. For example, the central part of Kobe Port Island did not develop liquefaction due to a variety of soil densification measures (Yasuda et al., 1996). For economical densification, dynamic consolidation in terms of free fall of heavy weight was proved useful in Lu-Kang site of Taiwan in 1999 (Figure 9). Gravel drains prevented liquefaction and heavy subsidence in Kushiro Harbor in 1993 (Figure 10).

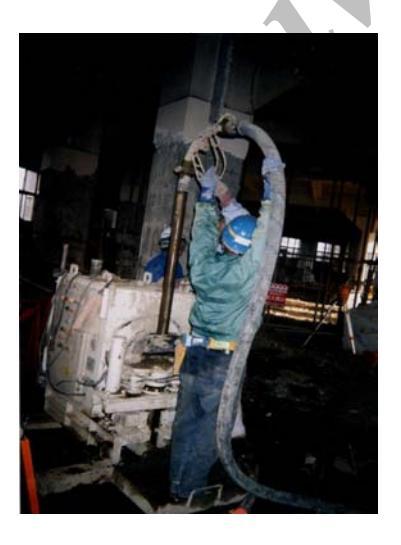
Figure 11. Compaction grouting in basement of existing building

More difficult aim has emerged in the recent times in which liquefaction-induced damage has to be mitigated in "existing" structures. Although these structures were designed to resist previous design earthquakes, the increased intensity of design earthquake in the recent times requires reinforcement of those structures. Since the ground surface is occupied by existing structures, it is practically impossible to bring in big tamping machines or to cause ground vibration for densification. Figure 11 illustrates ongoing densification of soil under an existing building. This work was carried out by compaction grouting from a basement of the building. Figure 12 shows injection of silicate grout close to an existing harbor structure immediately behind a quay wall.

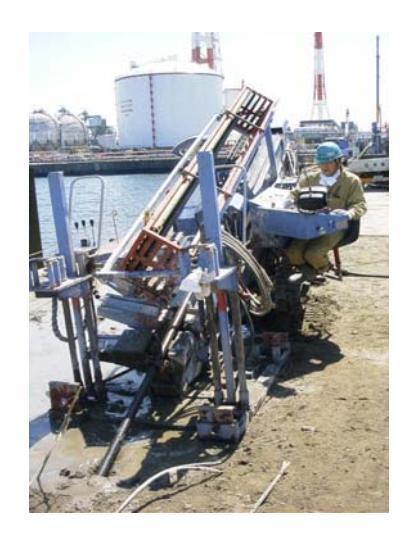
Figure 12. Soil improvement by means of silicate grout under existing structure in the vicinity of quay wall

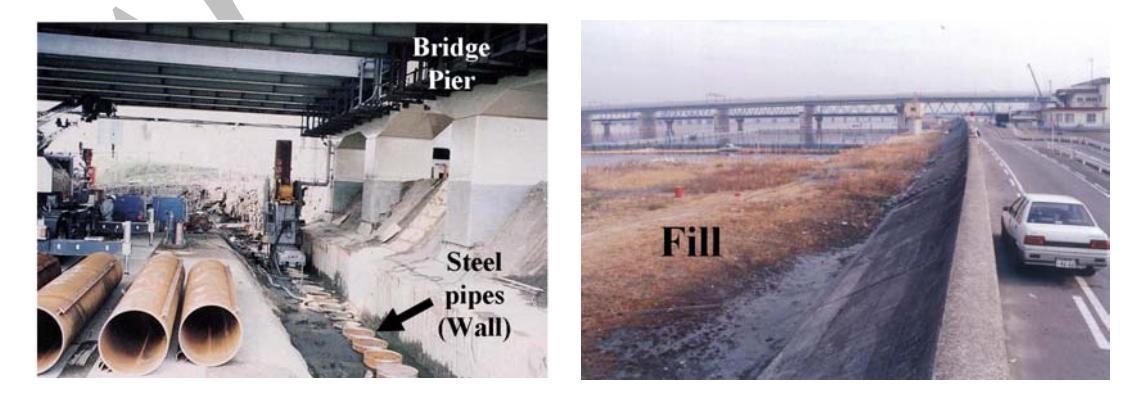
Figure 13. Sheet pile wall as mitigation

Figure 14. Minor distortion of Yodo River in

Figure 13 illustrates an example of steel pipe installation in front of an existing bridge pier. The steel pipe wall prevents lateral displacement of soils around the pier and protects it from the significant earth pressure induced by soil movement. Note that the use of steel pipe wall does not try to prevent liquefaction in the surrounding subsoil. It is attempted therein to reduce the ground displacement by installing a rigid wall. The effect of underground wall is supported by the good performance of Yodo River dike in Takami site (Figure 14) which is located to the upstream direction of the heavily damaged dike in Figure 7. To understand the reasons for different seismic performances of dikes in these two areas, Figure 15 illustrates the subsoil conditions as well as the depth of sheet pile walls. Note that the sheet pile walls under the dike were installed not to prevent liquefaction problems but to reduce seepage flow under the dike. The situations in the Takami site are characterized by three features; different soil conditions (deltaic alluvial soil which is different from younger reclaimed soil in Torishima site), the length of sheet pile wall, and the existence of fill on the river side of the dike. Since more aged soil has less possibility of liquefaction, the soil condition may be the cause of different dike performance. Moreover, the thickness of alluvial sand (deltaic deposit) which is prone to liquefaction is approximately 10 meters along the river channel. Thus, the sheet pile in the Takami site reached the bottom of this sandy layer, and was probably able to prevent the lateral displacement of the foundation sand towards the river channel. The mitigative mechanism of underground walls is illustrated in Figure 16 in which the subsidence of the overlying dike is associated with the subsoil movement in the lateral direction. Installation of walls can reduce the lateral soil movement and consequently the subsidence of the overlying embankment.

Another reason for different behaviors is the existence of fill on the river side of the dike. Since the Takami site (Figure 14) had a fill which measured 50 m in width, its weight reduced the potential of lateral sliding. This is in good contrast with the dike in Figure 7 that had no such a fill. Figure 17 shows another evidence of wall effects. The foundation of the building on the left side was surrounded by a wall which was constructed upon excavation of the basement. Since this wall existed when the building was shaken by the 1995 Kobe earthquake, the building was not affected by the soil movement caused by a nearby quay wall deformation.

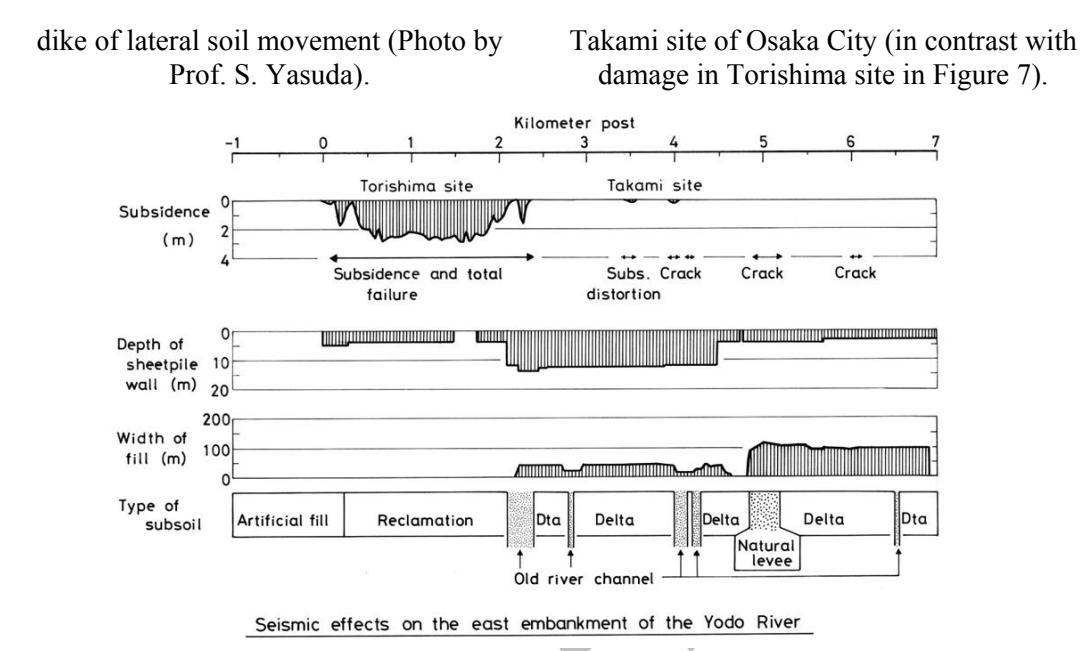
Figure 15. Variation of depth of sheet pile wall and width of river-channel fill along Yodo River

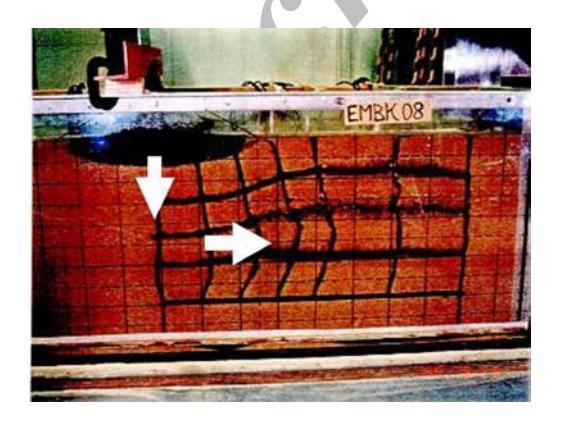
Figure 16. Displacement of liquefied subsoil under embankment model (Mizutani et al., 2001)

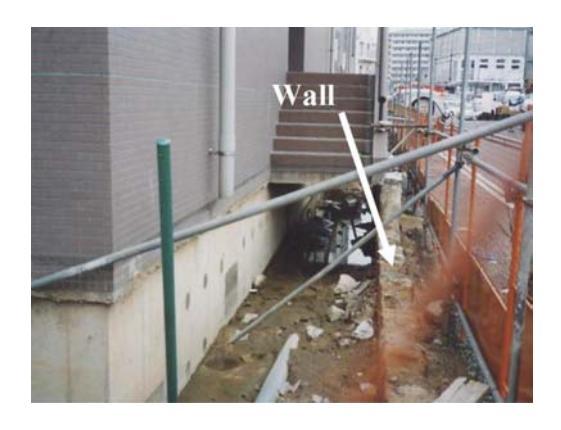
Figure 17. Protected building near quay wall in Kobe Harbor (Photo by Prof. J.Koseki)

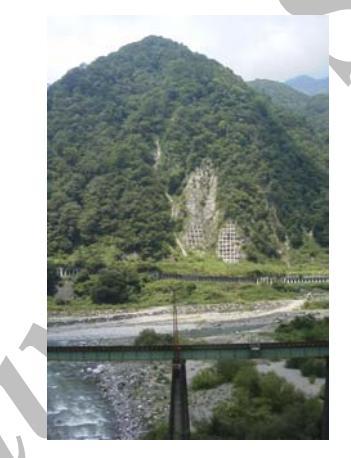
Figure 18. Slope reinforcement to prevent its failure and production of debris (mitigation at source)

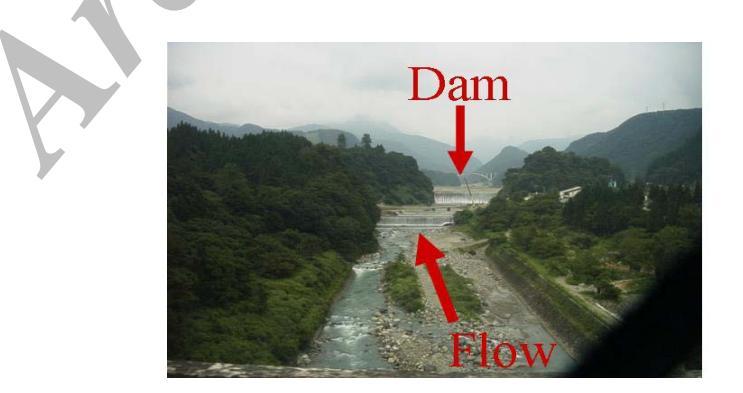
Figure 19. Erosion control dam to stop mi-gration of debris to downstream area (mitigation on path).

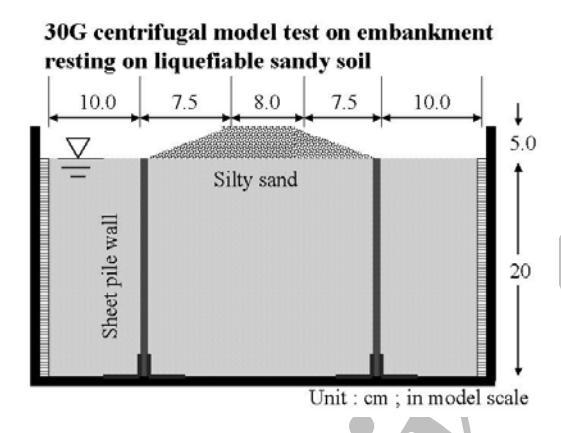
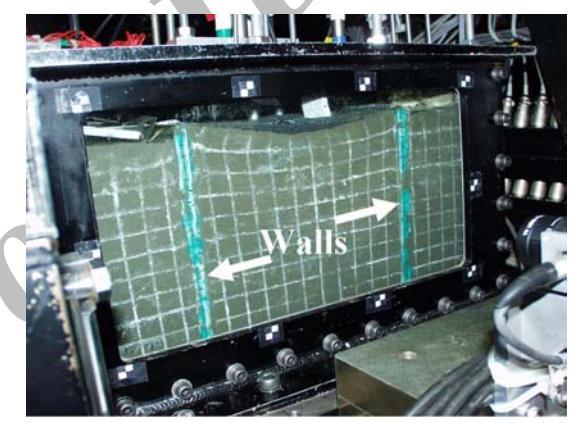
Figure 20. Centrifugal model test on mitigation of subsidence of embankment

Figure 21. Embankment model after subsidence (30-G model)

Model tests on the mitigative effects of underground walls have been undertaken on a variety of situations. The first testing concerns the subsidence of embankment or river dike which rests on liquefiable subsoil. Figure 20 illustrates a 30-G centrifugal model in which two sheet pile walls were installed under the foot of the slopes. The bottoms of the walls were fixed at the base in order to prevent translation and rotation. This reproduces the reality in which walls penetrate into an unliquefiable soil layer. As illustrated in Figure 16, those walls were intended to decrease the lateral displacement of liquefied subsoil, reducing consequently the subsidence of the surface embankment. Figure 21 shows the appearance of the model after subsidence. The walls developed their bending stiffness to reduce lateral displacement of subsoil. As the subsidence of the embankment shows, walls cannot perfectly prevent the subsidence, because soil movement between two walls (Figure 22) cannot be prevented and is still able to induce subsidence.

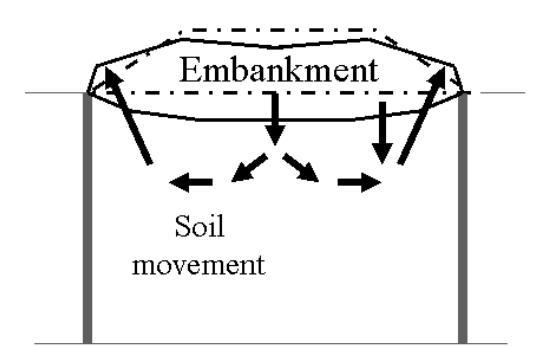
Figure 22. Subsidence of embankment induced by soil migration between two underground walls.

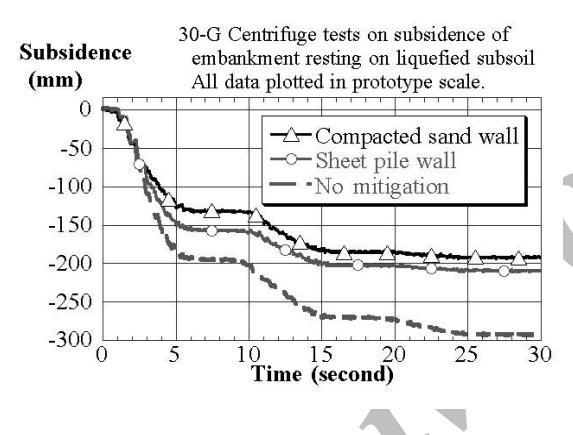
Figure 24. Time history of subsidence at bottom of surface embankment.

Figure 23 illustrates the time history of base shaking in the test on embankment. Excitation took place three times with decreasing the amplitude in order to reproduce the effects of aftershocks in reality and also to study the effects of continued shaking on deformation of liquefied sandy ground. Accordingly, the time history of subsidence in Figure 24 consists of three stages of development. Deformation of subsoil thus occurred only when shaking was ongoing. While two kinds of underground walls were employed in the present tests (sheet pile wall and compacted sand wall), both measures were able to reduce the subsidence.

By comparing Figures 24, 30, and 36 it is detected that mitigation of floating is more effective than that of subsidence of tank and embankment. The reason for this is illustrated in Figure 38. When liquefied soil tries to come in towards the underground structure, sheet pile walls are pushed inward as well. While bending stiffness is the source of resistance of walls against soil movement, the stiffness of walls is further increased by the rigidity of the underground structure. In case of subsidence, on the contrary, sheet pile walls are simply pushed outwards and there is no such additional stiffness. It seems thus promising to install walls around existing structures in order to reduce floating.

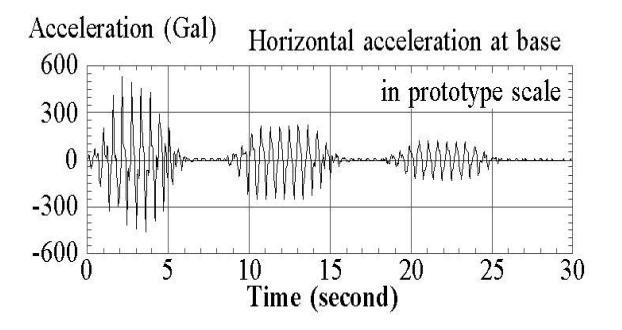
Figure 23. Time history of base acceleration in test of Figure 19

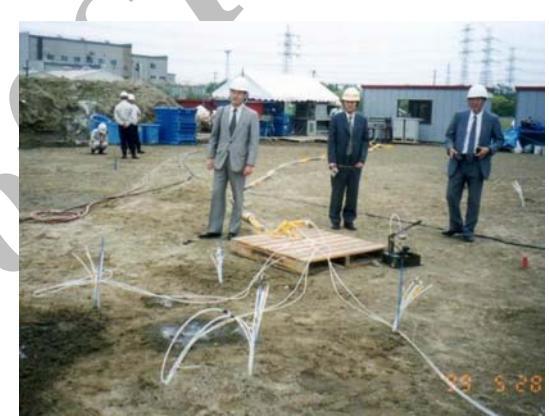
Figure 25. Seeping of silicate liquid into sandy ground

Grouting can construct an underground near an existing structure as well. Figure 25 shows the injection of silicate liquid slowly and uniformly into sandy ground. This procedure does not employ any big equipment and does not cause vibration. Figure 26 demonstrates an excavated shape of grouted sand. This effect of uniform seeping is permanent without weathering and is not poisonous to human health either.

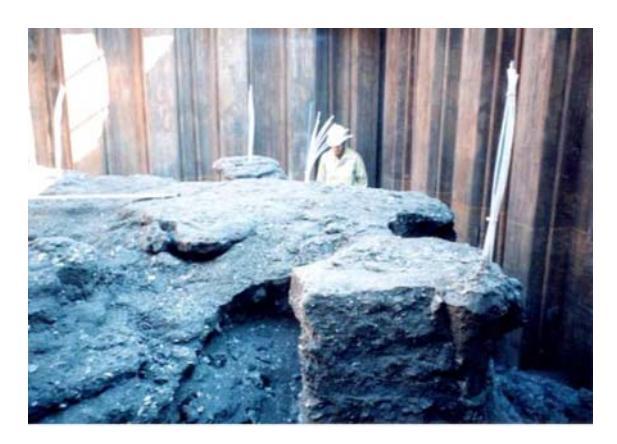
Figure 26. Excavation of subsoil grouted by seeping of silicate liquid.

Towhata and Kabashima (2001) conducted triaxial shear tests to examine the improved behaviour of grouted sand. Triaxial compression and extension tests in drained manner (Figure 27) revealed that rigidity of sand was improved by this grouting. Figure 28 further shows the increased liquefaction resistance of grouted sand. Although cost is high, this measure is able to improve sand under difficult situation where ground deformation or vibration is not allowed by existing structures. To examine the mitigation of subsidence by this grouting, 1-G model tests were conducted. Figure 29 illustrates a model of liquid storage tank with underground walls made by grouting. Base shaking with 500 Gal and 10 Hz with 20 cycles caused different extent of subsidence in accordance with the type of walls (Figure 30). Although grouting of entire subsoil exhibits the best performance, grouting with limited width achieved satisfactory results as well.

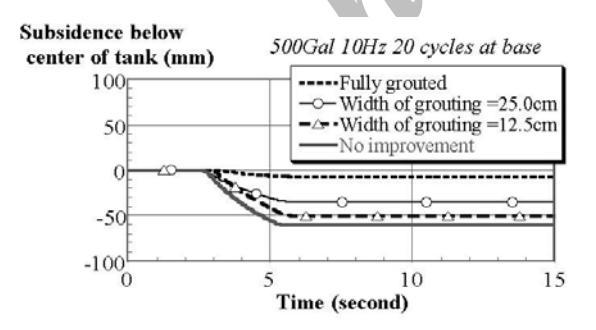
Figure 30. Time history of subsidence of tank model with and without grouted walls.

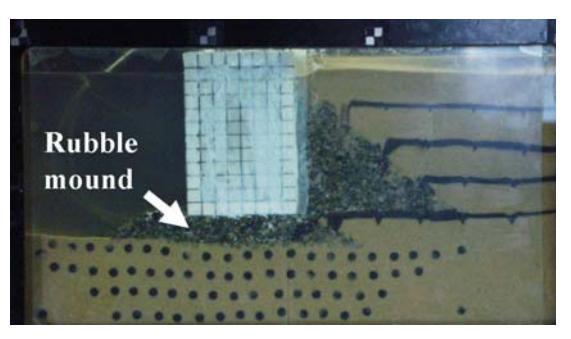
Figure 31. Deformed shape of gravity quay wall model without mitigation(30-G centrifugal test)

A series of shaking table tests were conducted in a 50-G centrifugal environment. Base shaking was of 430 Gal in amplitude, 2 Hz in frequency, and 20 seconds in duration time; all expressed in the prototype scale. Figure 31 indicates the distortion of a model without mitigation. The black dots under the quay wall are markers that indicate displacement of the sand replacement. After shaking, the foundation sand moved out towards the sea and the quay wall model translated and tilted in the same direction. Thereinafter three more tests were carried out in order to examine the effects of several mitigative measures (Figure 32). The first mitigation was the seeping grout under the quay wall. The second one was a use of sheet pile wall in front of the wall which was intended to prevent lateral displacement of the foundation sand. The third mitigation was the densification of both foundation and backfill. Although this measure is not of practical value because it is too costly, it was examined for comparison purposes.

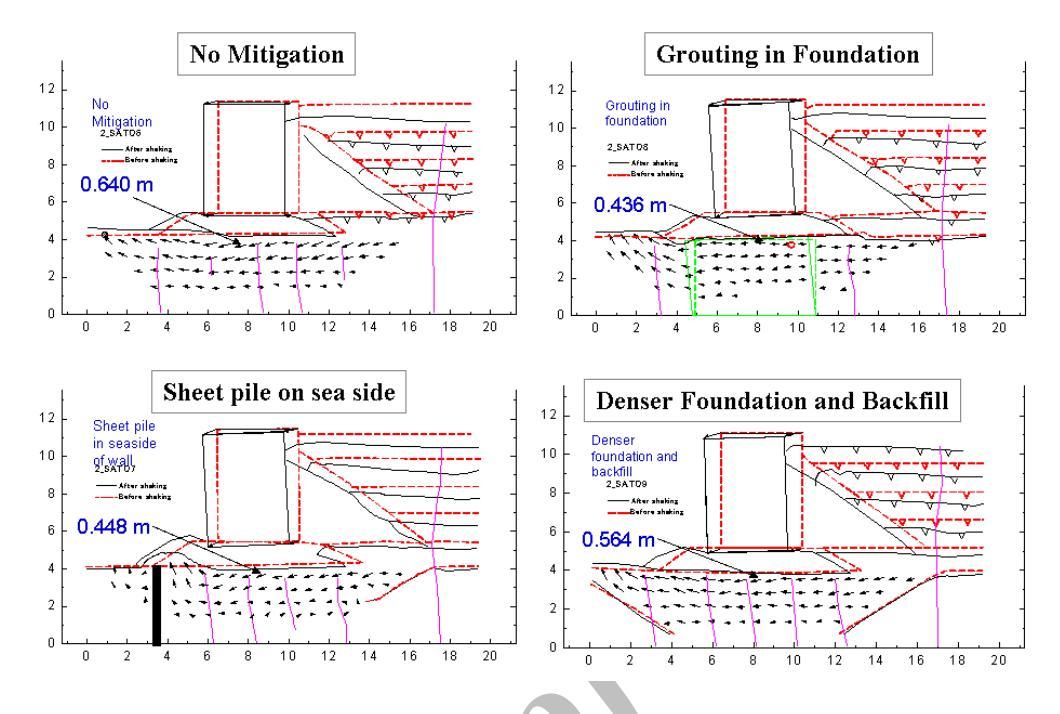
Figure 32. Deformation of foundation sand under gravity quay wall obtained by 30G centrifugal tests)

The consequent deformation in the foundation was observed by using marker locations

and was illustrated in Figure 32. It is indicated by the displacement numbers in the figure that all the three mitigative measures reduced the lateral displacement at the top of the foundation sand. This mitigative effect was particularly important in the case of sheet pile wall and grouting. The displacement at the top of the quay wall was, however, similar in all tests. This is because shear deformation in the rubble mound (see Figure 31) was greater and the tilting of the quay wall body was greater as well when foundation sand did not deform very much (Figure 33). Probably the stabilized foundation sand increased the inertial effects and dynamic earth pressure behind the wall.

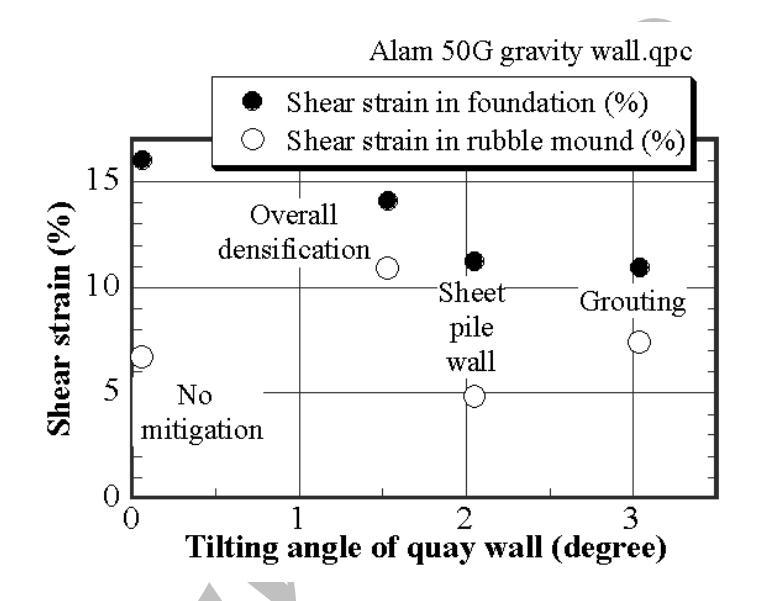
Figure 33. Effects of mitigative measures on deformation of quay wall model.

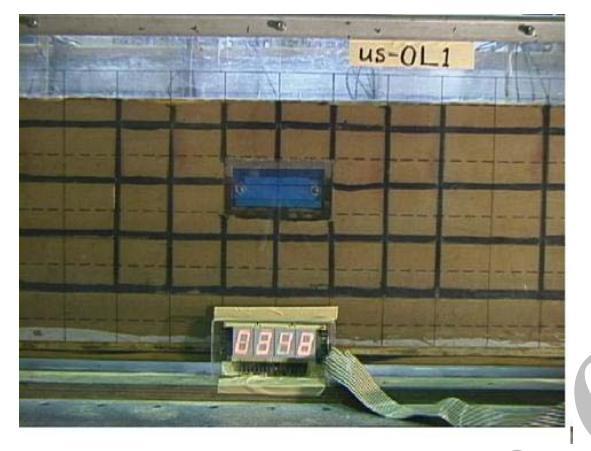
(a) prior to shaking

(b) after shaking and liquefaction

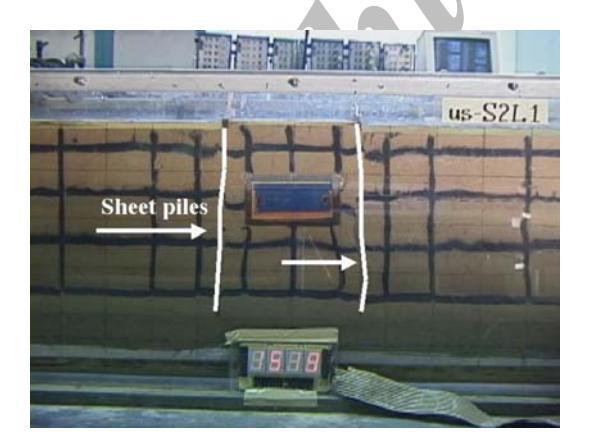
Figure 35. Reduced floating of underground structure model after liquefaction

Figure 35 illustrates the appearance of a model with sheet pile walls on both sides. Although floating still occurred, its magnitude was drastically reduced. Figure 36 compares the effects of three mitigative measures on the magnitude of floating. In addition to an ordinary sheet pile wall, tests were run on walls made by densification of soil and special sheet pile wall with drainage pipe (Figure 37). It is found there that floating is reduced to 10% or less by installing suitable mitigation measure.

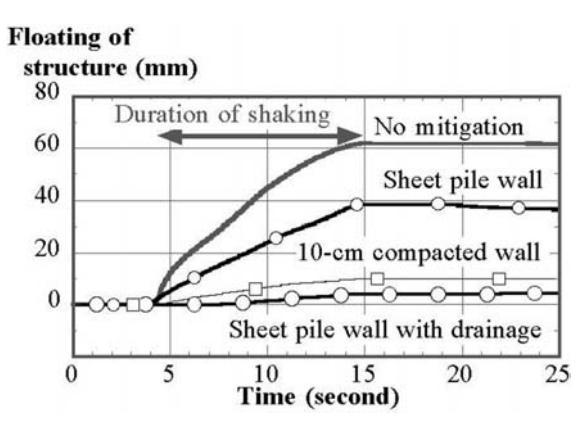
Figure 36. Comparison of floating of underground structure models with and without mitigation

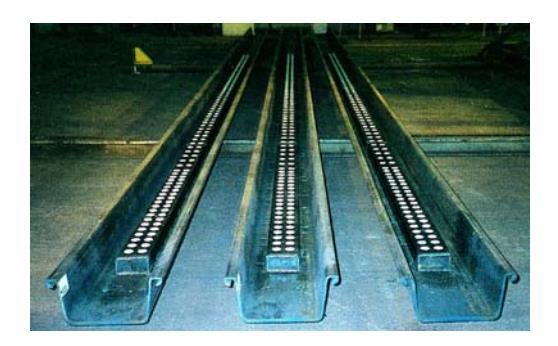
Figure 37. Sheet pile wall with drainage pipe

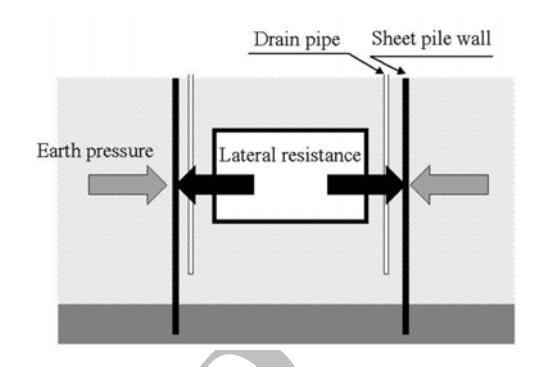
Figure 38. Cause of effective mitigation in floating of underground structure

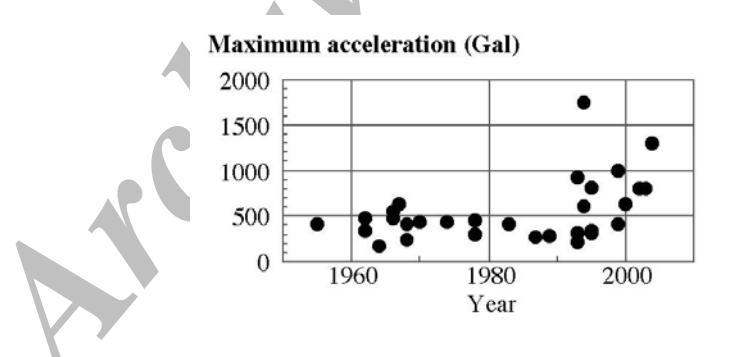
Figure 39. Maximum accelerations which have been recorded during past earthquakes

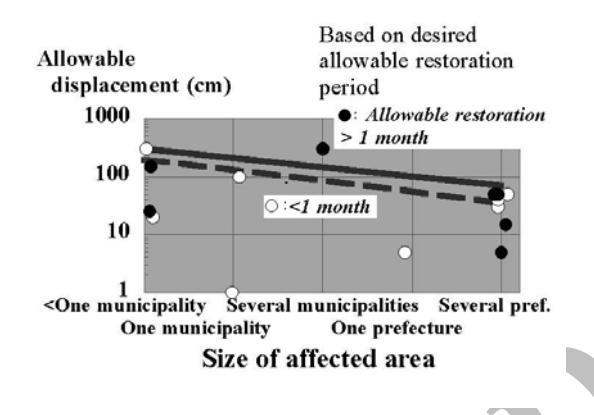
Figure 41. Relationship between allowable displacement and size of area to be affected in terms of allowable restoration period.

By considering thus that the negative effects to the public consist of time and aerial size, Figure 41 was obtained. In this figure, people's opinion on the allowable time for restoration (allowable time without service) is summarized in relation with the allowable displacement and size of affected area. To make the idea clear, Figure 41 classified the allowable restoration time into two groups; longer or shorter than one month. This classification is related with the importance of structures (shorter time for important structures) and also the type of design earthquake (longer restoration time for very rare earthquakes).

Figure 41 is intended to help decide the allowable displacement / deformation of

geotechnical structures in a rational way. As stated before, direct decision on the allowable deformation is not easy. It is on the contrary easy to decide the restoration "time" such as one week or three months. It is very possible to decide the size of an area which would be affected by damage in concerned structure as well. For example, closure of a national important highway would affect the whole nation, while stopping of local gas supply affects a much smaller area. By combining these aerial and time factors, Figure 41 gives the allowable displacement. In other words, the earthquake-induced deformation should remain within a limit for which the restoration period is shorter than the target restoration time. This basic principle is easy to be followed in practice, although detailed relationship between displacement and restoration time varies with types of structures and other situations.

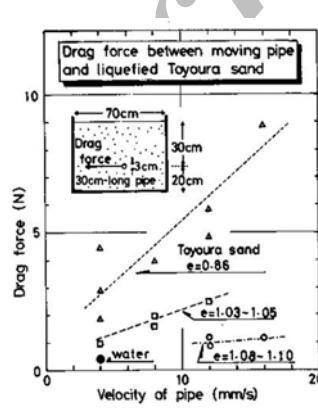
stress embedded pipe

$\begin{array}{c} & \overbrace{0}^{l} & \overbrace{0}^{l} & \overbrace{10}^{l} & \overbrace{10}^{l} & \overbrace{20}^{l} \\ \hline & Velocity of pipe (mm/s) \end{array}$ Figure 42. Rate dependency of drag force stepwise quick loading of deviator
Figure

While there is a variety of idea on the mechanical properties of liquefied sand, the author makes use of the idea of (Bingham) viscous modeling. This idea originally comes from model tests by Kogai et al. (2000) in which the drag force to pull a pipe in liquefied ground increases linearly with the velocity (Figure 42). Similar observation has been made from lateral load exerted by flow of liquefied sand on pile (Sesov et al., 2004).

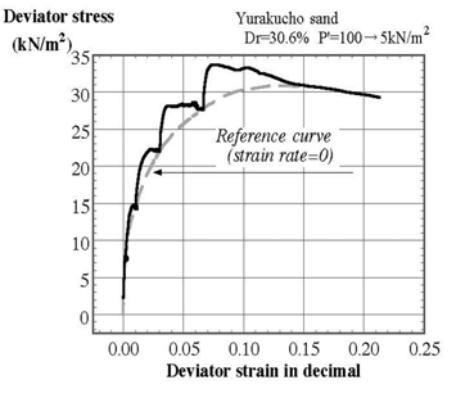
Figure 43. Triaxial compression test with in drained manner (Gallage et al., 2005)

In the test of Figure 43, a loose sandy specimen was consolidated under 100 kPa, and the effective stress was reduced to 5 kPa by introducing high back pressure (pore water pressure controlled externally) or running undrained cyclic loading. This procedure reproduces the process of liquefaction in reality. A drainage valve of a triaxial apparatus was then opened and triaxial compression was conducted while maintaining constant the pore water pressure and the lateral effective stress (σ'_3). In the stress-strain diagram of Figure 43, the deviatoric stress, $\sigma_1-\sigma_3$, was increased by steps followed by constant value. This way of loading was intended to measure creep deformation of sand and thereby to obtain the viscous parameters of sand. The reference curve in the figure was obtained by connecting the stress-strain state at the end of creep. Therefore, this curve indicates rate-independent and frictional nature of sand, and the difference between the measured and reference curves gives the rate-dependent nature.

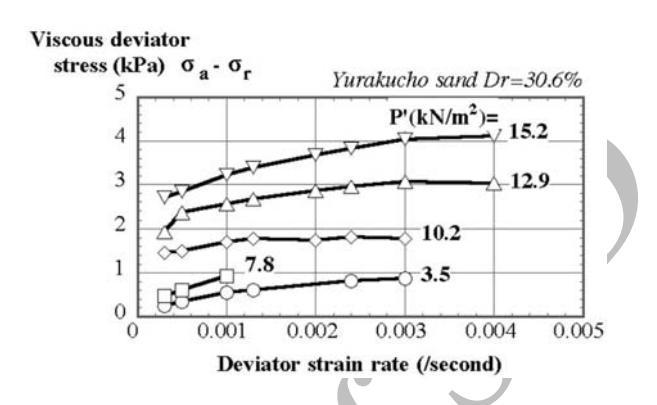
Figure 44. Bingham nature of liquefied sand under low effective stress.

Figure 44 depicts the viscous component of stress which changes with strain rate. Although there is no proportionality, a linear relationship is reasonable between strain rate

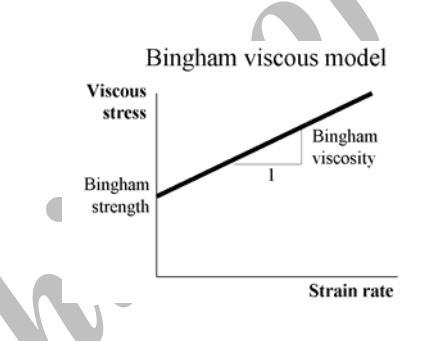
Figure 45. Schematic diagram of Bingham viscous model

and stress. Therefore, it was decided to model this behavior by Bingham viscous model which is expressed by strength and viscous coefficient (Figure 45). These Bingham viscosity parameters were read from experimental data and were plotted in Figures 46 and 47 against the mean effective stress. Since triaxial specimens could not maintain their shape and stability under zero effective stress, test results under low but still positive effective stress were collected, plotted, and were extrapolated towards zero stress in order to assess the nature of liquefied sand. It was found accordingly that the Bingham strength vanishes in completely liquefied state, changing sand to a Newtonian viscous liquid, and that the viscosity coefficient lies in the range of 30 to 100kPa.sec.

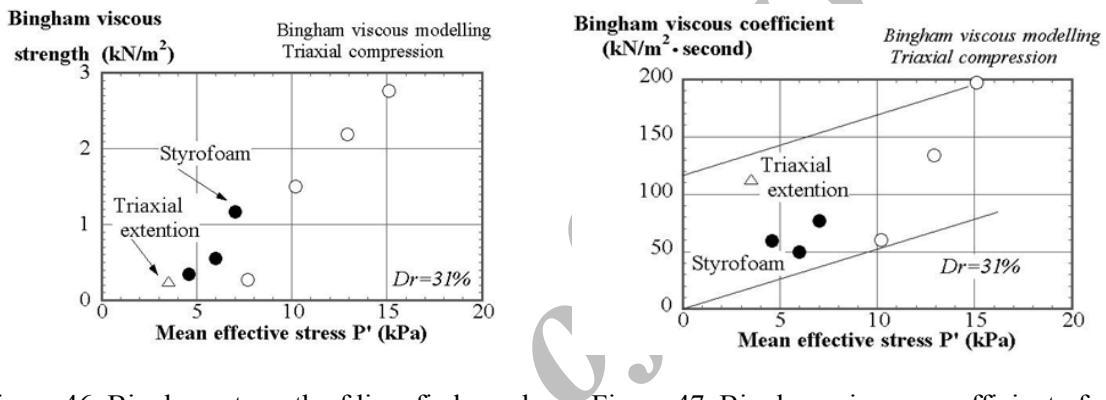
Figure 46. Bingham strength of liquefied sand under low effective stress.

Figure 47. Bingham viscous coefficient of sand changing with effective stress.

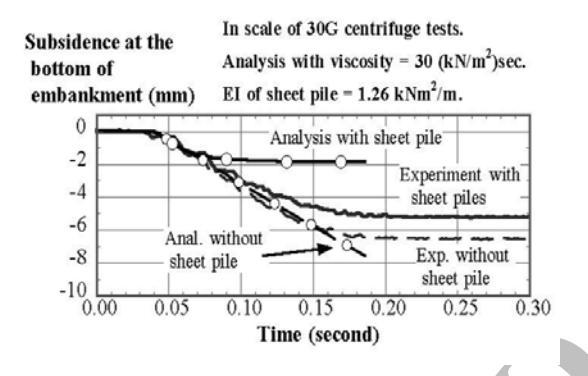
Figure 48. Viscous analysis on subsidence of embankment resting on liquefied subsoil

By using the obtained viscous parameters (Bingham strength=zero), a few calculation was conducted. For the analytical details, refer to Towhata et al. (1999). Firstly, the centrifugal test on subsidence of embankment resting on liquefied subsoil (Figure 20) was calculated in Figure 48. The mitigative effects of sheet pile walls are included here. The calculated time history of subsidence seems to be reasonable. Noteworthy is that this calculation requires only a limited number of data such as thickness of liquefiable soil layer and viscosity together with unit weight of soil. The second analysis concerned the floating of an underground structure (Figures 34 and 35). An analysis on the case without mitigation (Figure 34) was conducted by varying the viscosity and the best-fitting coefficient of viscosity was found to be 10kPa.sec (Figure 49) By using this, the case with sheet pile walls was analyzed in Figure 50. Although the agreement is not yet satisfactory, the mitigative effects were somehow reproduced by the analysis.

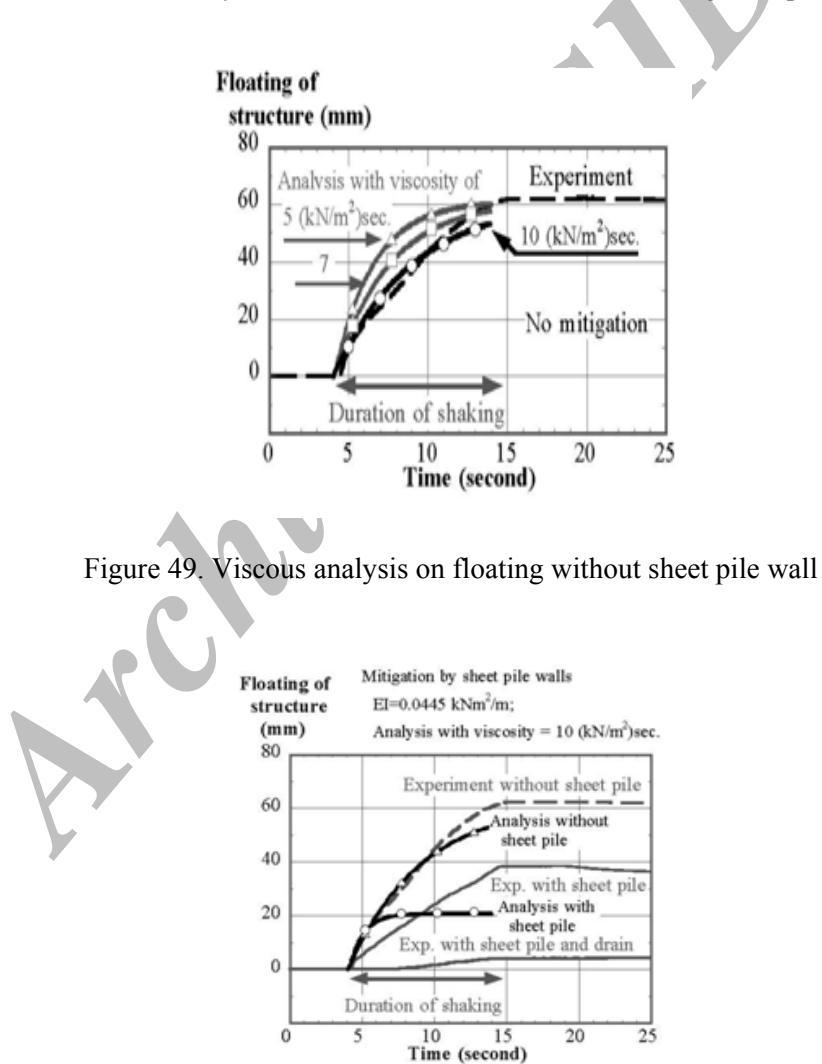
Figure 50. Viscous analysis on floating with mitigation by sheet pile walls

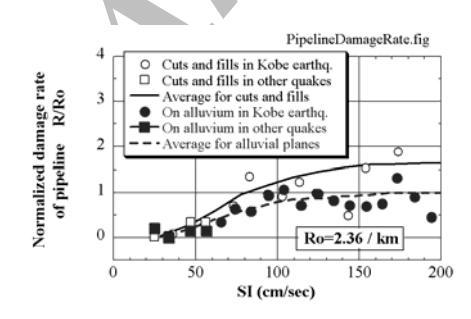
Figure 51. Relationship between number of damage of low-pressure gas pipeline and SI value (after Shimizu et al., 2006).

In which T stands for the natural period of a structure and the critical damping ratio is 20%. There is an empirical correlation between SI and the number of gas pipeline damage per km (Figure 51).

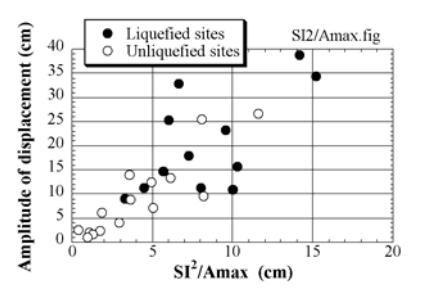
Figure 52. Empirical correlation between ground displacement, SI, and Amax (Towhata et al., 1996)

The validity of this equation is verified in Figure 52. Based on model tests and analyses of earthquake motion records, it was decided by Towhata et al. (1996) to use a displacement mode in Figure 53, and, by using the assessed displacement, the thickness of liquefied soil is quickly assessed by

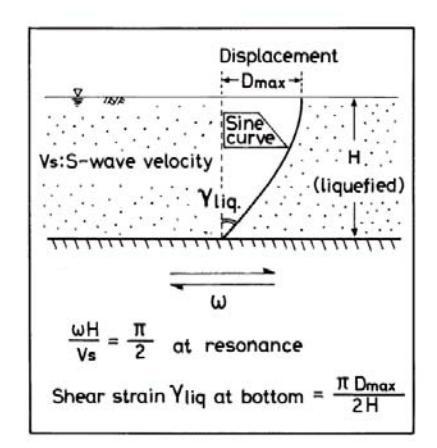
Figure 53. Mode of displacement in liquefied soil

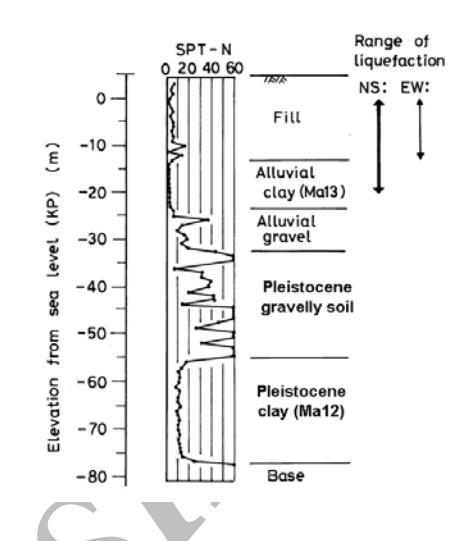
Figure 54. Assessed thickness of liquefaction in Kobe Port Island

Among many examples to validate this formula, the case of Kobe Port Island is illustrated in Figure 54. By deploying 3,700 monitoring stations, SUPREME is expected to help avoid emergency problems due to gas leakage.
