ASIAN JOURNAL OF CIVIL ENGINEERING (BHRC) VOL. 14, NO. 2 (2013) PAGES 225-238

RESISTANCE OF REINFORCED GEOPOLYMER CONCRETE BEAMS TO ACID AND CHLORIDE MIGRATION

K. Kannapiran^{*}, T. Sujatha and S. Nagan Thiagarajar College of Engineering, Madurai-625 015, Tamilnadu, India

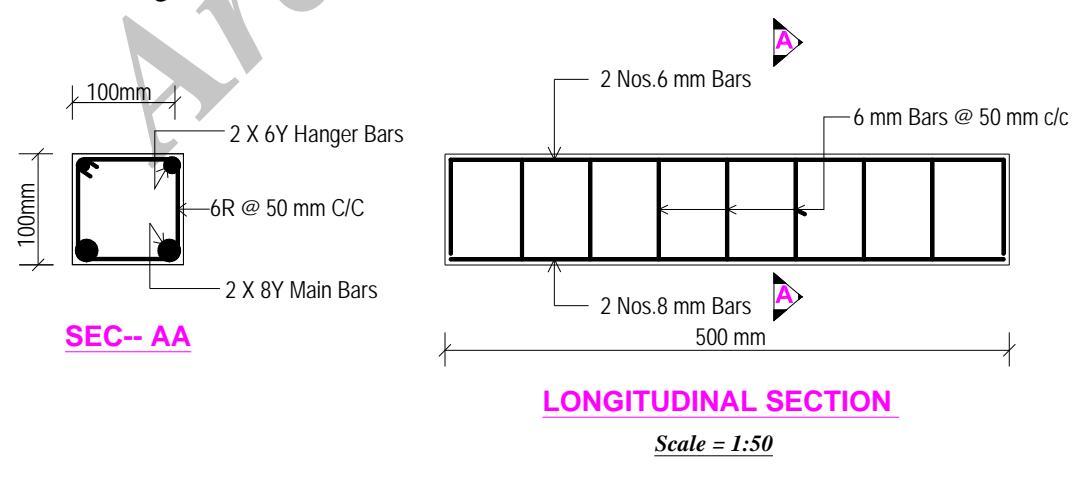
Figure 1. Sectional views of specimen (typical)

Weighed quantity of Sodium hydroxide (NaOH) in flake form to suit 8M is allowed to dissolve in potable water. Heat is generated when NaOH gets dissolved in water and the solution is stirred till it is cooled. This solution is mixed with sodium silicate solution to obtain alkaline solution. Fly ash and fine aggregate are first mixed in a 150kg capacity Pan mixer for about 2 minutes for uniform mixing. Alkaline solution is added to the dry mix of fly ash and fine aggregate and allowed to get mixed for 5 minutes. Surface wet coarse aggregate is added to the mixture and mixed for another 5 minutes[8]. Measured quantity of super plasticizer is added to the mixture for considerable workability. Oil is applied onto the surfaces of 100mm x 100mm in cross-section and 500mm long steel moulds for easy demoulding. 2 numbers, 8mm diameter rods for tensile reinforcement (1%), 2 numbers, 6mm dia hanger rods with 6mm dia two legged stirrups at 50mm centres are fabricated and placed inside steel moulds. The Longitudinal section and cross sectional details of Specimen are shown in Figure 1.

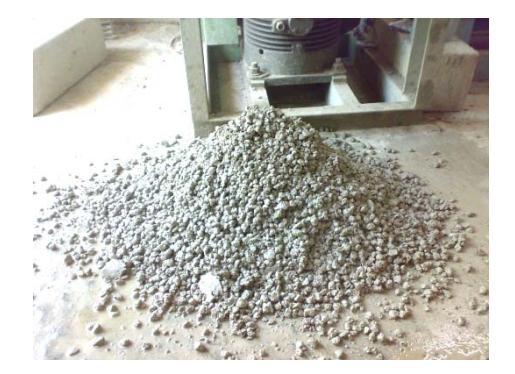
Figure 2. Fresh geopolymer concrete ready to use

Prepared geopolymer concrete is poured into the moulds in layers and the concrete is vibrated in table vibrator for better compaction. The glassy appearance of fresh Geopolymer Concrete is shown in Figure 2.

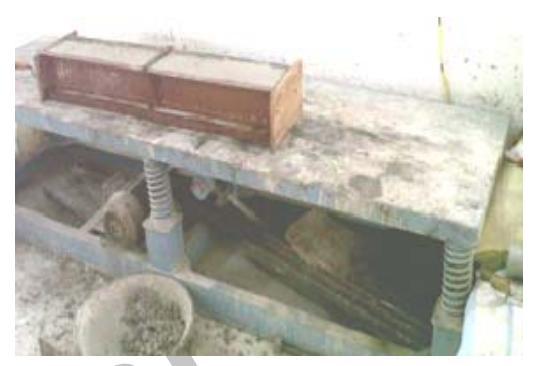
Figure 3. Specimen being vibrated

Geopolymer concrete beams in steel moulds are placed inside heat curing chamber and cured at 70° C for 24 hours. The beams are allowed to get cooled in room temperature for one day and are demoulded. Totally 27 numbers of beams are manufactured of which 12 numbers each for sulfuric acid attack and chloride attack tests with 3 numbers being control specimens. The casting of specimen is shown in Figure 3.

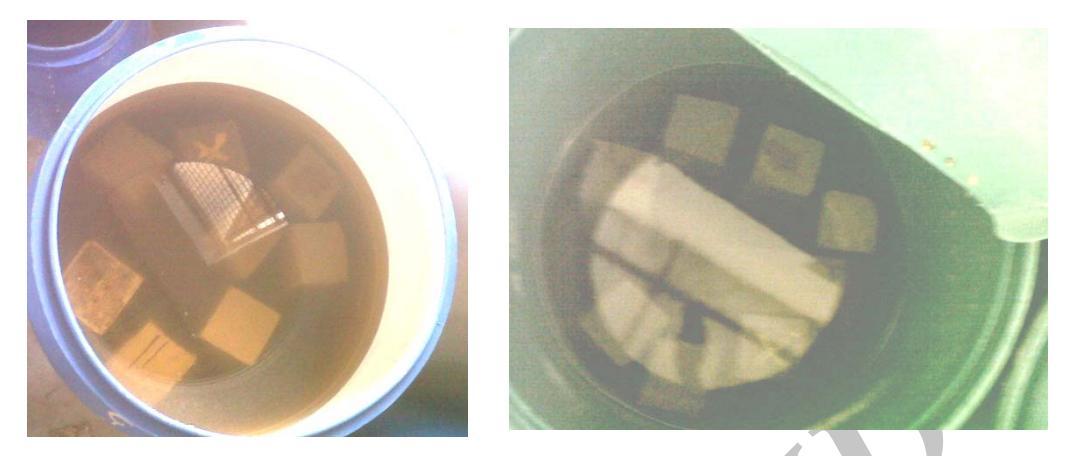
Figure 4. Specimens immersed in the solutions

The concentrated sulfuric acid of 98% purity and density of 1.85 g/cc was utilised to prepare the sulfuric acid solution. 55 ml of concentrated H₂SO₄ was mixed with 945 ml of potable water to reach one litre of acid solution. Sulfuric acid (H₂SO₄) solution was prepared in plastic container to 10% concentration. For the study on chloride attack, solution was prepared by mixing 5% hydrochloric acid (HCl) and 5% sulfuric acid (H₂SO₄) in plastic container. 12 numbers of specimens were immersed in their corresponding solution for 180 days. The volume of solution was kept in such a manner that not less than four times the volume of specimens immersed was maintained throughout this study. The solution was replaced with fresh one after 30 days. The specimens subjected to Chloride attack is designated as 'A' and acid attack as 'B'. The specimens put in the respective solution are shown in Figure 4.

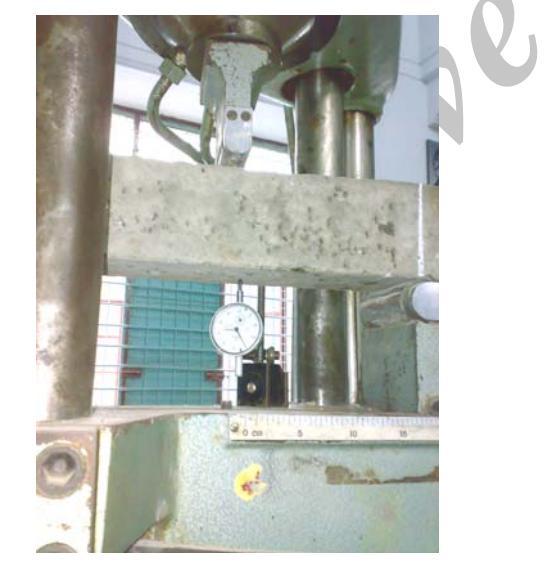
Figure 5. Typical flexural strength test set up before test

Two specimens were taken out after 7, 15, 30, 60, 120 and 180 days from respective solutions. All the specimens were allowed to dry in room temperature for 24 hours and then dried in heat curing chamber at 60° C for 2 hours. Visual appearance, weight loss and change in flexural strength were noted. The flexural strength test set up is shown in Figure 5. The change in microstructure due to permeability of aggressive solution was also studied by X-ray diffraction (XRD) and scanning electron microscopy (SEM), at the end of 180 days.

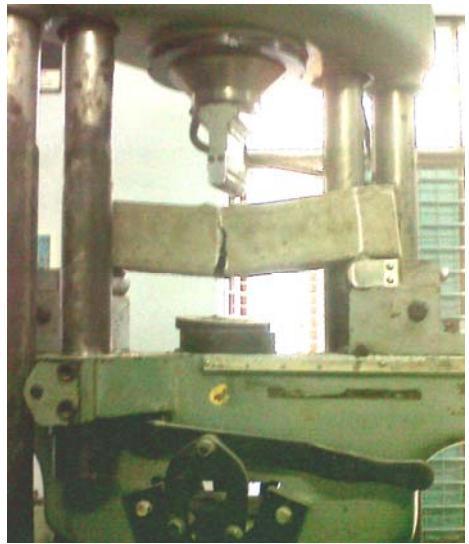
Figure 6. Typical flexural strength test set up after test

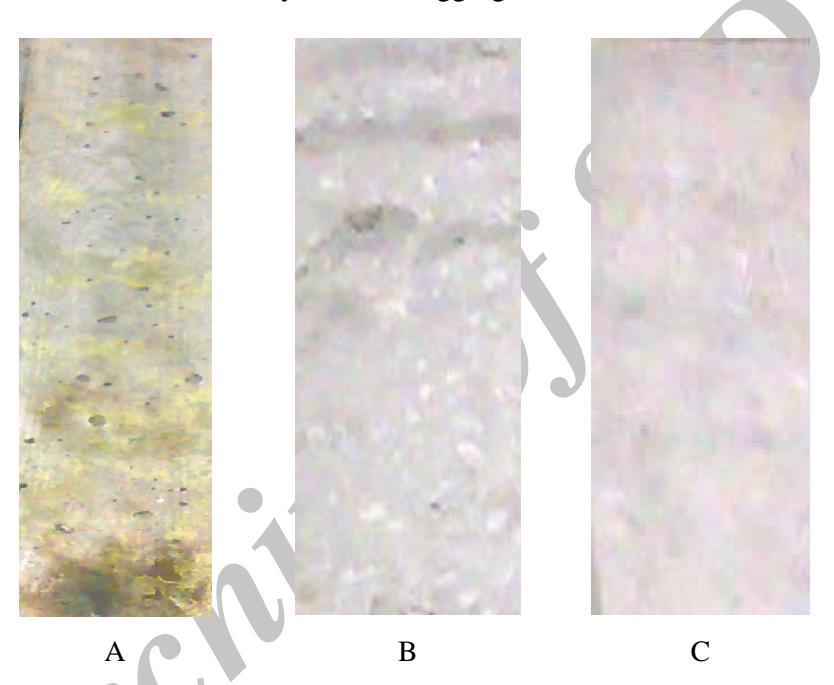
Figure 7. (A) Typical beam after 180 days of exposure to Sulphuric acid solution (B) Typical beam after 180 days of exposure to HCl+H₂SO₄ solution (C) Typical unexposed specimen

Prolonged exposure of fly ash based geopolymer concrete beams in 5% $HCl + 5\% H_2SO_4$ solution (chloride attack) showed very little deterioration of top surface of specimens, less than 2mm, which had led to visibility of coarse aggregates.

Whereas beams immersed in 10% H₂SO₄ solution, visible yellowish green hue patches were seen on the surfaces. This could be seen from the pictures given in Figure 7. The beam with designation 'C' represents specimen not subjected to aggressive exposure. Before exposure to acid solution, specimens possessed a fairly smooth surface and due to exposure, deterioration of the surfaces started which appeared to be very marginal, less than one mm. The specimens kept in Sulfuric acid solution showed good resistance to acid. Throughout the duration of exposure, specimens were taken from solutions periodically and checked for any noticeable changes on the surfaces. This phenomenon of acid resistance can very well be applied in manufacturing sewers, lining material in acid storing containers **such as** sewage disposing structures. There was no visible rusted surface seen in all the specimens. After 180 days of exposure to chloride, specimens 'B' showed no traces of corrosion, which is shown in Figure 8.

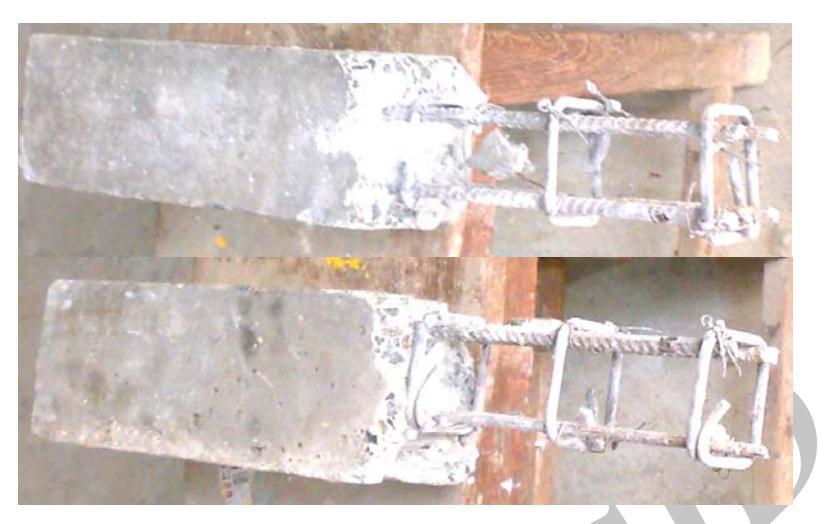
Figure 8. Top-uncorroded rod in specimen 'A' Bottom-uncorroded rod in specimen 'B'

- 5. There was no trace of visible corroded particles present on the rods taken from the tested specimens. There was no loss of weight of reinforcement rods after the exposure period. This might be due to the impermeability of concrete. The depth of penetration of acids and chlorides into concrete was less than 3mm and 4mm respectively, much lesser than the cover to steel (10mm).

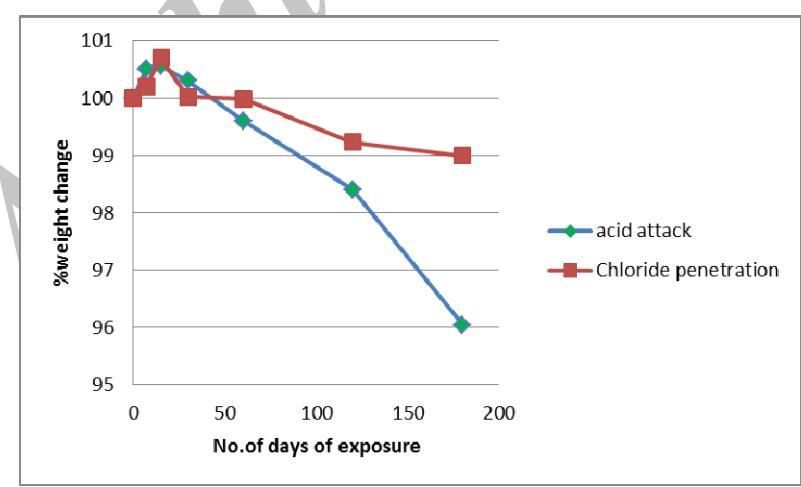
Figure 9. Change in weight (%) after exposure to acid and chloride

The change in weight of geopolymer concrete beam specimens after exposure to acid and chloride **was** compared with the weight of control element 'C'. All the specimens except control elements recorded weight loss and it was observed to be 3.26% in specimens subjected to acid attack. Almost all the specimens retained their shape and texture and there was no noticeable weight loss in specimens subjected to chloride attack. The loss of weight in the case of specimens subjected to chloride attack was noted and found to be 1%. The results are illustrated in Figure 9. The rods were taken out from the Specimens at the end of 180 days of study and weighed. There was not even a fraction of gram weight loss noticed in both the beams.

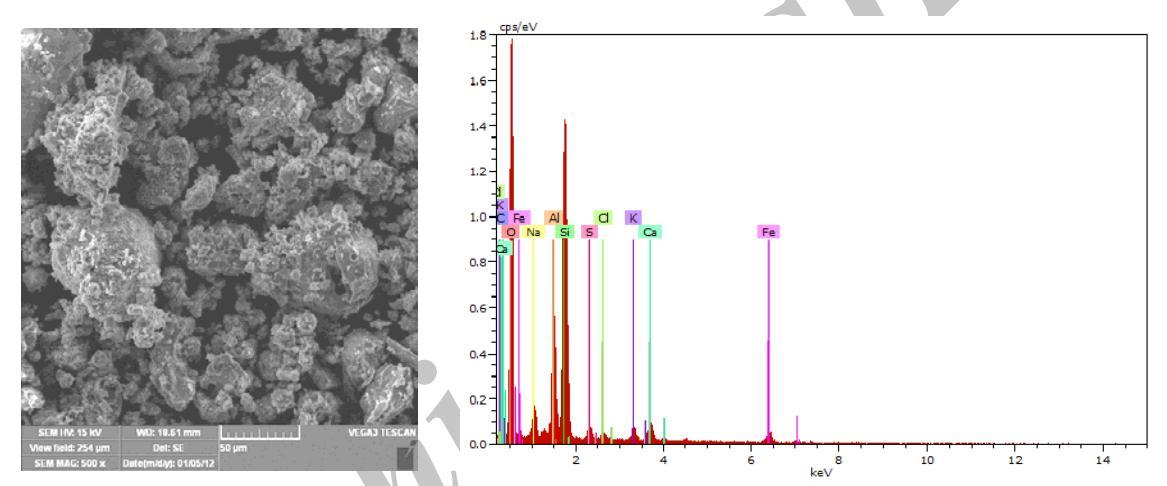
Figure 10. SEM image of specimen A and its corresponding EDAX spectrum after 180 days of 10% H₂SO₄ exposure

of geopolymer concrete beams after 180 days of submergence in acid and chloride environment, which are designated as sample A Series and sample B series, illustrated in Figure 10 and Figure 11. And the unexposed specimens as sample C series is shown in Figure 12. In reference specimen C, un reacted fly ash particles could not be noticed rendering it a high denser microstructure of concrete. From EDAX spectrum of Sample C, it **could** be noted that iron oxide content was 3.7%. Also it revealed the presence of Si, Al, K, Na and C as the main elements. After 180 days of exposure to 10% H₂SO₄ solution, specimens appeared to have deteriorated by the acid attack and at the same time EDAX spectrum also reported that a change in the presence of elemental traces. The iron oxide content had increased from 3.7% to 6.02% for Specimen A and the content of iron oxide for Sample B had decreased from 3.7% to 3.11%. This shows that the metal was not corroded under acid attack. From SEM images of samples A and sample B, the presence of light precipitates which might be a product of degradation was seen.

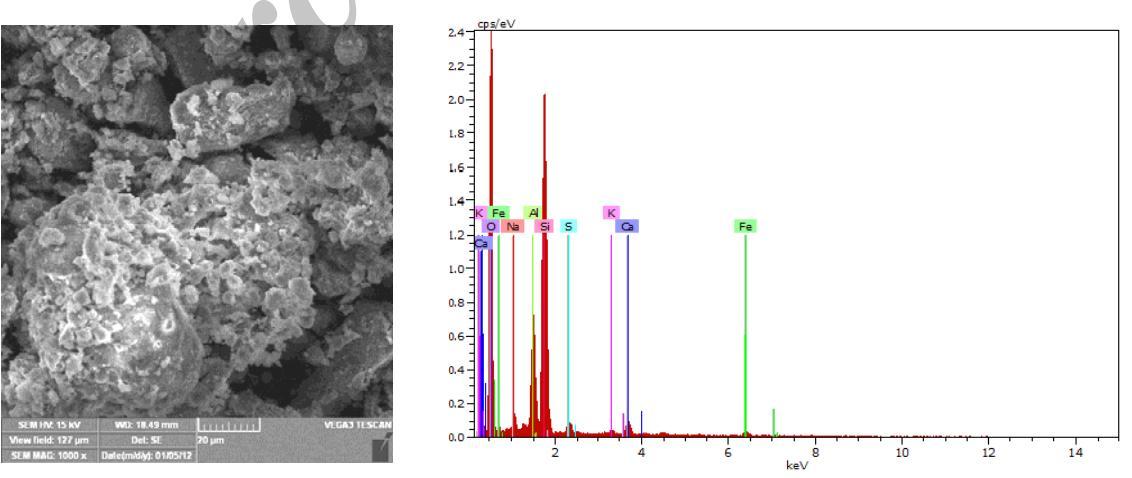
Figure 11. SEM image of specimen B and its corresponding EDAX spectrum $after 180 days of 5\% H_2SO_4 + 5\% HCl exposure$

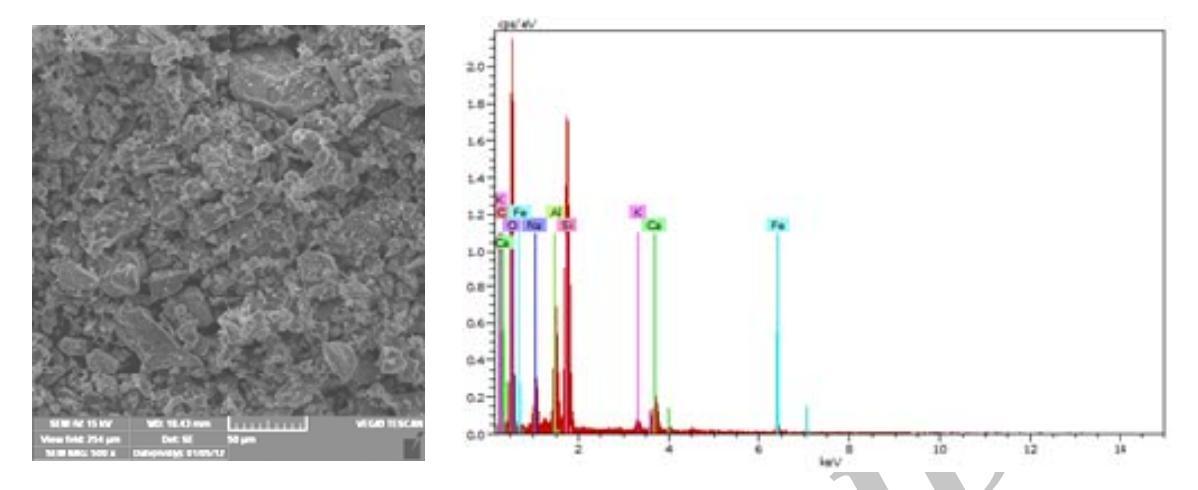
Figure 12. SEM image of specimen C and its corresponding EDAX spectrum before exposure

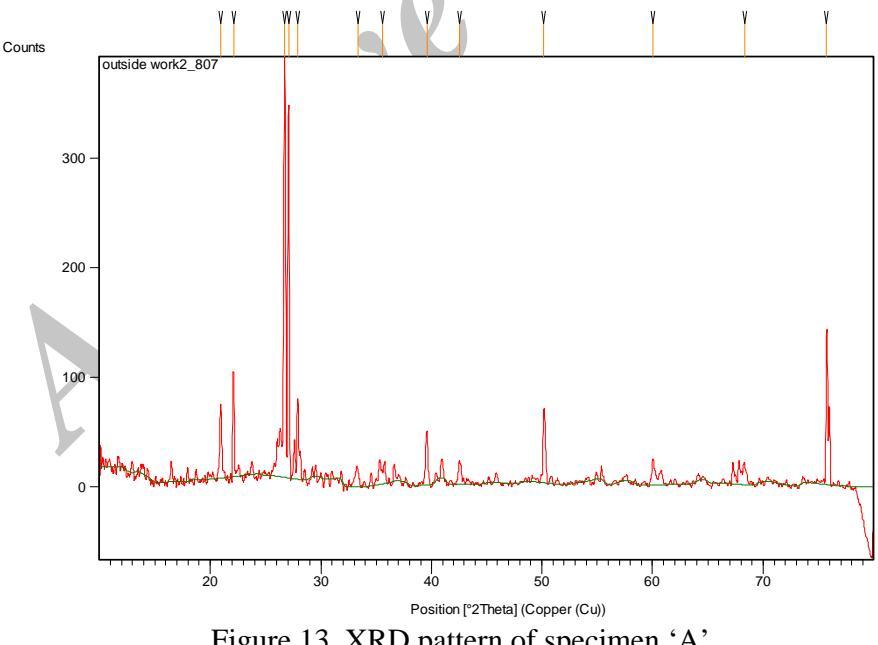
Figure 13. XRD pattern of specimen 'A'

XRD patterns of the sample 'A', sample 'B' and sample 'C' are illustrated in Figure 13, Figure 14 and Figure 15 respectively. From this spectrum of specimen A, we could infer that peaks for Zeolitic phases have reduced and new mullite arising from aluminosilicate gel formed between 20 and 21° 2Θ which indicates eruption by sulphur. Also new hematite crystals appeared at 78° 2 Θ might have reduced the peak intensity seen in the 26-29° 2 Θ .

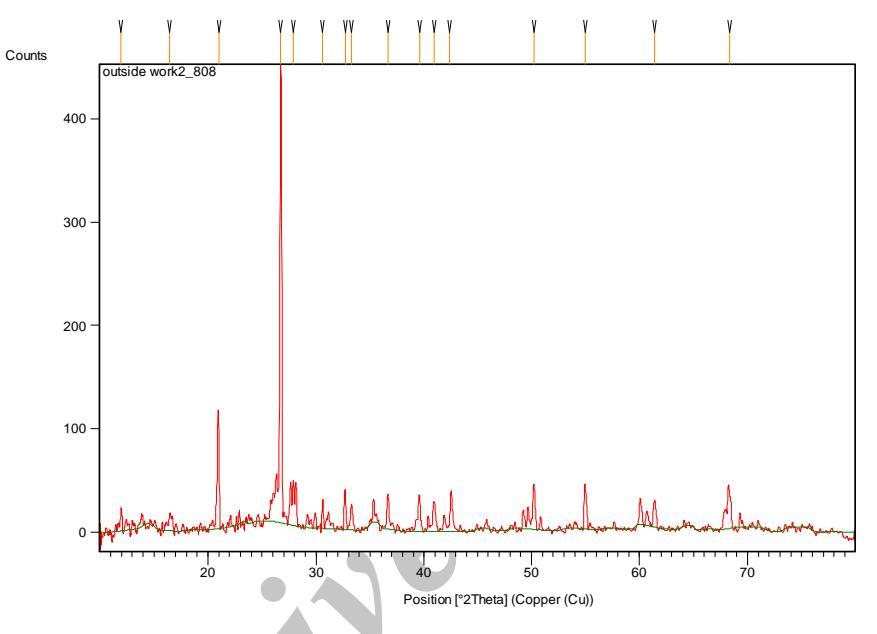
Figure 14. XRD pattern of specimen 'B'

After 180 days of exposure to Chloride solution, the peak intensity of Zeolitic phases have reduced a little, without any noticeable change in the microstructural profile. This shows the resistance to chloride. This characteristic of low calcium based geopolymer concrete may very well be adopted in structures in coastal areas, off-shore structures, tetrapods provided on the sea shores to withstand tidal waves and erosion due to chloride attack. Interaction of geopolymers with the sulfuric acid solution **have caused** replacement of the exchangeable cations (Na) in polymers by hydrogen or hydronium ions. The observation of the mass changes of the samples exposed to acidic solutions and results obtained from SEM, EDAX and XRD analyses gave a positive sign of hypothesis test of depolymerisation of aluminosilicate polymer gel.
