Original Article

The Effect of Porcelain Firing and Type of Finish Line on the Marginal Fit of Zirconia Copings

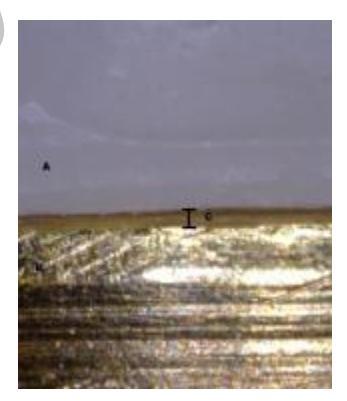
Figure 3: Captured image of coping-die interface (Zirconia coping (A), Brass master die (B), marginal gap (C))

The process of marginal discrepancy evaluation started with the copings being placed over the master dies using a special metallic device. To measure the marginal fit of the copings, the perpendicular measurement from the internal surface of the restoration margin to the most outer edge of the finish line of the preparation (AMG) was taken at 18 previously- marked points by use of a digital microscope (AM413FIT Dino-Lite Pro; Dino-Lite electronic Corp., Taipei, Taiwan). The microscope was mounted on a desktop stand (MS35B; Dino-Lite, Taipei, Taiwan), connected to a personal computer (PC) via USB 2.0 connection and photographed sequentially

at 230 x magnification. High-resolution photographs were captured and displayed on the computer monitor. (Figure 3) Then, the measurements were taken based on the produced images.

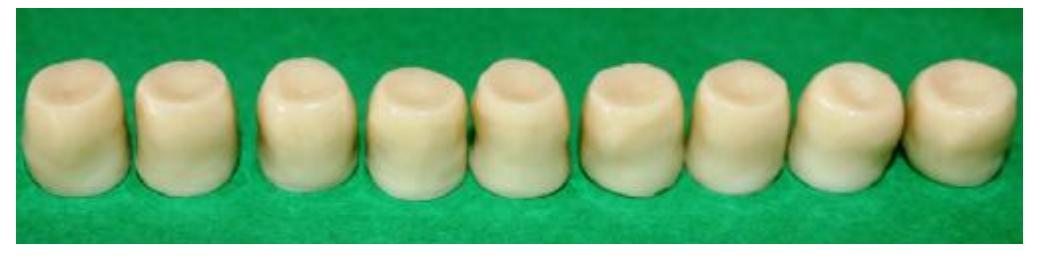
Figure 4: The completed crowns after porcelain firing

At this stage, the copings were prepared for porcelain application (Vita VM9; Vident, Germany). Porcelain application was done 0.5 mm short of margin. [24, 33] A silicone index was used to standardize the shape and the size of veneers. Next, the dentin and enamel porcelain were applied. (Figure 4) After each step, porcelain thickness was measured with a gauge (POCO 2N; Kroeplin, Schlüchtern, Germany). For all of the copings, porcelain application and firing cycles were done by a skilled technician based on the current standards. The marginal fit was measured again on the final master dies at the previously marked points.

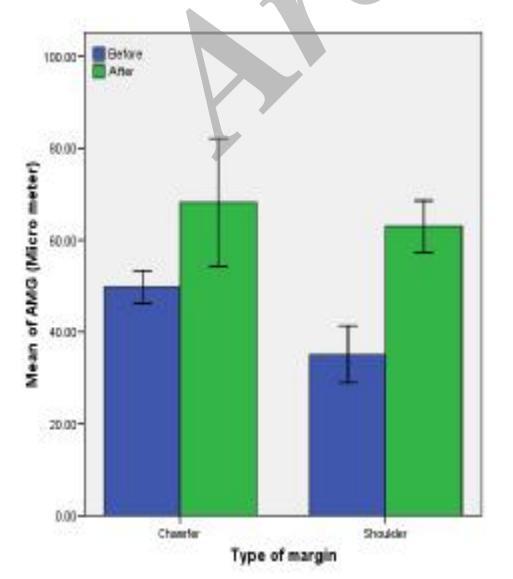
Figure 5: Mean values of marginal gap before and after porcelain firing

The means of different groups were compared using student's t-test at the significant level of 0.05. Paired t-test was also performed to compare the amount of marginal fit before and after the veneering of porcelain within the same group. (Figure 5)

There were significant differences between marginal fit of the two groups before and after porcelain firing (p < 0.05). The mean score of marginal gap in deep chamfer marginal design before and after the porcelain application was 49.8 µm and 68.2 µm, respectively. The mean score for marginal gap in rounded shoulder marginal design was 35.2 µm before and 63.06 um after the porcelain application. The marginal fit of shoulder copings was significantly better than chamfer copings (p=0.000), but there were no significant difference between the two margins, after firing the porcelain (p=0.341). These findings suggest that porcelain firing cycles change the marginal fit of shoulder copings more adversely. For both margin configurations, the marginal discrepancy of zirconia copings showed significantly smaller gaps than that of completed crowns. However, there was no significant difference between completed crowns of both chamfer and shoulder marginal designs.
