Int J Adv Struct Eng (2017) 9:259–267 DOI 10.1007/s40091-017-0162-0

# Seismic risk assessment of Trani's Cathedral bell tower in Apulia, Italy

Mariella Diaferio<sup>1</sup> · Dora Foti<sup>1</sup>

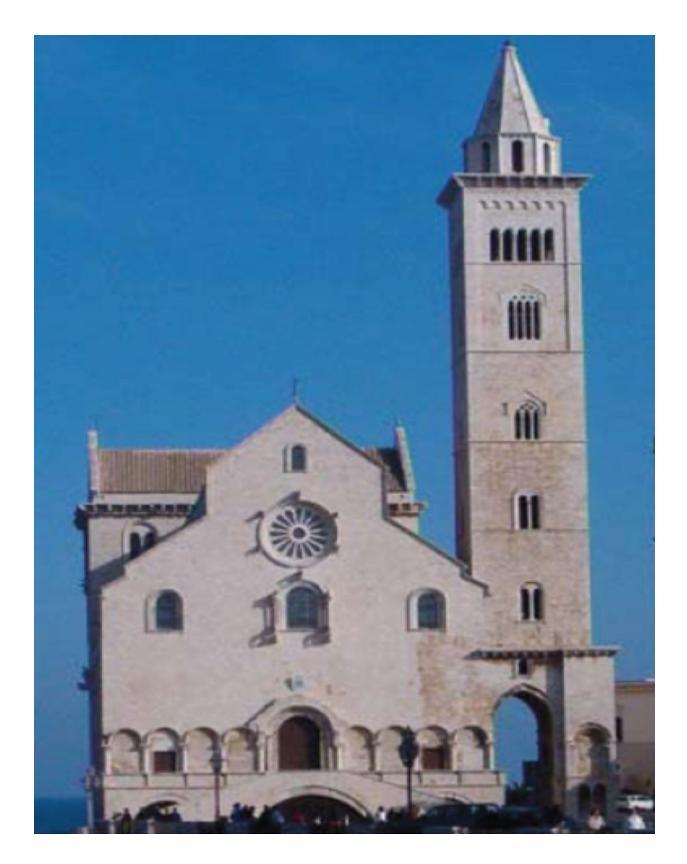
Fig. 1 Trani's Cathedral and its bell tower

Trani's Cathedral is one of the most significant structures in Apulian Romanesque style (Fig. 1); its construction began at the end of the eleventh century and ended in 1143. The bell tower was built starting in 1240 and ended in the second half of 1300.

Trani's Cathedral bell tower has a square transversal section, above the pointed arch that connects the tower to the Cathedral. Up to the arch, at a level of about 14.30 m, there is a rigid floor in correspondence of the opening that connects the bell tower to the church.

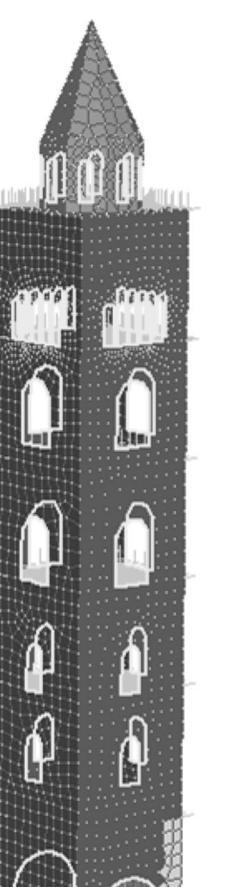
Fig. 2 FE model of Trani's Cathedral bell tower

Based on the available information a three-dimensional FE model has been defined by means of Straus Software package (Straus7). The tower has been modeled with 8-nodes 4093 plate elements (QUAD8) that can better describe the behavior of thick plates like the ones here considered (Fig. 2); such shell element is a quadrilateral element which assumes as nodes the four corners and other four extra nodes along the four edges. The tower has been considered fully fixed at the base, while its connection with the adjacent Cathedral has been modeled by means of springs. Moreover, the stairs and the bells have been neglected into the FE model as their values are not significant respect to the structural mass. The thickness of the shell elements has been defined in accordance with the available drawings.

The walls have been modeled with a homogeneous material. In fact, as confirmed by GPR tests, there is a perfect connection between the external Trani's stones and the concrete core. Consequently, the walls have been modeled with a uniform material whose mechanical properties (i.e., density and elastic modulus) have been obtained by weighted averaging of the contributions of the stones and the concrete with respect to the thickness

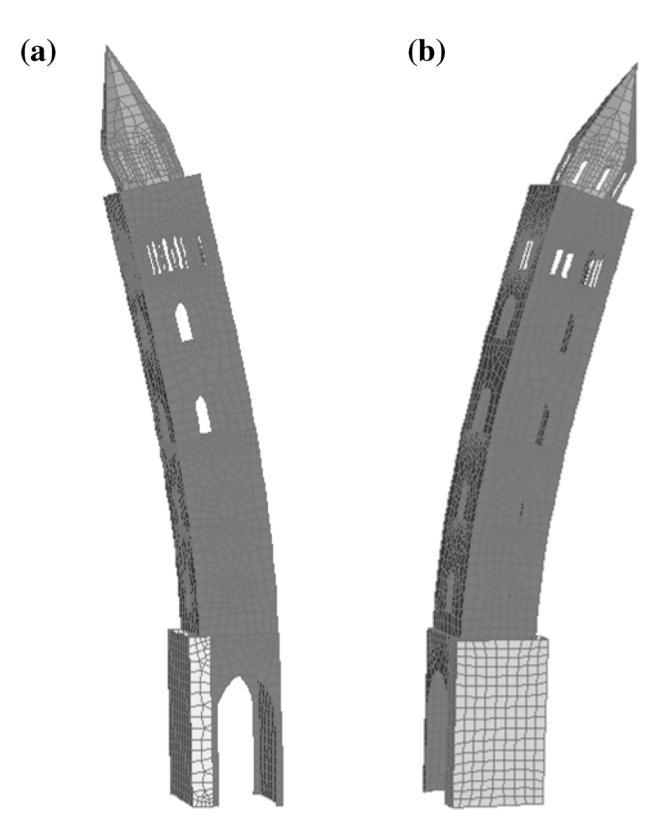
Fig. 3 a The first mode shape  $f_1 = 2.04$  Hz; b the second mode shape  $f_2 = 2.25$  Hz

In Fig. 3, the first two natural mode shapes are sketched. The considered static loads acting on the tower are due

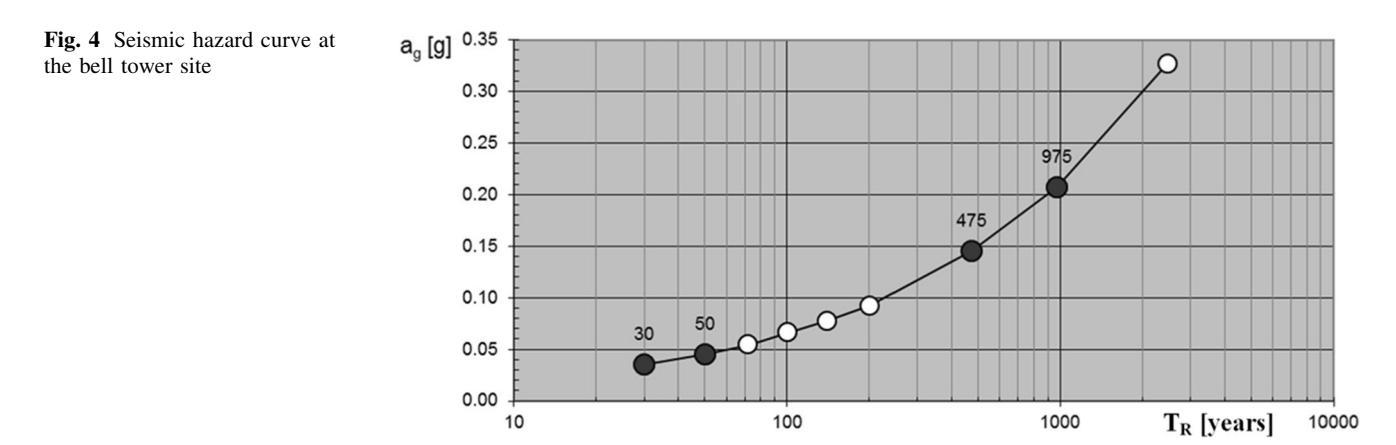
Trani's area is a seismic prone zone. According to the seismic Italian code (NTC 2008; DPCM 2011), the site is characterized by the hazard curve in Fig. 4, where the PGA at the bedrock  $a_{\sigma}$  is plotted varying the return period  $T_{\rm R}$ . The PGA at the bedrock with a 475 years return period is equal to  $a_{\rm g} = 0.145$  g. For the site effect, a rock mass has been assumed for the subsoil condition and a flat land for the topographic condition; on such basis an amplification factor S = 1.0 has been adopted in accordance with the Italian building code (NTC 2008; DPCM 2011).

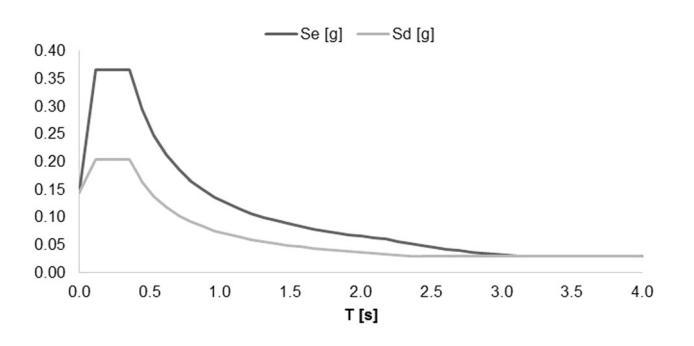
Fig. 5 Elastic and design response spectra for life safe limit state

08) for towers irregular in elevation like in the case here considered, which is characterized by the presence of the Cathedral only on one side of the tower. In Fig. 5. the elastic response spectrum  $S_e$  and the design response spectrum related to the horizontal direction  $S_d$  are shown for the life safe limit state.

Moreover, the model has been subjected to the design spectra in Fig. 5. The walls have been verified; in Fig. 7b an example of the performed analysis is shown for the wall at the first floor, the latter reported in Fig. 7a.

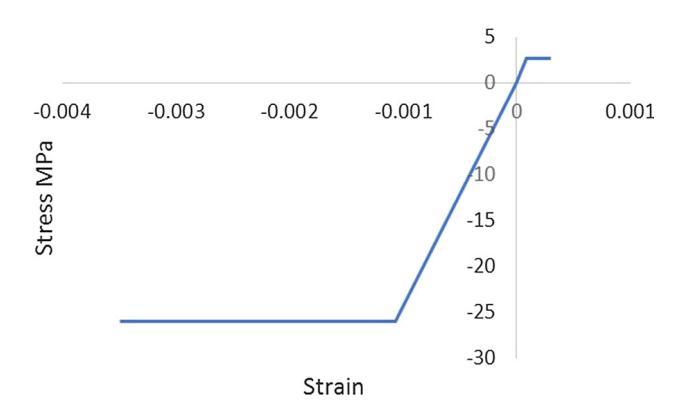
Fig. 8 Stress-strain relation of the structural material

Figure 8 shows the stress–strain relationship that has been adopted for describing the nonlinear behavior of the structural material.

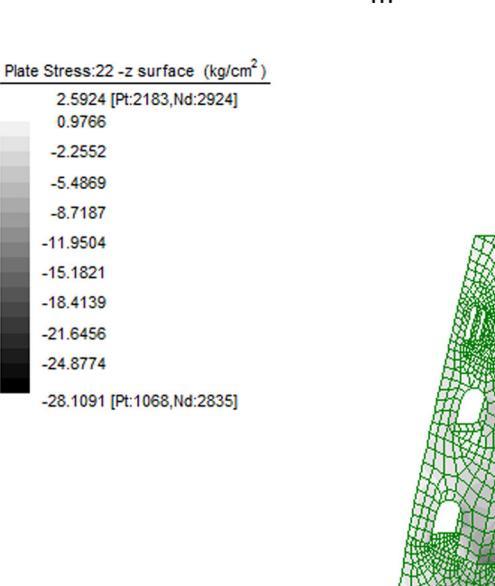
Fig. 9 Stress pattern of nonlinear static analysis (Rankine criterion)

Analyzing the distribution of the stress along the tower during the sequence of load increment, it can be verified that at the 12th step the maximum compressive strain is reached in correspondence of a load that is 20% greater than the load of life safe limit state (Fig. 9).

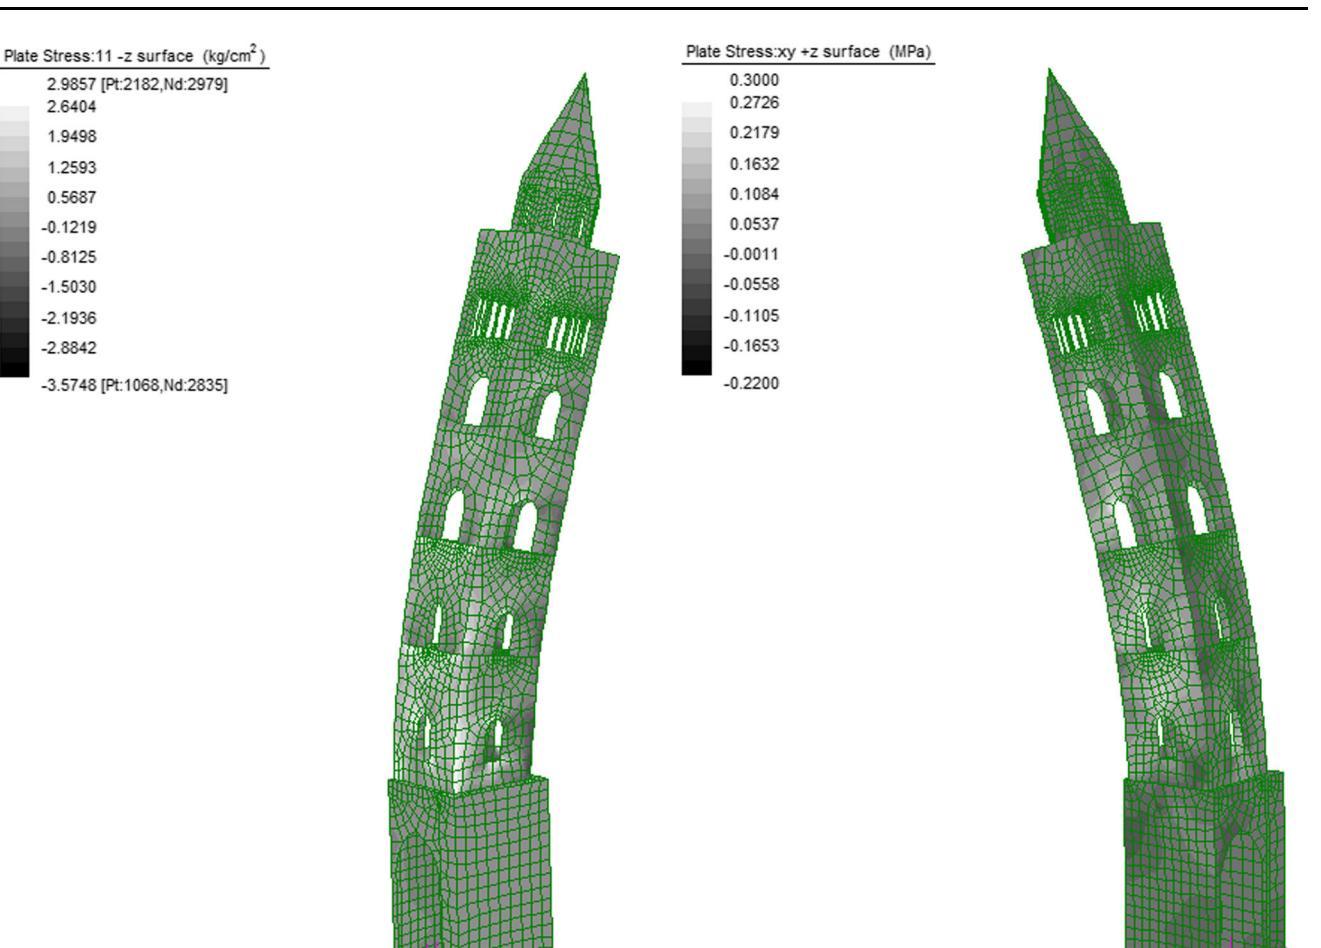
Fig. 10 Stress pattern of nonlinear static analysis (maximum tensile stress)

Moreover, the maximum tensile stresses appear at the 8th step that is in correspondence of a load equal to 80% of the load for the life safe limit state (Fig. 10).

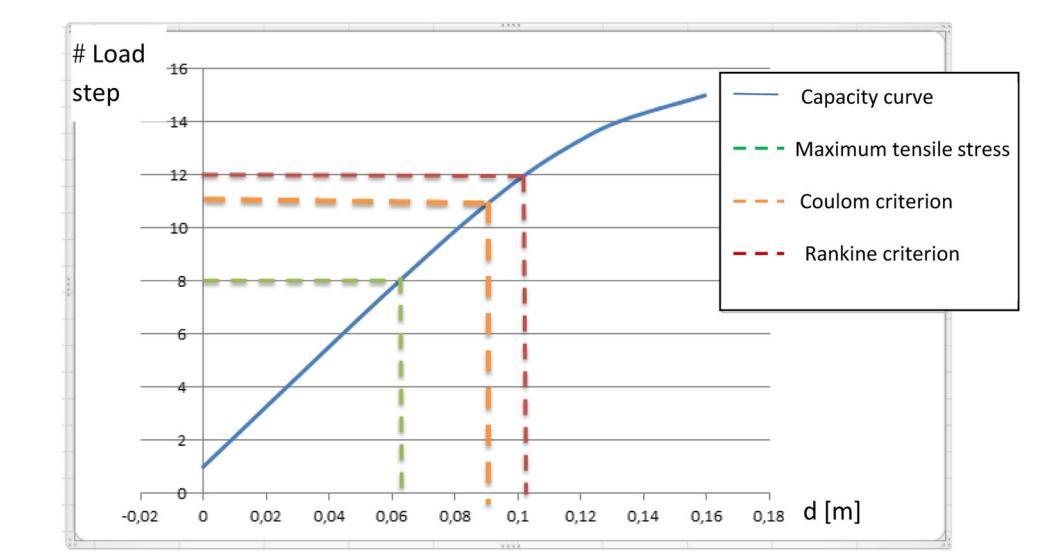
In Fig. 12, the capacity curve (number of the load step increment vs. the maximum displacement of the center of mass of the upper level) of the examined bell tower is shown, and the displacement capacity, evaluated for each one of the aforementioned criteria, is plotted.

The maximum tensile stress criterion is the one that estimates the lower displacement capacity; consequently, it is the one adopted as risk assessment criteria.

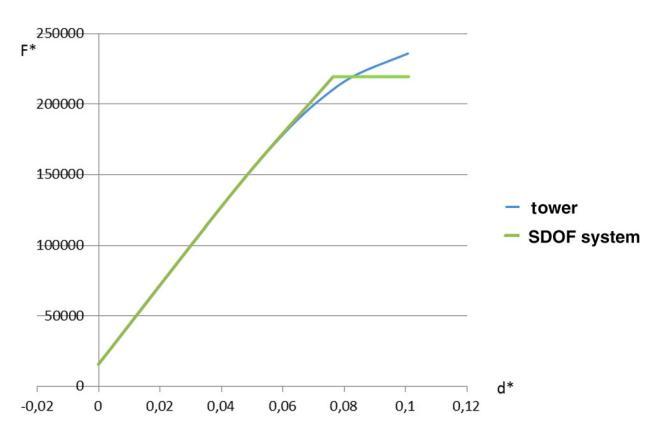
Fig. 13 Comparison between the capacity curve of the tower (blue line) and the bilinear curve of the equivalent SDOF system (green line)

On such basis the equivalent SDOF system has been defined in accordance with the Italian building code (NTC 2008; DPCM 2011). Figure 13 shows the comparison between the capacity curve of the tower and the bilinear

curve of the equivalent SDOF system. The bilinear curve gives a behavior factor that is defined as the ratio between the maximum displacement and the yielding displacement equal to 1.34, lower than the value suggested by the Italian code (NTC 08).
