# International Journal of Engineering

# Seismic Evaluation and Retrofit of Gas Stations: Case Study

#### F. Nateghi-A.\*, A. Rezaie Tabrizi and M. khazaei Poul

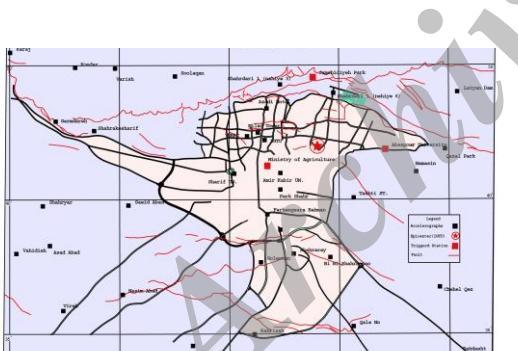
Figure 1. Location and seismicity of Tehran

City of Tehran is located at the southern outskirts of Alborz Mountain range. This location lies in the highest seismic zone of the nation. Throughout the history this city has experienced many large magnitude earthquakes. Figure 1 shows the location of Tehran and indicates the seismic history of the region. As seen, the city with more than 10 million populations is constantly threatened by a large earthquake .

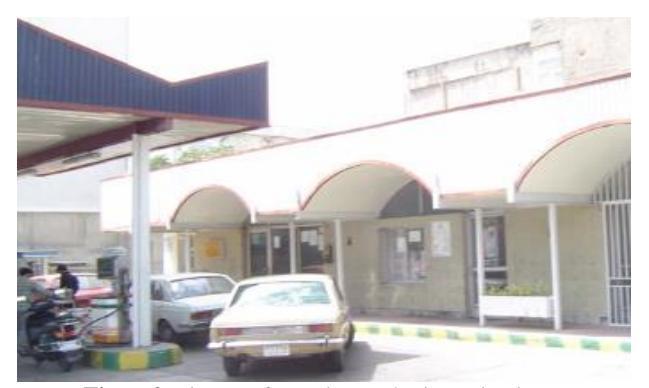
Figure2. Picture of a station under investigations

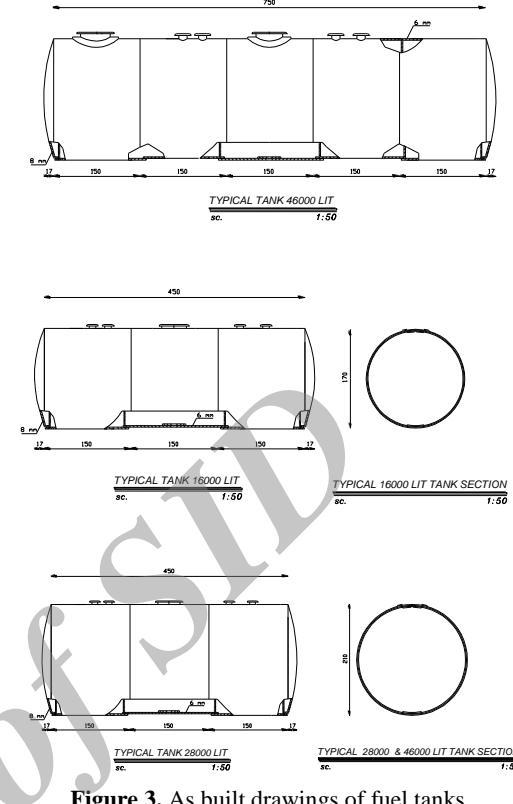
Figure 3. As built drawings of fuel tanks

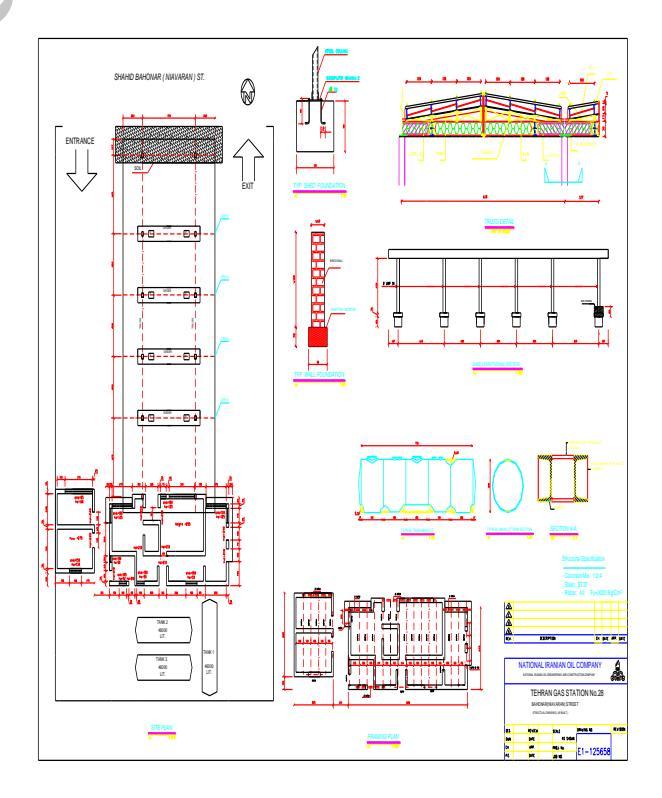
Figure 4. As built drawings of typical building and shed structures of a gas station under investigation

problem, a series of points were marked on the structures, mainly the main building and the shed structures which then were opened. Then, Ddrawings of the as built structures were recreated after inspections of the opened sections. Of course, different structures were used in different stations. A typical masonry building with steel framed shed will be present herein for the limited paper length. Pumps, fuel tanks and piping had detailed drawings and were similar in about all of the stations. Therefore, after inspections, original drawings were used for the analysis. Figure 2 shows a picture of a station used for the study. Figures 3 and 4 show the as built drawings for a complete typical station. As mentioned above, building structures were mainly constructed as masonry with Jack-Arch roofs. Some newer buildings also had structural steel framing with R/C joists as roofing system. Both types of structures were analyzed.

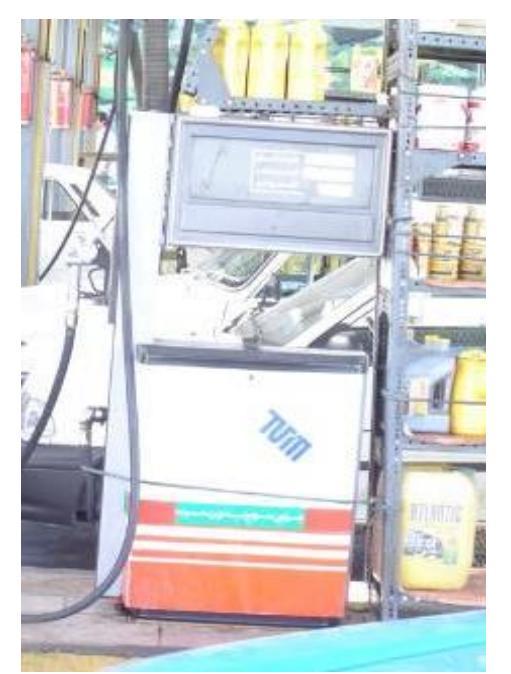
3. 3. Pumps Pumps were analyzed for the loads mandated by the Iranian seismic code. As seen in Figures 5 and 6, overturning and sliding of pumps were also controlled. As shown, pumps in general created no seismic threat.

Figure 5. A typical pump used in gas stations in Tehran

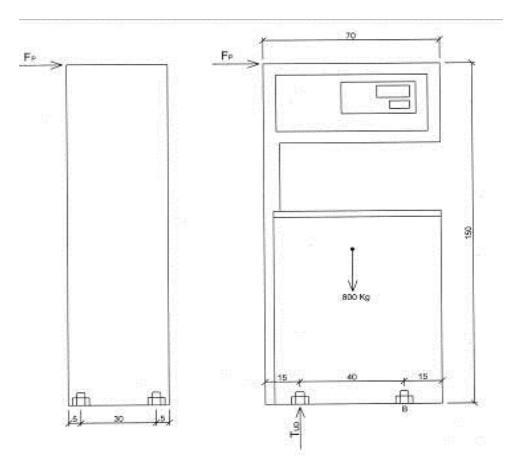
Figure 6. Free body diagram of pumps

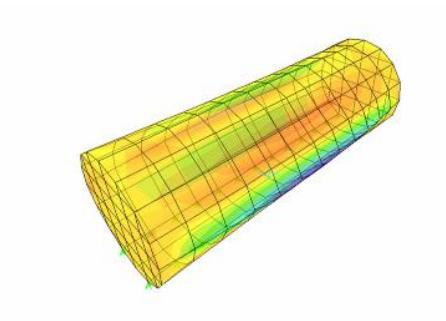
**3. 4. Fuel Storage Tanks** Just about all of the tanks were stored in the ground. Through piping, fuel was transferred to the pumps. Three different finite element models were considered as shown in Figure 7. As shown by the calculations, in any case, fuel tanks did not cause concern. Also, due to corrosion, a minimum thickness of 8 mm was calculated for different size of tanks as safe operation thickness. Maximum stress is shown in Table 2.

Figure 7. Model considered for the fuel storage tanks

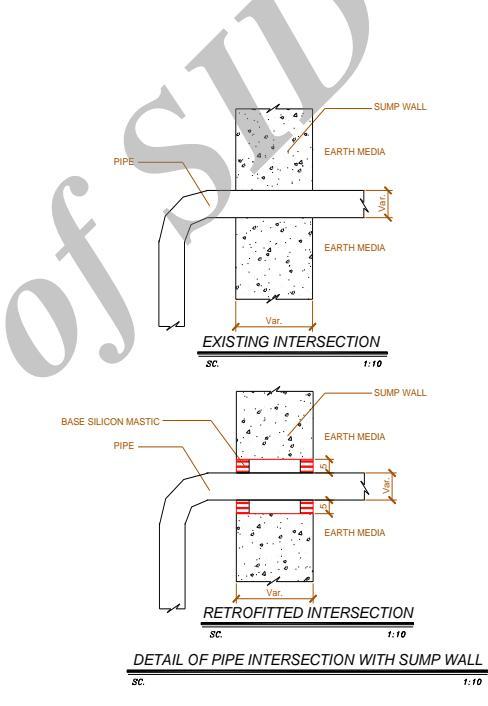
**3.5. Piping** Due to restricted piping regulations used by the Oil Company, no significant hazard was realized during inspections. All pips were embedded on lose sand and encased by more than 2 inches of sand, around, for flexible behavior. Only problem encountered was the joint where the piping from the tanks connected to the main pips. A flexible connection was devised for better and ductile behavior as shown in Figure 8. Electrical lines and switches were all installed on the walls from the outside by flexible attachments; therefore no significant hazard was associated with them.

Figure 8. Ductile connection between tank and main piping system

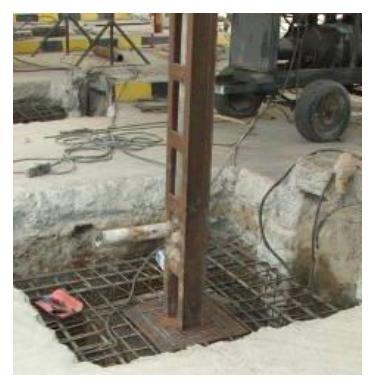
Figure 9. Photo of Foundation Retrofitting

For shed structure which almost all were vulnerable, depending on type of structure, use of new and stronger connections and addition of steel plates to columns while strengthening foundations were proposed as shown in Figure 9. Figures 10 and 11 show pictures of strengthening construction used in one such station. Figure 12 showes a typicak Strengtheeing sheet for typical gas station.

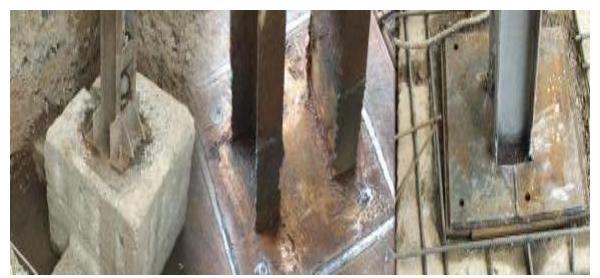
Figure 10. Photo of strengthening construction in a gas station in Tehran

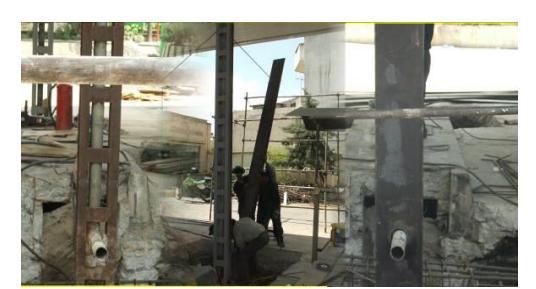
Figure 11. Photo of strengthening construction of a gas station in city of Tehran

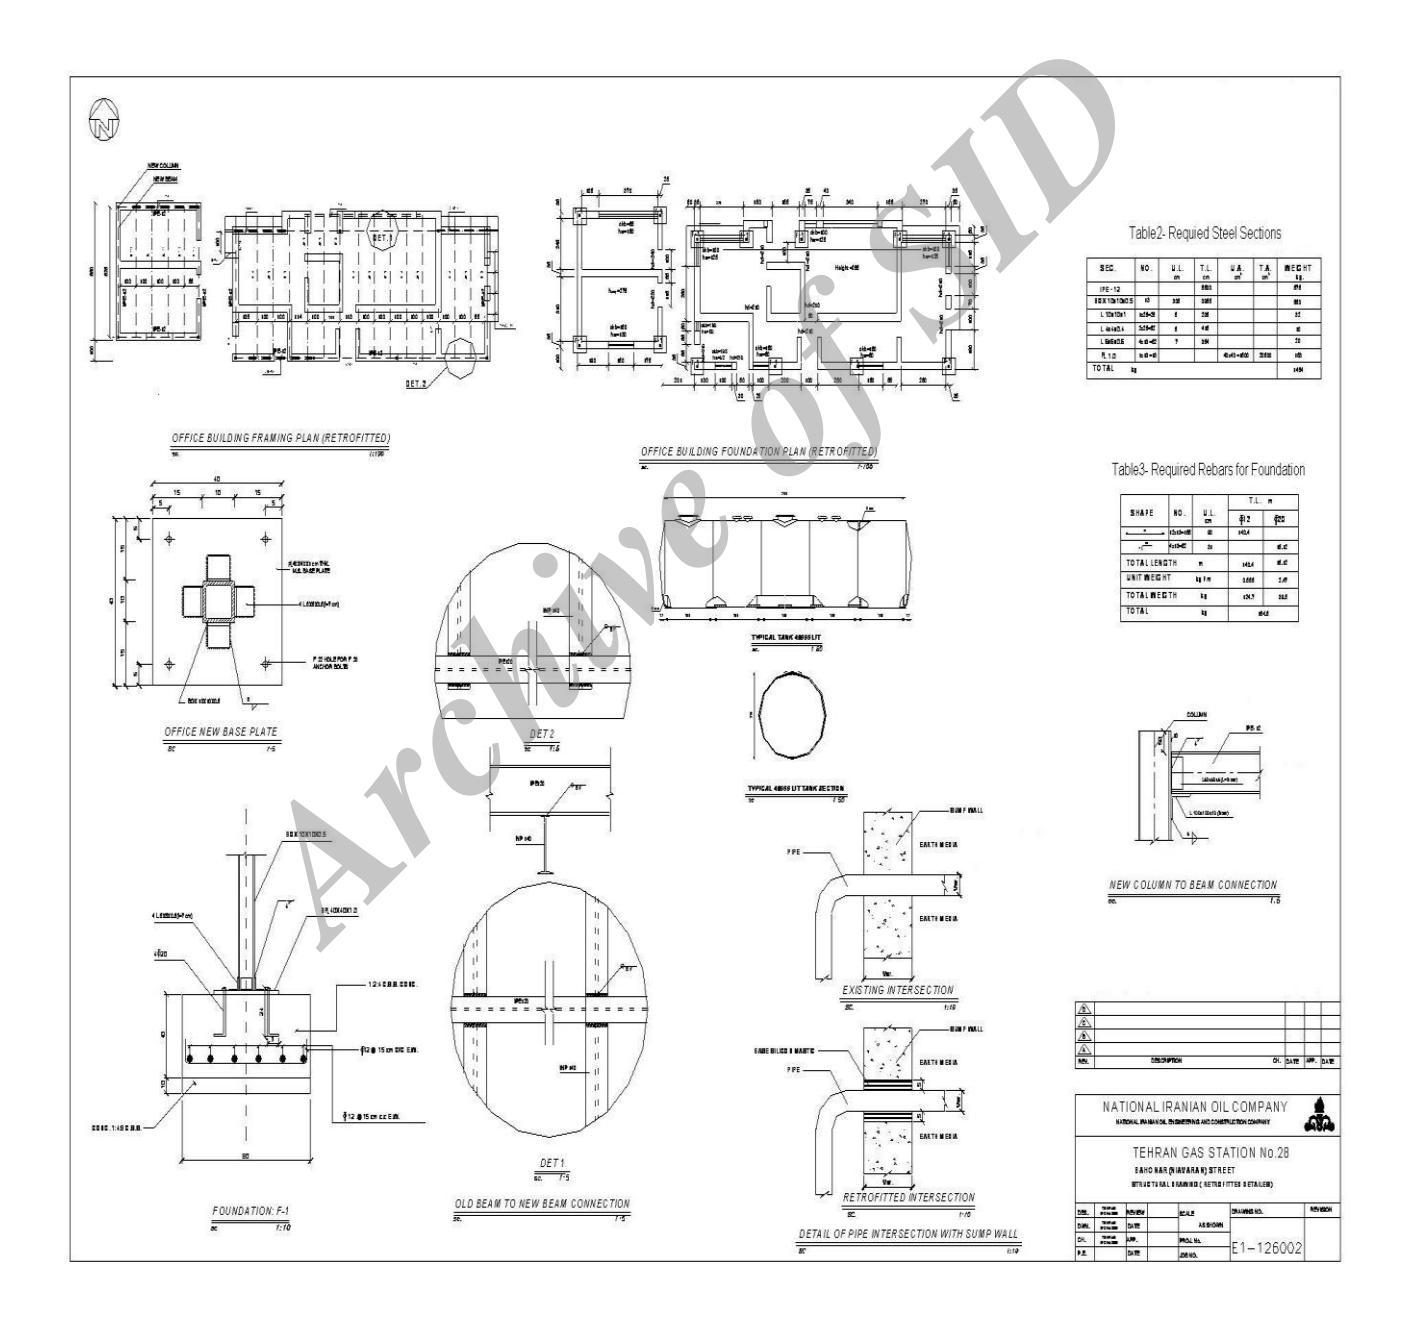
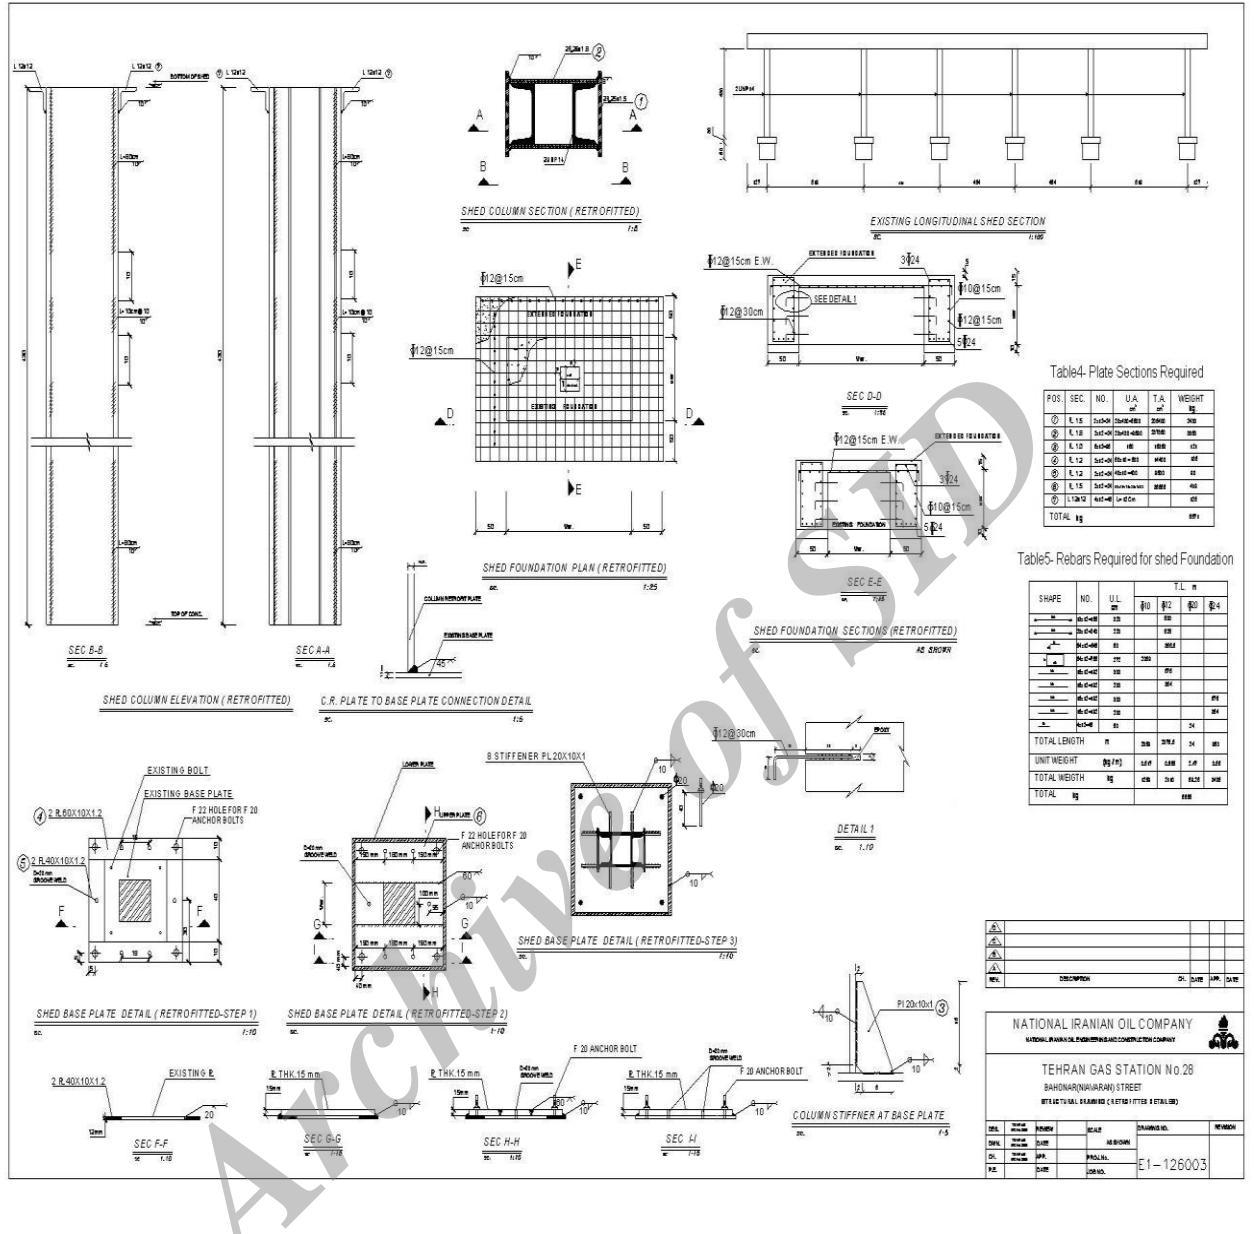
Figure 12. Strengthening schemes used for a typical gas station

Different schemes were used for strengthening different sections. For masonry buildings, main attempt was to create a structural system with providing a grid of steel sections joint with proper connections in between walls and by welding roof beams and joist to these newly framed steels. In framed buildings, addition of bracing and welding of new sections to existing ones were the main retrofitting philosophy used. For pumps, pips and tanks no upgrading recommendations were considered. It was suggested that if after NDT tests of tanks for possible corrosions, the thicknesses were less than the ones suggested for the safe operation by this study, it would be wise to replace the tank totally. This would be of course much economical and trying to do some alterations.
