THE BOND BETWEEN REPAIR MATERIALS AND CONCRETE SUBSTRATE IN MARINE ENVIRONMENT

K. Behfarnia*, H. Jon-nesari and A. Mosharaf,
Isfahan University of Technology, Isfahan, Iran

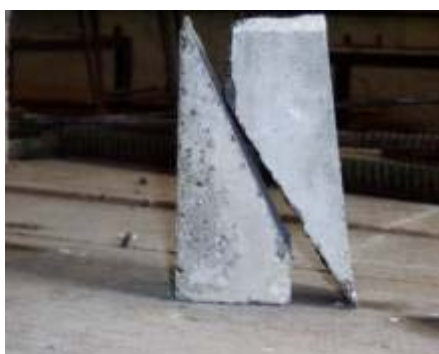
Figure 1. Concrete samples prepared based on BS 6319: Part 4

Old concrete samples were made based on BS 6319: Part 4 standard, figure 1. They were cast as 55x100x150 mm prisms and then cut at 30 deg to the vertical axis using a diamond saw. The acid etching method with use of hydrochloric acid was used to prepare the surface of samples.

Old concrete samples were made based on BS6319 Part 4 Standard [1]. Four methods including, smooth as-sawn, wire-brushed, hand-chiselled, and acid etching were used in order to prepare the surface of old concrete samples. Ordinary concrete, made with type II portland cement, and concrete containing 15 percent microsilica were used as repair materials. The mix proportions, specimen preparation and repair procedure are explained in next sections.

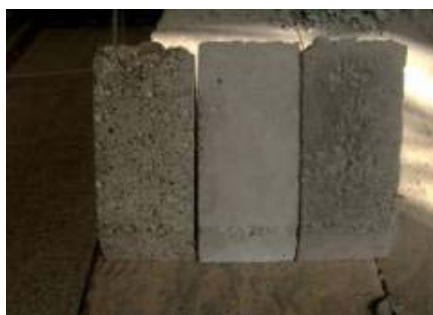
Figure 3. Concrete samples prepared with different surface preparation method

To study the effect of surface preparation method on bond strength, four surface preparation methods, smooth as-sawn (SS), wire-brushed (WB), hand-chiselled (HC), and acid etching (AE) were used to prepare the samples, figure 3. Samples tested by slant shear test method at age of 28 days. The results of bond strength are given in Table2.

The obtained results show that with use of surface preparation methods the bond strength could considerably be increased. Based on the given results in Table 2, the bond strength of repaired samples is increased 176%, 204%, and 235% with use of WB, HC, and AE methods compare to that of samples with no surface preparation, respectively.

The bond strength of repair materials can be considerably increased with use of a surface preparation method in repair process. The results show that the acid etching method is the most effective method among the four methods implemented in this study.
