## **STUDY OF ELECTROCHEMICAL CHLORIDE EXTRACTION AS A NON-DESTRUCTIVE REPAIR METHOD: PART 2. STRUCTURAL ELEMENT TEST SAMPLE**

This paper is the second part of the paper that provides information on representative parameters in electro-chemical chloride extraction. In part one, results of discrete test samples were outlined. A structural element in the form of Reinforced Concrete (RC) slab was constructed and tested to evaluate the ECE performance in a simulated structure. The representative parameters of ECE were determined experimentally. The experimental program investigates chloride and alkali concentration, chloride removal efficiency, transference number and half-cell potential.

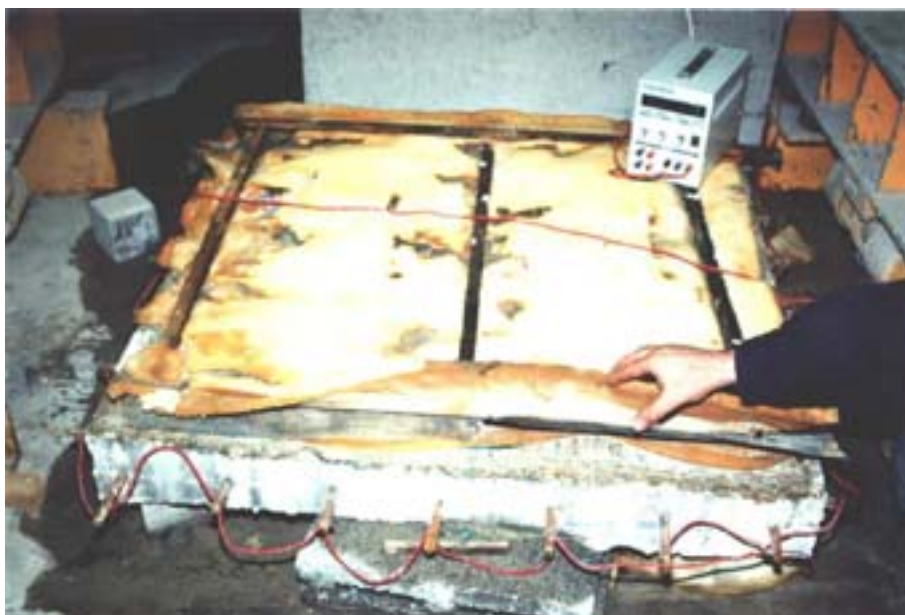
- I) A layer of foam saturated with  $\text{Ca}(\text{OH})_2$  was placed on the top surface of slab.
- II) A titanium electrode mesh was placed on the foam.
- III) A second layer of foam saturated with  $\text{Ca}(\text{OH})_2$  was placed on the electrode mesh.
- IV) Slab rebar and titanium electrode mesh was connected to the negative and positive pole of an AC/DC rectifier, respectively.
- V) The power supply was switched on and adjusted for a current density of 1A/m<sup>2</sup> of concrete surface, which correspond to 1.6A/m<sup>2</sup> current density of steel surface (Figure 2).

Figure 2. Equipment and application of electric field

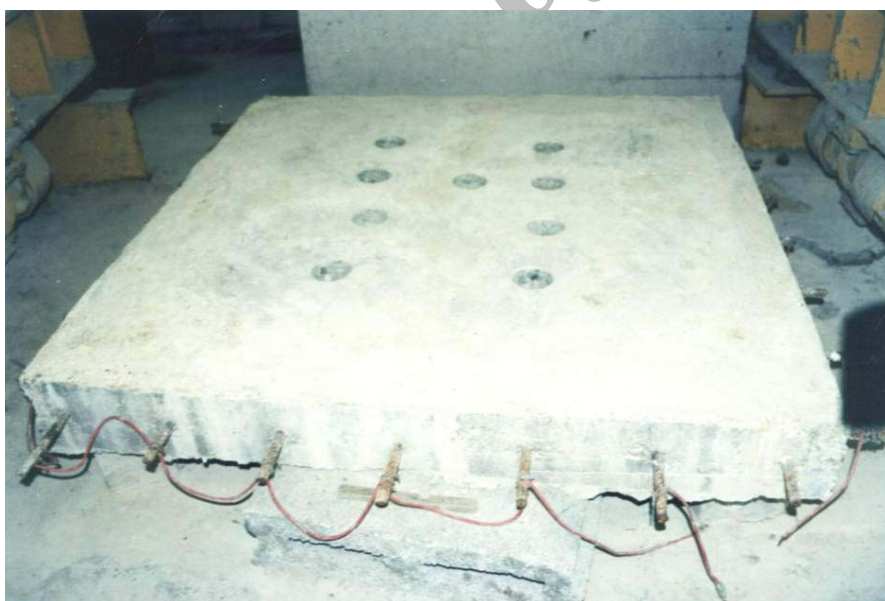
Figure 3. Pattern of core drilling in slab

Nine 2" (50 mm) cores were taken from the slab at different times up to 8 weeks of treatment. The cores pattern was taken at rebar intersection (Figure 3). The drilled cores were sliced with a thickness of 1.5 cm from various depths. The slices were grinded and tested to obtain the average of total chloride. As shown in Figure 4, it is concluded that: 1) the efficiency of chloride extraction is higher near the reinforcement than that at the concrete surface and 2) after 6 to 8 weeks of treatment chloride content around rebar reduced to the constant value of about 0.4% of cement mass, known as threshold value for corrosion prevention [2]. Almost similar conclusion was obtained in discrete test samples for chloride concentration around steel bars [1].

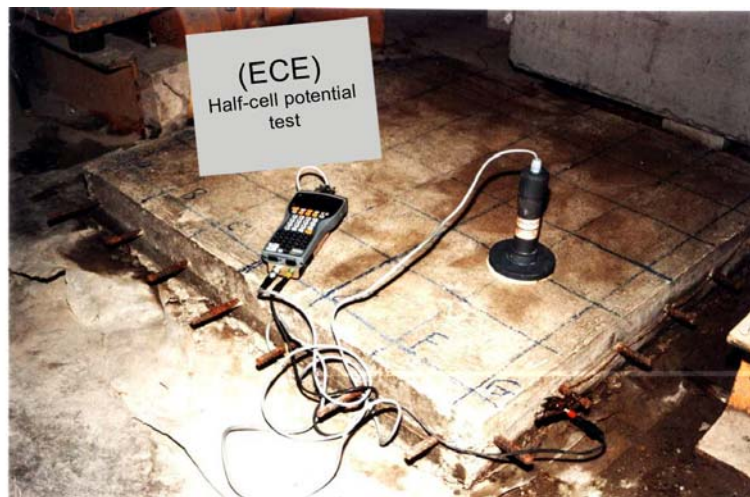
Figure 7. Half-cell potential instrument

Changes in half-cell potentials of steel bars in slab before, during, and after treatment were measured relative to Ag/AgCl reference electrode (Figures 7 and 8). All half-cell potentials of rebar were classified in the corrosion area (i.e., between  $-353$  and  $-428$  m.V based on Ag/AgCl reference electrode). Also, during and just at the end of treatment half-cell potentials were classified in the protection area before treatment (i.e., between  $-838$  and  $-1022$  m.V based on Ag/AgCl reference electrode). Furthermore, a new electro-chemical state was appeared in the slab reinforcement 8 weeks after the end of treatment in which the half-cell potentials were classified in the non corrosion area (i.e., between  $-33$  and  $-97$  m.V based on Ag/AgCl reference electrode).

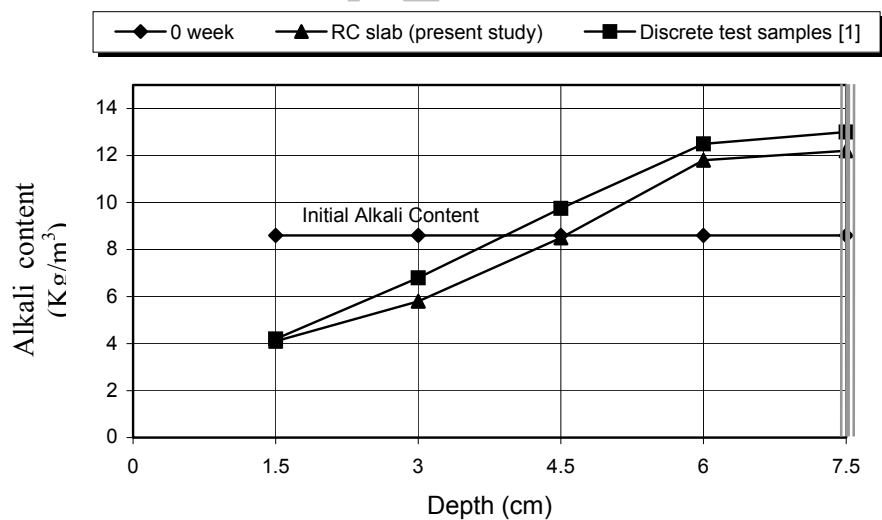
Figure 9. Distribution of alkali ions in concrete cover at various depth after 8 weeks of ECE
