## Original Article

## The Effect of Porcelain Firing and Type of Finish Line on the Marginal Fit of Zirconia Copings

Cite this article as: Vojdani M., Safari A., Mohaghegh M., Pardis S., Mahdavi F. The Effect of Porcelain Firing and Type of Finish Line on the Marginal Fit of Zirconia Copings. *J Dent Shiraz Univ Med Sci.*, June 2015; 16(2): 113-120.

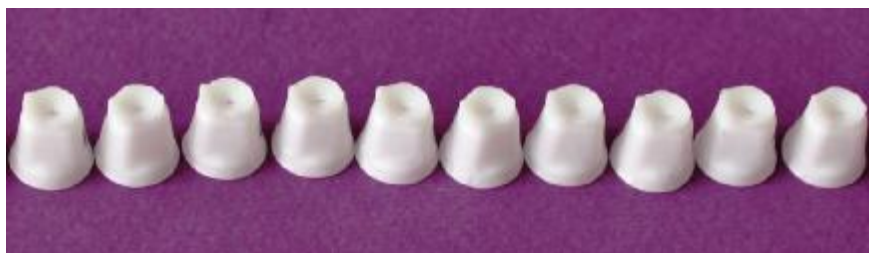
Figure 1: Brass master die

Brass master dies (Figure 1) were prepared for rounded shoulder and deep chamfer margins in a lathe (CNC350; Arix Co. Tainan Hsin, Taiwan).

Preparation of master dies was done in accordance with the current standards of full-ceramic restorations. [1] The preparation was standardized using a 1 mm wide smooth continuous margin, free of any irregularities, with occlusal convergence of 6 degrees with a height of 7 mm. A ledge was formed at the occluso-axial line angle to serve as anti-rotational feature. The measuring areas for evaluation of absolute marginal gap (AMG) were marked as 18 grooves at 20 degree intervals with a high speed handpiece (KaVo K9; KaVo dental GmbH, Biberach, Germany) and a diamond needle bur on a 2 mm groove below the margin. The sample size and the number of measurements per die were selected based on previous published studies. [15-16]

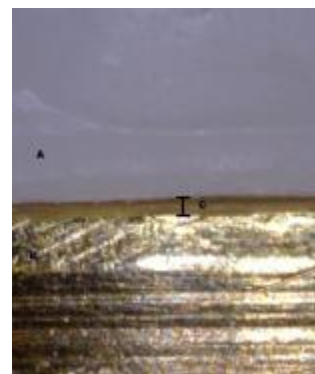
**Figure 3:** Captured image of coping-die interface (Zirconia coping (A), Brass master die (B), marginal gap (C))

The process of marginal discrepancy evaluation started with the copings being placed over the master dies using a special metallic device. To measure the marginal fit of the copings, the perpendicular measurement from the internal surface of the restoration margin to the most outer edge of the finish line of the preparation (AMG) was taken at 18 previously- marked points by use of a digital microscope (AM413FIT Dino-Lite Pro; Dino-Lite electronic Corp., Taipei, Taiwan). The microscope was mounted on a desktop stand (MS35B; Dino-Lite, Taipei, Taiwan), connected to a personal computer (PC) via USB 2.0 connection and photographed sequentially

at 230 x magnification. High-resolution photographs were captured and displayed on the computer monitor. (Figure 3) Then, the measurements were taken based on the produced images.

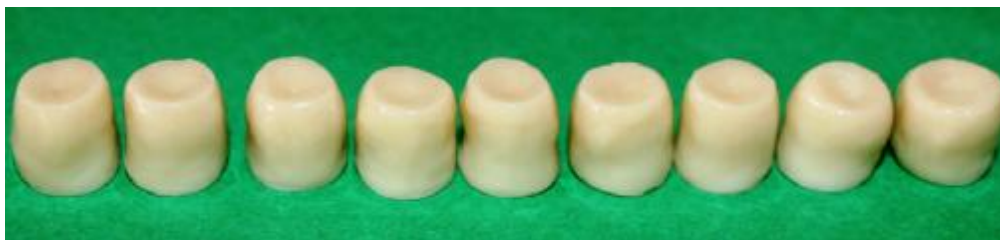
Figure 4: The completed crowns after porcelain firing

At this stage, the copings were prepared for porcelain application (Vita VM9; Vident, Germany). Porcelain application was done 0.5 mm short of margin. [24, 33] A silicone index was used to standardize the shape and the size of veneers. Next, the dentin and enamel porcelain were applied. (Figure 4) After each step, porcelain thickness was measured with a gauge (POCO 2N; Kroeplin, Schlüchtern, Germany). For all of the copings, porcelain application and firing cycles were done by a skilled technician based on the current standards. The marginal fit was measured again on the final master dies at the previously marked points.

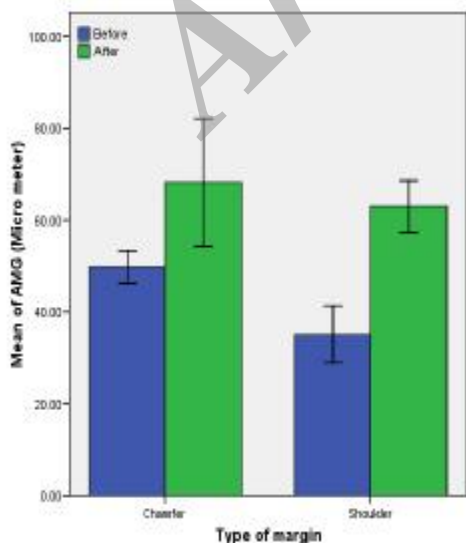
Figure 5: Mean values of marginal gap before and after porcelain firing

The means of different groups were compared using student’s t-test at the significant level of 0.05. Paired t-test was also performed to compare the amount of marginal fit before and after the veneering of porcelain within the same group. (Figure 5)

There were significant differences between marginal fit of the two groups before and after porcelain firing ( $p < 0.05$ ). The mean score of marginal gap in deep chamfer marginal design before and after the porcelain application was 49.8 µm and 68.2 µm, respectively. The mean score for marginal gap in rounded shoulder marginal design was 35.2 µm before and 63.06 µm after the porcelain application. The marginal fit of shoulder copings was significantly better than chamfer copings ( $p = 0.000$ ), but there were no significant difference between the two margins, after firing the porcelain ( $p = 0.341$ ). These findings suggest that porcelain firing cycles change the marginal fit of shoulder copings more adversely. For both margin configurations, the marginal discrepancy of zirconia copings showed significantly smaller gaps than that of completed crowns. However, there was no significant difference between completed crowns of both chamfer and shoulder marginal designs.
