The Effects of New Design of Access Hole on Porcelain Fracture Resistance of Implant-Supported Crowns

Reza Derafshi ^a, Mitra Farzin ^a, Masoumeh Taghva ^b, Hossein Heidary ^b, Berivan Atashkar ^b

^aDept. of Prosthodontics, School of Dentistry, Shiraz University of Medical Sciences, Shiraz, Iran.

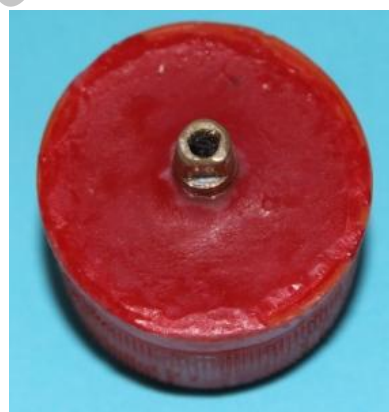
Figure 1: Brass die embedded in acrylic resin block

A 5×6.5 implant analog (Dio Corp.; Busan, Korea) was connected to a straight abutment. Then it was duplicated as 36 brass dies by using a lathe (CNC 350; Arix Co., Tainan Hsin, Taiwan). Then, five millimeters of each die was embedded vertically in an acrylic resin block with the aid of a dental surveyor (Figure 1).

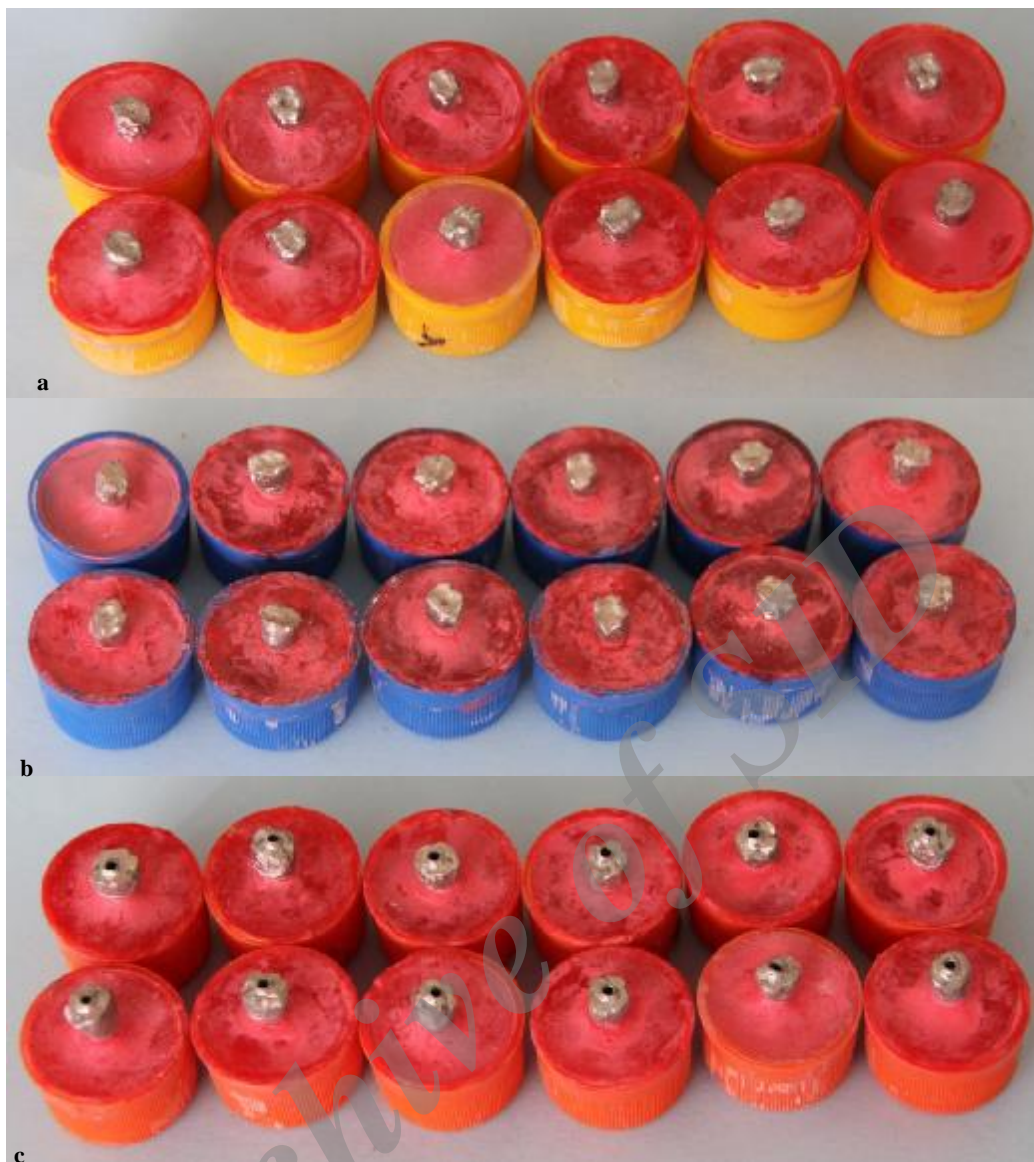
Figure 2a: 12 conventional metal-ceramic implant frameworks of group 1 **b:** Group 2; implant frameworks **c:** Group 3; implant frameworks

Subsequently 36 metal ceramic crowns were fabricated with 3 designs; group 1 consisted of 12 conventional metal-ceramic crowns with cement-retained restorations as control group (Figure 2a), group 2 included 12 crowns with porcelain stain used to define the location of screw access channel (Figure 2b). Group 3 was constituted of 12 crowns during framework fabrication of which, a ledge was designed in wax-up in the location of screw access channel (Figure 2c). The ledge was 1.5 mm in height and 1 mm in thickness around a 2-mm hole in the center of occlusal surface (Figure 3). This area was defined in the crown by using porcelain stain.

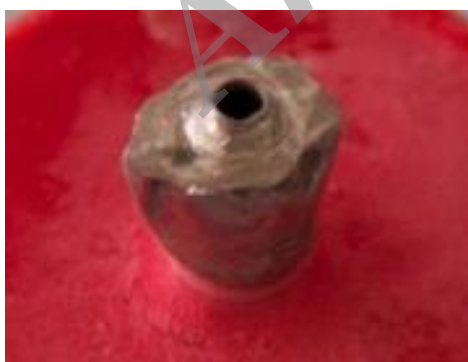
Figure 3: The ledge designed in the location of screw access channel of the third group of metal ceramic crowns

- Presence of screw access opening in cement-retained implant restoration would not compromise the fracture resistance.
- Designing a ledge in the framework of cement-retained implant restorations in the location of screw access opening could be a useful method to retrieve restoration, without compromising its strength.

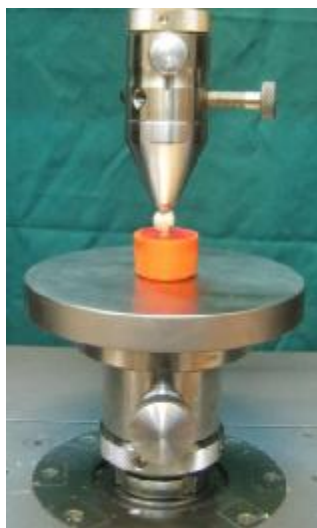
Figure 4: Frontal view of specimen positioned in the universal testing machine

Finally, all specimens were thermocycled for 500 cycles between 50-65°C for 30 seconds with 12-second intervals according to the literature. [31-32] Each specimen was subjected to vertical compression load by using a universal testing machine (Zwick-Roell Z020; Zwick Gmb H & Co. KG, Ulm, Germany) (Figure 4).

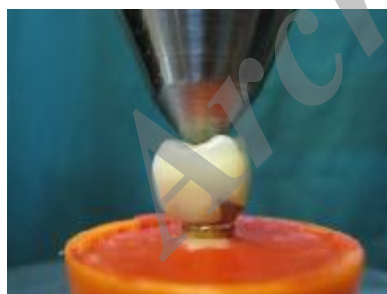
Figure 5: Close up view of loading apparatus

The force was applied perpendicular to the occlusal surface in the central part of the restoration with a cross-head speed of 2mm/min. In order to simulate the contact established by the opposing tooth, the rounded edges of the loading pin simultaneously contacted the triangular ridges of both buccal and lingual cusps of the crowns (Figure 5). The specimens were loaded to failure. Maximum values of loads at failure were recorded for each specimen. Mean values of fracture resistance for all groups were calculated and compared by using one-way ANOVA. The level of statistical significance was set at $\alpha=0.05$.
