Masoud Parirokh¹ DDS, MS, Karim Ardjomand² DDS, MS, Hamed Manochehrifar³✉ DDS

Artifacts in Cone-Beam Computed Tomography of a Post and Core Restoration: A Case Report

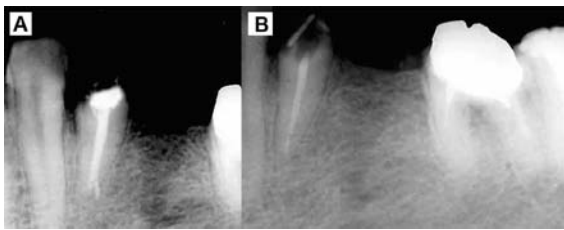
Figure 1. A) Radiographic image of the tooth #21 before retreatment; B) Radiographic image of tooth #21 after retreatment 11 years before taking CBCT image

A 56-year-old male was referred for evaluation of his left mandibular first premolar tooth (#21). His past dental history showed that the tooth had been retreated 11 years previous (Figure 1) followed by a post and core restoration. A fixed prosthetic restoration that employed teeth #18 and #21 as abutments was made at the same time.

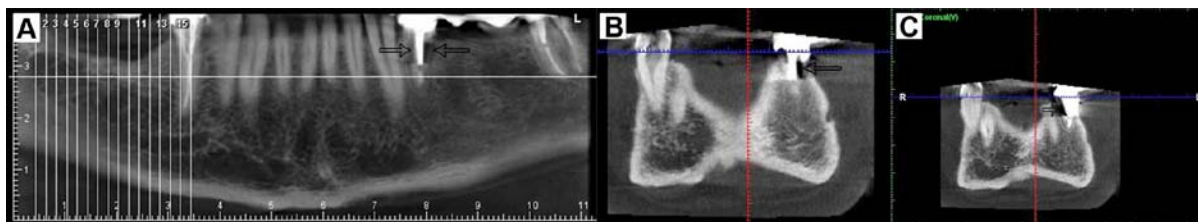
Figure 2A-C. Cone-beam computed tomography images from the tooth #21 shows radiolucent lesion inside and around the tooth (open arrows)

ridge. A CBCT was ordered by the periodontist and during the evaluation of the images a radiolucent lesion was detected around the tooth #21 at both coronal and sagittal views (Figure 2). The bridge and subsequently the post were removed. Then a periapical radiograph was taken (Figure 3). The patient was then referred to our office for further evaluation and consultation. The tooth was examined under a dental operative microscope (DOM; Carl Zeiss, Oberkochen, Germany) for any sign of resorption or perforation. No sign of perforation was observed either during root observation by DOM or the periapical radiographic image (Figure 3). Pperiodontal status of the tooth was evaluated and was found to be within normal limits. The tooth was diagnosed as being sound with only a CBCT artifact. The patient was advised to have a root canal retreatment of the tooth before placing a new post and crown because of the inadequate amount of remaining gutta-percha in the root canal following previously performed post space preparation. A recent article introduced map reading for overcoming this shortcoming [9]; however, in the present case map reading could not help the examiners to distinguish between the presence of sound intact tooth and periodontal structure. In fact, map reading from the coronal view illustrated severe damage of the root structure of the tooth.

This case report shows how CBCT can cause artifacts in teeth with intracanal posts; this is a significant disadvantage of CBCT imaging technique. Presence of a metallic artifact in the field of scan will produce streaks and dark bands because a portion of the beam passes through an object at one position making it harder in the other tube positions. Several techniques and equipments have been described to overcome this predicament: filtration [12], calibration [11], linearization [13] and correction beam hardening software [11]. A recent investigation demonstrated that the presence of metallic post reduced both sensitivity and specificity of CBCT for the detection of horizontal root fracture [14].

Both coronal and sagittal views of the tooth CBCT falsely emulated root perforation image contraindicating the periapical radiograph and clinical findings of the tooth. In our case study, an inappropriate post-space preparation had left an empty space between the post and the root canal filling material which could have misled the clinician in believing that the CBCT showed a real lesion.

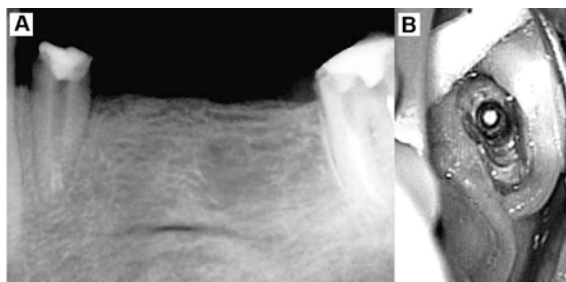
Figure 3. A) Periapical radiographic image which was taken following bridge and post removal; B) Photographic image of the tooth #21 taken with a dental operative microscope camera ($\times 1.6$)

In the present case, DOM was used as a diagnostic aid for evaluating the root structure. Direct view by DOM showed no discrepancy at the post space.
