SEISMIC ASSESSMENT AND STRENGTHENING OF AN EXISTING STEEL BRIDGE IN PORTUGAL

Catarina Fernandes¹ and Humberto Varum²

Department of Civil Engineering, University of Aveiro, Aveiro, Portugal

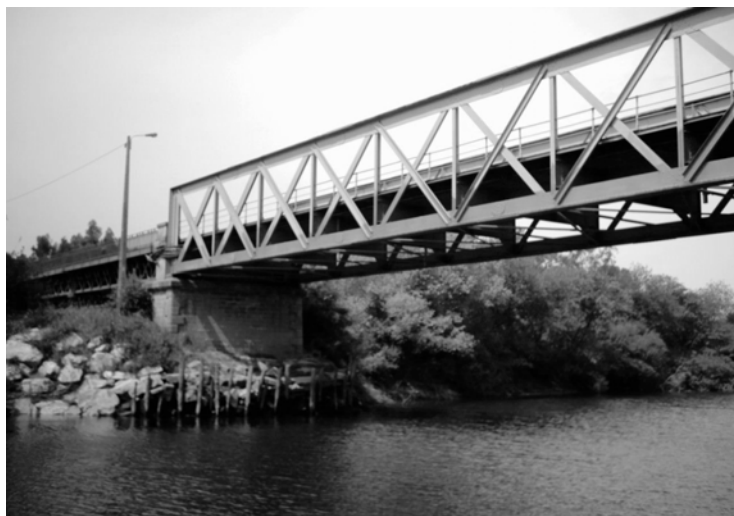
Figure 1. General view of the S. João de Loure bridge (Furtado et al., 2003)

The S. João de Loure bridge under analysis (Figure 1) is located in S. João de Loure, district of Aveiro, Portugal, and it is a part of the national highway EN 230-2.

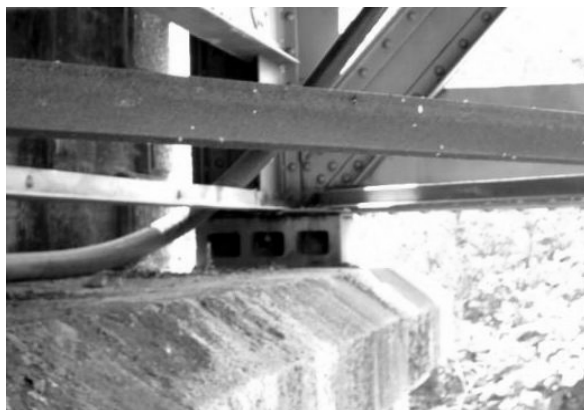
Figure 3. Fixed support in the north abutment (Furtado et al., 2003)

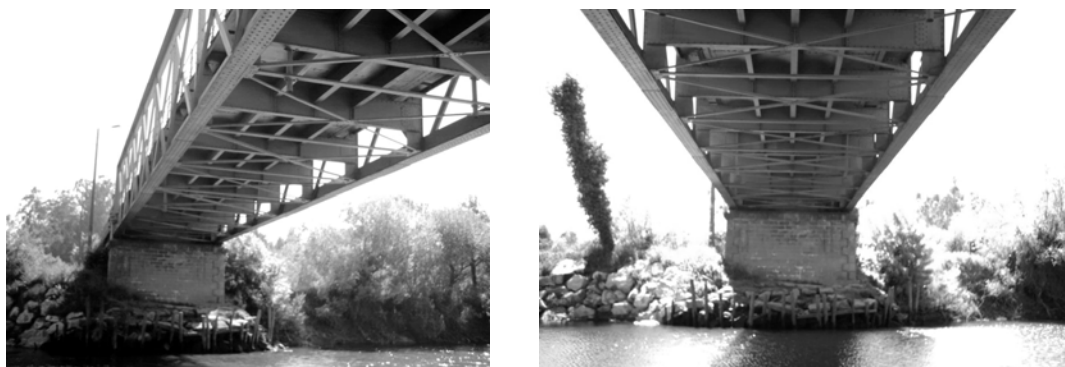
Figure 4. Bottom views of the S. João de Loure bridge: bracing system (Furtado et al., 2003)

The bridge has a single span with approximately 43.36 m. Eleven panels can be identified, each with a length of 3.54 m. Table 2 summarizes the main geometrical characteristics of the bridge. The connection between elements is assured by rivets, as shown in Figure 2. The main structure is supported by two different types of bearings located in masonry abutments: fixed supports in the north abutment (Figure 3) and roller bearings in the south one. At the level of the bottom flanges, a bracing system guarantees the protection against lateral torsional buckling (Figure 4).
