Seismic risk assessment of Trani's Cathedral bell tower in Apulia, Italy

Abstract The present paper deals with the evaluation of the seismic vulnerability of slender historical buildings; these structures, in fact, may manifest a high risk with respect to seismic actions as usually they have been designed to resist to gravitational loads only, and are characterized by a high flexibility. To evaluate this behavior, the bell tower of the Trani's Cathedral is investigated. The tower is 57 m tall and is characterized by an unusual building typology, i.e., the walls are composed of a concrete core coupled with external masonry stones. The dynamic parameters and the mechanical properties of the tower have been evaluated on the basis of an extensive experimental campaign that made use of ambient vibration tests and ground penetrating radar tests. Such data have been utilized to calibrate a numerical model of the examined tower. A linear static analysis, a dynamic analysis and a nonlinear static analysis have been carried out on such model to evaluate the displacement capacity of the tower and the seismic risk assessment in accordance with the Italian guidelines.

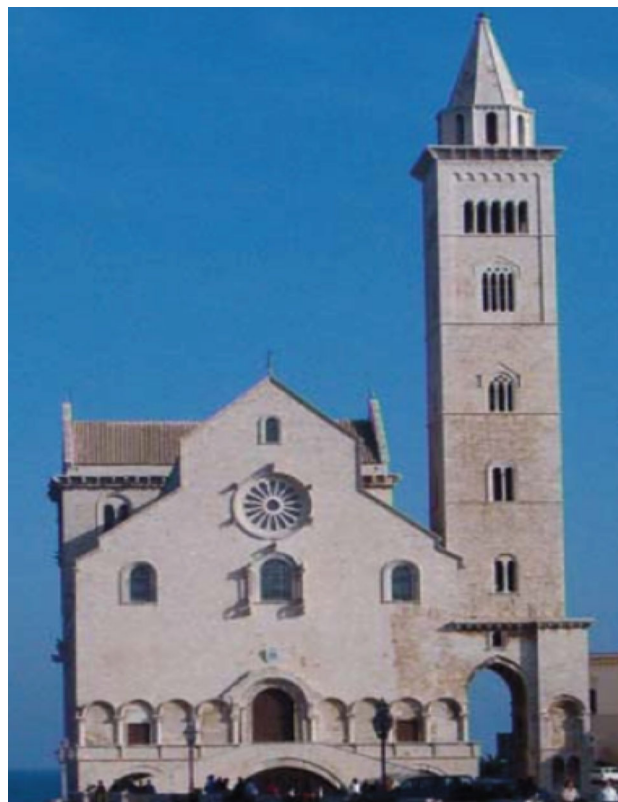
Fig. 1 Trani's Cathedral and its bell tower

Trani's Cathedral is one of the most significant structures in Apulian Romanesque style (Fig. 1); its construction began at the end of the eleventh century and ended in 1143. The bell tower was built starting in 1240 and ended in the second half of 1300.

Trani's Cathedral bell tower has a square transversal section, above the pointed arch that connects the tower to the Cathedral. Up to the arch, at a level of about 14.30 m, there is a rigid floor in correspondence of the opening that connects the bell tower to the church.

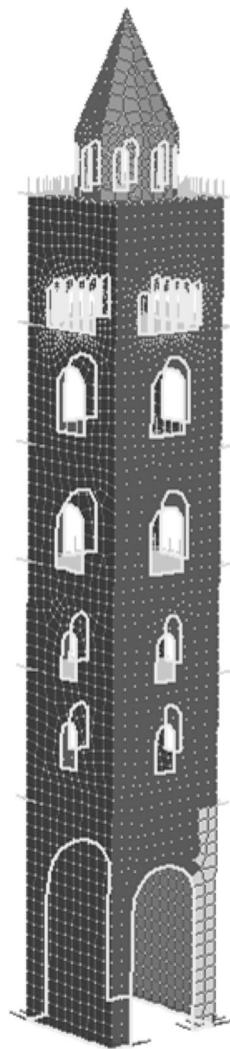
Fig. 2 FE model of Trani's Cathedral bell tower

Based on the available information a three-dimensional FE model has been defined by means of Straus Software package (Straus7). The tower has been modeled with 8-nodes 4093 plate elements (QUAD8) that can better describe the behavior of thick plates like the ones here considered (Fig. 2); such shell element is a quadrilateral element which assumes as nodes the four corners and other four extra nodes along the four edges. The tower has been considered fully fixed at the base, while its connection with the adjacent Cathedral has been modeled by means of springs. Moreover, the stairs and the bells have been neglected into the FE model as their values are not significant respect to the structural mass. The thickness of the shell elements has been defined in accordance with the available drawings.

The walls have been modeled with a homogeneous material. In fact, as confirmed by GPR tests, there is a perfect connection between the external Trani's stones and the concrete core. Consequently, the walls have been modeled with a uniform material whose mechanical properties (i.e., density and elastic modulus) have been obtained by weighted averaging of the contributions of the stones and the concrete with respect to the thickness

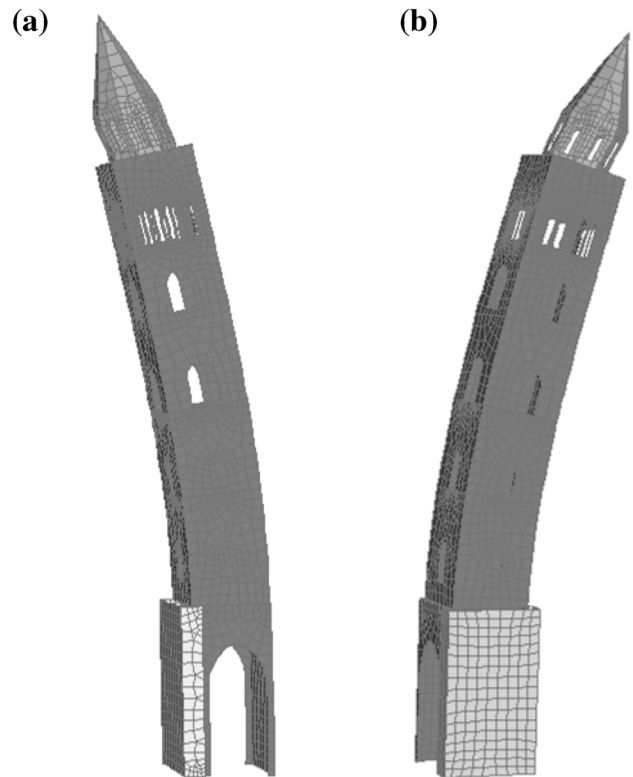
Fig. 3 a The first mode shape $f_1 = 2.04$ Hz; **b** the second mode shape $f_2 = 2.25$ Hz

In Fig. 3, the first two natural mode shapes are sketched.

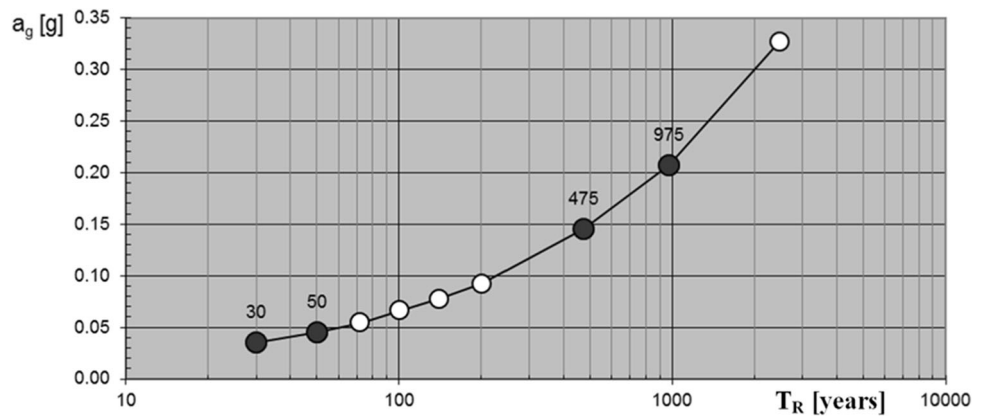
Fig. 4 Seismic hazard curve at the bell tower site

Trani's area is a seismic prone zone. According to the seismic Italian code (NTC 2008; DPCM 2011), the site is characterized by the hazard curve in Fig. 4, where the PGA at the bedrock a_g is plotted varying the return period T_R . The PGA at the bedrock with a 475 years return period is equal to $a_g = 0.145$ g. For the site effect, a rock mass has been assumed for the subsoil condition and a flat land for the topographic condition; on such basis an amplification factor $S = 1.0$ has been adopted in accordance with the Italian building code (NTC 2008; DPCM 2011).

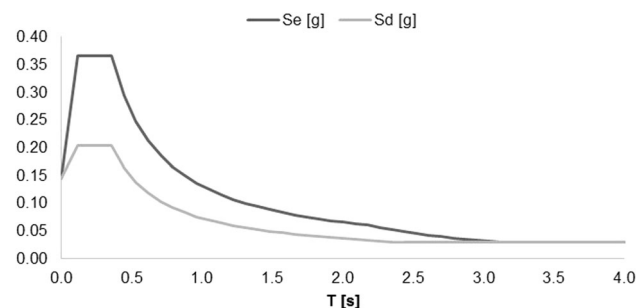
Fig. 5 Elastic and design response spectra for life safe limit state

08) for towers irregular in elevation like in the case here considered, which is characterized by the presence of the Cathedral only on one side of the tower. In Fig. 5. the elastic response spectrum S_e and the design response spectrum related to the horizontal direction S_d are shown for the life safe limit state.

Moreover, the model has been subjected to the design spectra in Fig. 5. The walls have been verified; in Fig. 7b an example of the performed analysis is shown for the wall at the first floor, the latter reported in Fig. 7a.

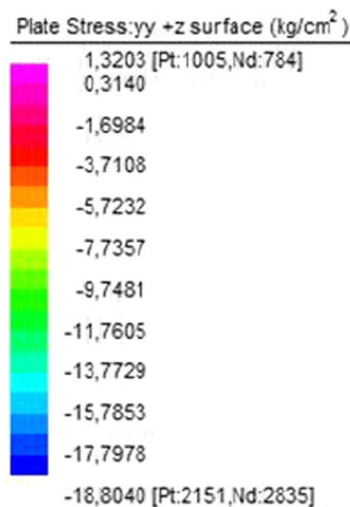
Fig. 6 Normal stress pattern due to static loads

A preliminary linear static analysis has been performed on the FE model of the tower, assuming the tower fully fixed at the base and by simulating the interaction with the adjacent Cathedral by means of springs, as aforementioned. The tower has been considered subjected to self-weights and live loads (the latter equal to 5 kN/m²), the evaluated normal stresses are shown in Fig. 6. It can be observed that the values are compatible with the ordinary resistances of concrete and masonry materials ($\cong 25$ N/mm²).

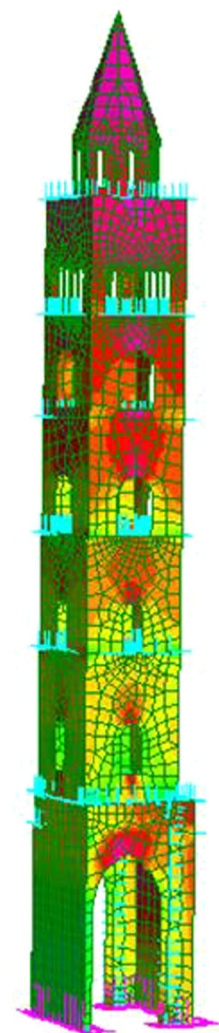
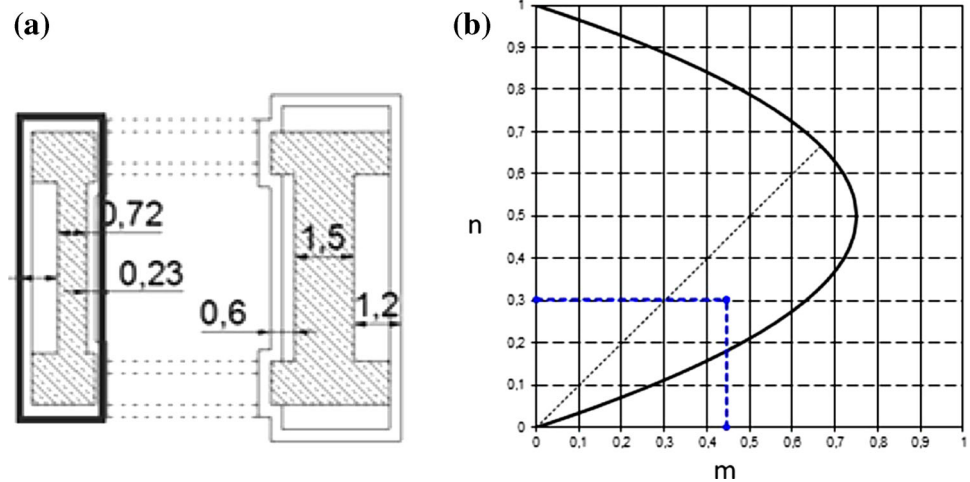
Fig. 7 **a** In the *black* rectangular the considered wall; **b** normal force–moment domain, in *blue* the stress condition

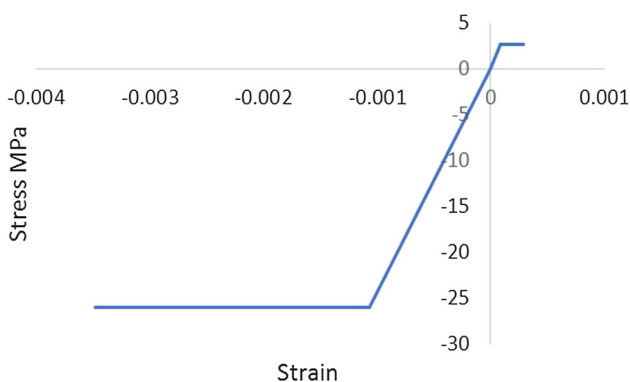
Fig. 8 Stress–strain relation of the structural material

Figure 8 shows the stress–strain relationship that has been adopted for describing the nonlinear behavior of the structural material.

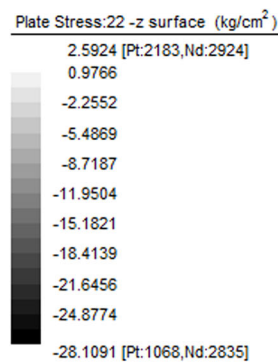
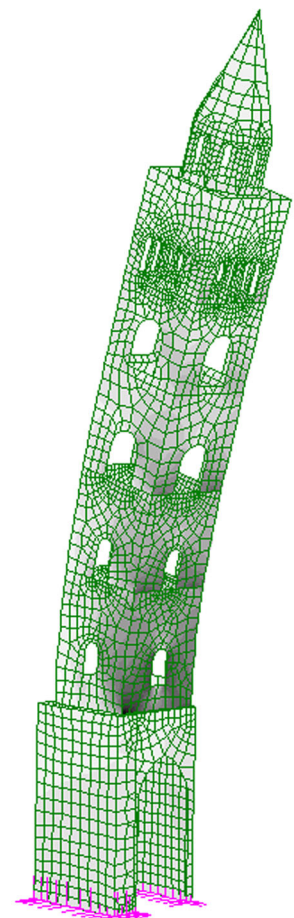
Fig. 9 Stress pattern of nonlinear static analysis (Rankine criterion)

Analyzing the distribution of the stress along the tower during the sequence of load increment, it can be verified that at the 12th step the maximum compressive strain is reached in correspondence of a load that is 20% greater than the load of life safe limit state (Fig. 9).

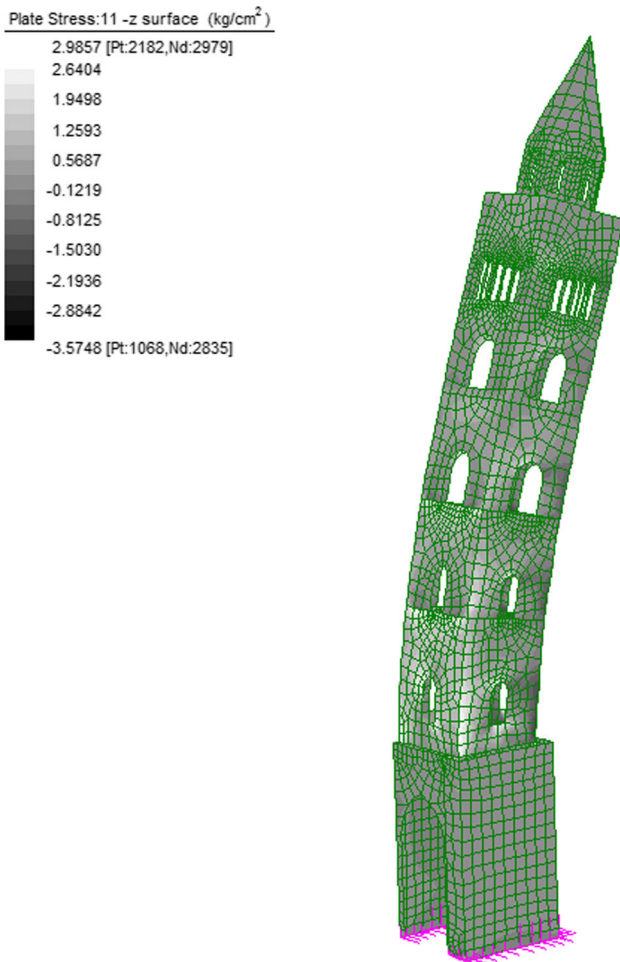
Fig. 10 Stress pattern of nonlinear static analysis (maximum tensile stress)

Moreover, the maximum tensile stresses appear at the 8th step that is in correspondence of a load equal to 80% of the load for the life safe limit state (Fig. 10).

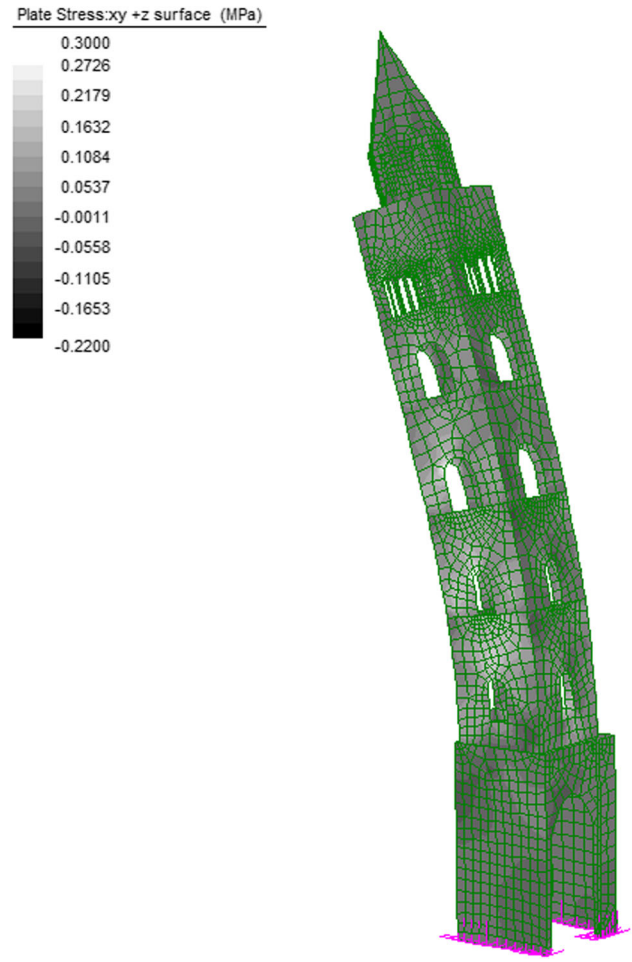
Fig. 11 Stress pattern of nonlinear static analysis (Coulomb criterion)

where τ is the shear stress, and it has been assumed $c = 0.37$, $\sigma = 0.64$ MPa and $\text{tg}(\varphi) = 0.4$. Thus, the limit value for the shear stress is equal to 0.29 MPa. Figure 11 shows the stress pattern of the tower the zones where the maximum shear stress compatible with the Coulomb criterion is achieved, can be observed.

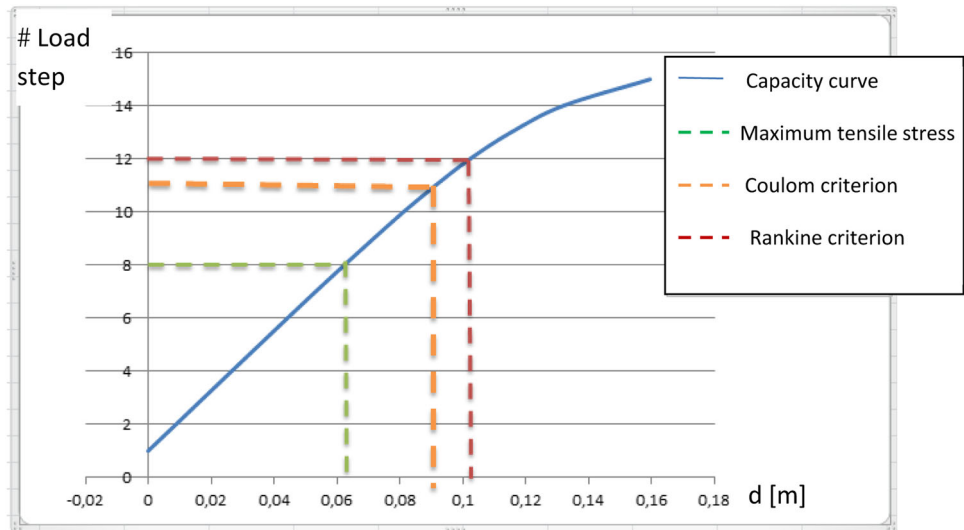
Fig. 12 Capacity curve of the bell tower

In Fig. 12, the capacity curve (number of the load step increment vs. the maximum displacement of the center of mass of the upper level) of the examined bell tower is shown, and the displacement capacity, evaluated for each one of the aforementioned criteria, is plotted.

The maximum tensile stress criterion is the one that estimates the lower displacement capacity; consequently, it is the one adopted as risk assessment criteria.

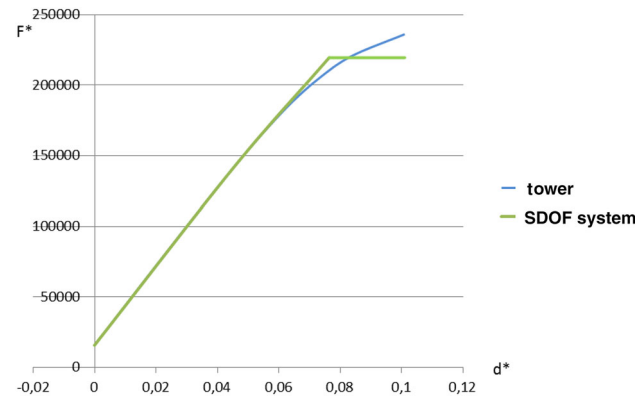
Fig. 13 Comparison between the capacity curve of the tower (blue line) and the bilinear curve of the equivalent SDOF system (green line)

On such basis the equivalent SDOF system has been defined in accordance with the Italian building code (NTC 2008; DPCM 2011). Figure 13 shows the comparison between the capacity curve of the tower and the bilinear

curve of the equivalent SDOF system. The bilinear curve gives a behavior factor that is defined as the ratio between the maximum displacement and the yielding displacement equal to 1.34, lower than the value suggested by the Italian code (NTC 08).
