Original Article

## Comparative Study of Shear Bond Strength of Three Veneering Ceramics to a Zirconia Core

**Cite this article as:** Aalaei Sh, Nematollahi F, Vartanian M, Beyabanaki E. Comparative Study of Shear Bond Strength of Three Veneering Ceramics to a Zirconia Core. J Dent Biomater, 2016;3(1):186-191.

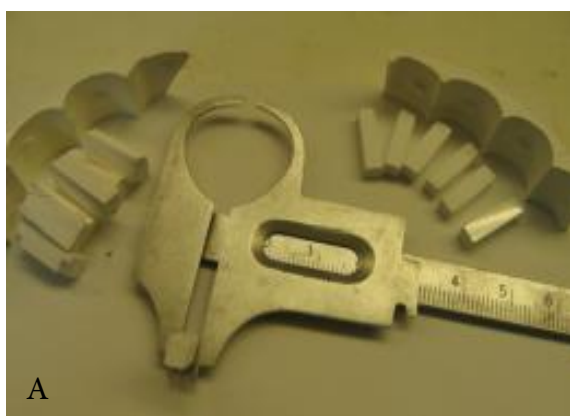
**Figure 1:** **A.** zirconia-based blocks (Zirkonzahn, Steger, Ahrntal, Italy) prepared at 4x4x12 mm dimensions. **B.** Three brands of veneering ceramics used for layering the zirconia cores.

Thirty zirconia-based blocks (Zirkonzahn, Steger, Ahrntal, Italy) with dimension of 4x4x12 mm were prepared using universal milling machine (Steger, Ahrntal, Italy) (Figure 1. A). The blocks were divided into three groups and placed in the sintering oven (Zirkonzahn, Italy) at room temperature which was raised to 1500 °C during 4 hours, and then remained in that temperature for 2 hours. Thereafter, the samples
