Original Article

Influence of Er,Cr:YSGG Laser Surface Treatments on Micro Push-Out Bond Strength of Fiber Posts to Composite Resin Core Materials

Cite this article as: Ghavami-Lahiji M, Benedicenti S, Karimian R, Shahabi S. Influence of Er,Cr:YSGG Laser Surface Treatments on Micro Push-Out Bond Strength of Fiber Posts to Composite Resin Core Materials. J Dent Biomater, 2018;5(1):533-542.

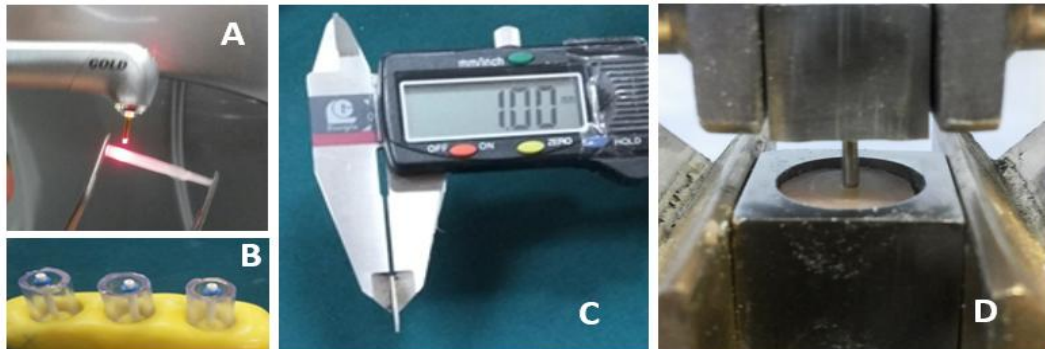
Figure 1: A) Irradiation of glass fiber posts with the Er,Cr:YSGG laser. B) Fixation of posts into the silicon impression material. C) Measuring the thickness of the specimens with a caliper. D) Applying the push-out load by using a Universal Testing Machine

Group 4: White Post DC post that received no surface treatment (control group). Group 5: White Post DC post irradiated with an Er,Cr:YSGG laser at energy level of 1W, the same as method 2 (Figure 1A). Group 6: White Post DC post that irradiated with Er,Cr:YSGG laser, at energy level of 1.5W, the same as method 3. After the surface treatments, a single layer of the silane coupling agent was applied with a micro brush to the post surfaces for 1 min, and gently air-dried. Then, a thin layer of unfilled resin (bonding agent) was applied on the surfaces and cured with an LED light curing unit (Bluephase G2, Ivoclar Vivadent). A cylindrical plastic tube (15.0 mm length and 7.0 mm inner diameter) was placed around the post. The apical part of the post was fixed into the putty additional silicon impression material (Panasil, Germany) with the post located at the center of the tube and allowed to set (Figure 1B). Resin core material was filled into the tube and light cured for 20 s each direction of the tube. To ensure optimal polymerization of the core material, an additional light-curing was performed at the end of the specimens for 40 s. Then, the specimens were removed from the tube by sectioning with a scalpel blade and stored in distilled water at 37°C for 24

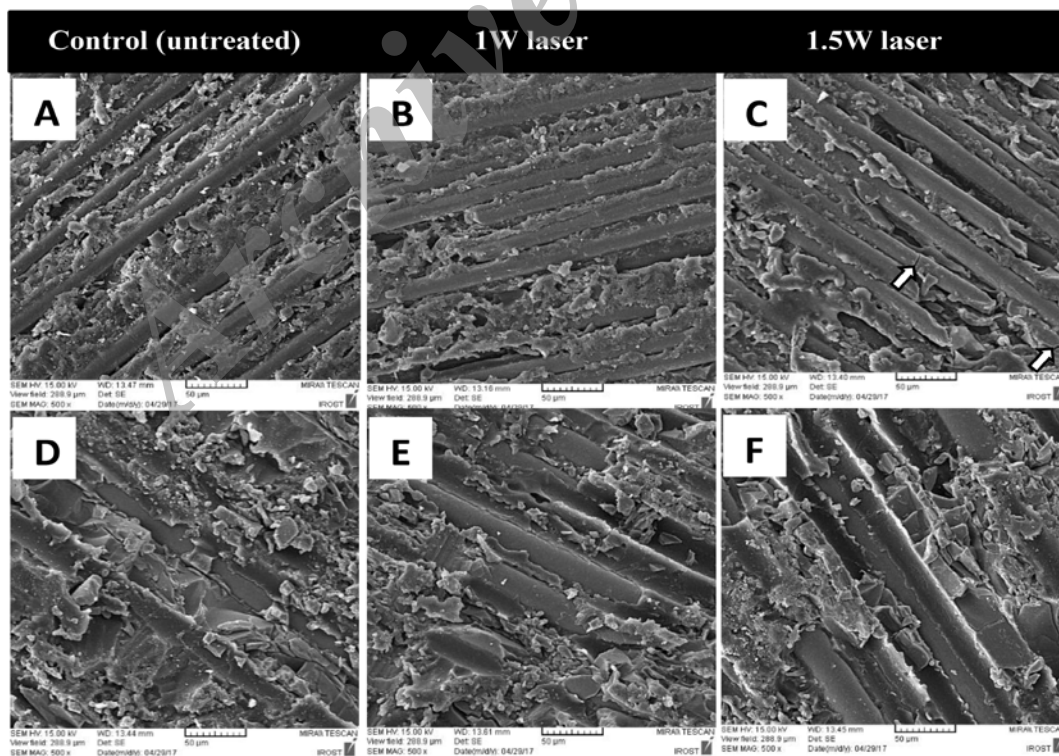
Figure 2: Field emission scanning electron microscopy (FE-SEM) micrographs of glass fiber post surface after different treatments at 500x magnification. (A-C) Exacto post, (D-F) White post DC. The differences in diameter of the fiber posts are clearly shown in the pictures. White post DC fibers are thicker than the Exacto fibers. White arrows show the cracked areas on the surface of the fiber post

post DC groups. However, several micro-cracks were found in Exacto posts irradiated with 1.5W Er,Cr:YSGG (Figure 2). Mode of failure after the push-out test revealed that the mixed failure mode had the most failure mode of all groups (Table 3).

Based on the results of the present study, we rejected the first null hypothesis. The results of FE-SEM micrographs revealed that the Er,Cr:YSGG laser caused surface changes in the fiber posts because the laser partially removed the cross-linked epoxy resin matrix. Therefore, the surface roughness and porosities of the post surface increased. This might provide better penetration of resin to the porosities and micromechanical locking would improve the retention of core materials. The second null hypothesis was partially rejected. In the White post DC groups as laser irradiation had no significant effect on the micro push-out bond strength. However, the 1.5W Er,Cr:YSGG laser irradiation of the Exacto posts significantly reduced bond strength. The micro push-out bond strength is classified as shear bond strength test.

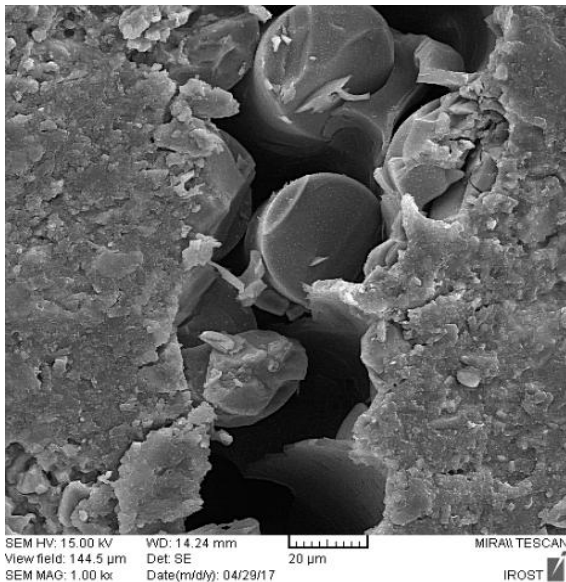
Figure 3: Field emission scanning electron microscopy (FE-SEM) micrographs of White post DC shows a cohesive fracture within the fiber post. The fractures within the fiber posts were observed in more specimens from the White post DC groups, which was probably due to the higher fiber diameters

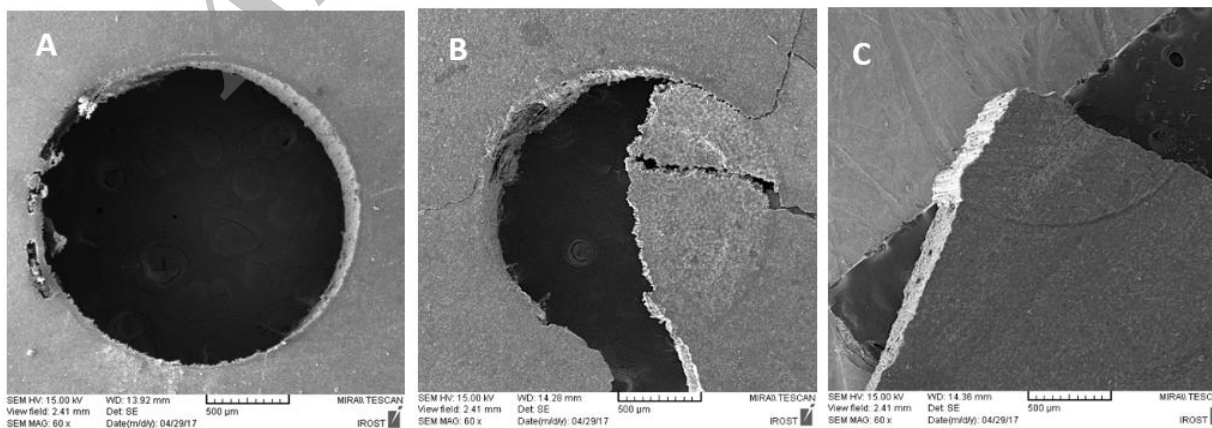
Figure 4: Adhesive (A), mixed (B), and cohesive failure (C) within post and core under field emission scanning electron microscopy (FE-SEM)
