## EXTENDED ABSTRACT

# Investigating the Pattern of Progressive Collapse in Double-Layer Dome Space Trusses

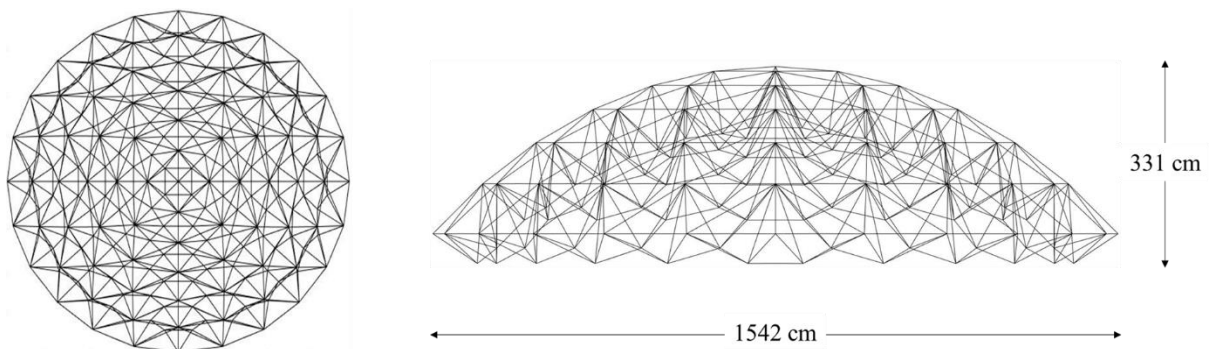
Fig. 1. Dimensional characteristics of the investigated structure

The model used in this study is based on studies by Safari (2016). A two-layer dome space truss with a height of 1.2 m and a radius of 7 m is studied in this paper. Fig. 1 displays the dimensional characteristics of the investigated space truss. Three types of pipe sections have been used in construction of the dome. Section profiles used for structural elements are given in Fig. 2. This figure also shows the group of elements for each type of pipe section.

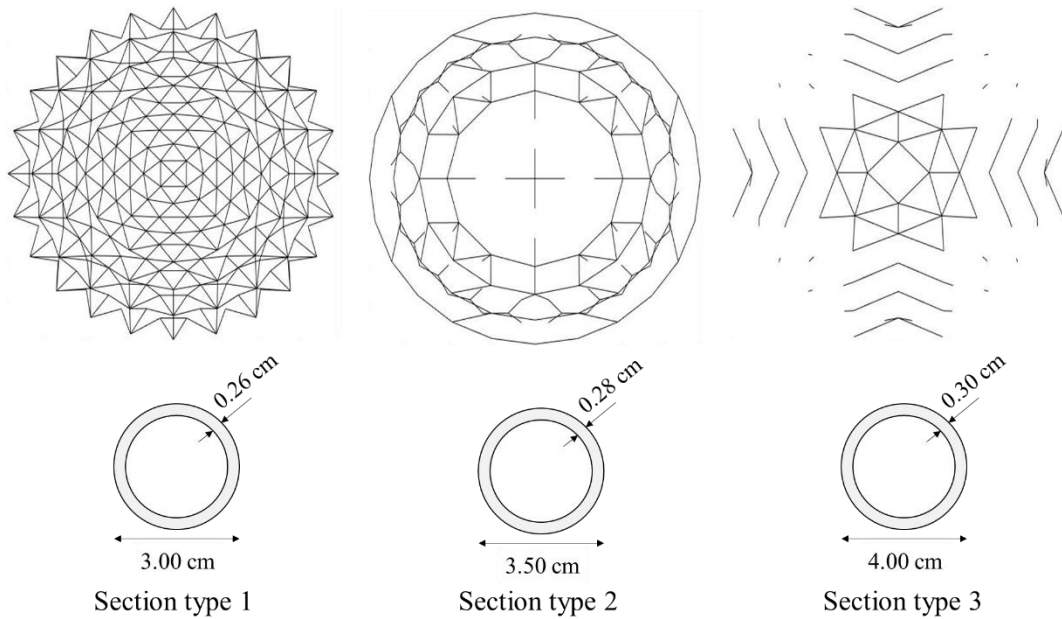
Fig. 2. Section profiles used for structural elements

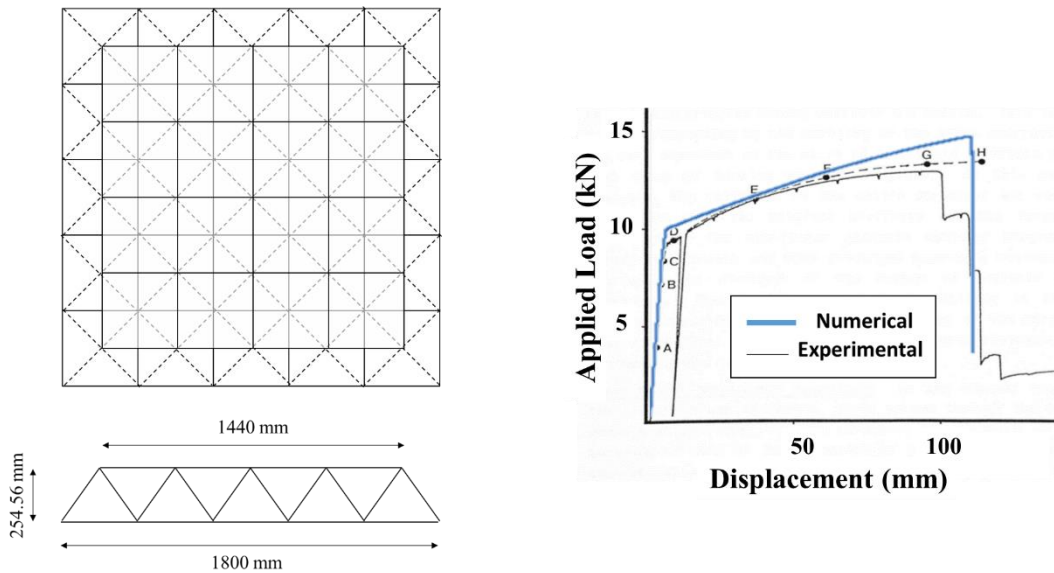
Fig. 3. Structure used for verification and comparison of results

The studied structures are modeled and analyzed using the nonlinear dynamic analysis in opensees software. Members are modeled using “dispBeamColumn” element with an L/1000 imperfection at the mid-length. “Steel02” uniaxial material is used to define stress-strain relationship. Modulus of elasticity and the yield stress for steel material is assumed to be 200 GPa and 250 MPa, respectively. To validate the models, a double-layered grid space truss whose test results were available in the literature (Parke 1989) was used at different levels of gravity loads. The geometry of the structure used for verification and comparison of results are shown in Fig. 3. According to the figure, it can be seen that there is a good agreement between experimental and numerical curves.

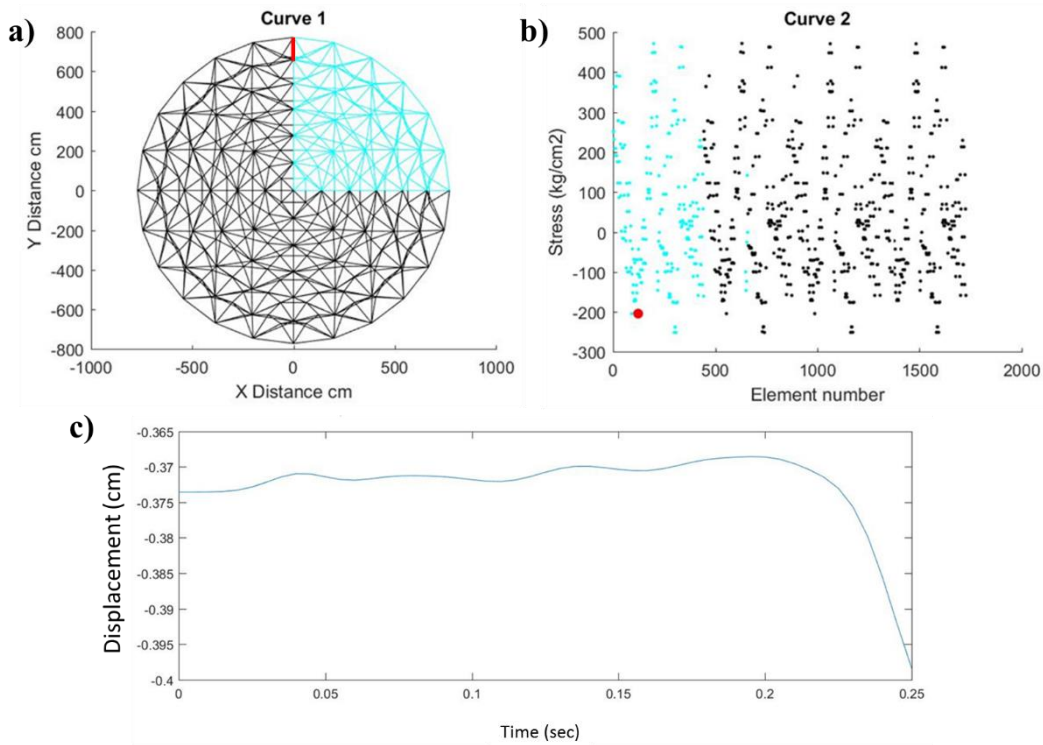
**Fig. 4.** Vibration of the vertex of the dome after removal of member 123: a) location of the removed element, b) stress level at removed element, c) Vibration of the vertex of the dome

For the considered dome structure under design loads (100% of the gravity loads) the progressive collapse occurs only by eliminating four compressive members located at the farthest points on four sides of the dome.

Fig. 4 displays vibration of the vertex of the dome after removing one of these compressive members. By increasing the gravity load to 140%, elimination of twelve tensile members and eight support nodes result in triggering the progressive collapse. Fig. 5 displays the location of members and supports which their elimination cause progressive collapse at 140% of the gravity loads.

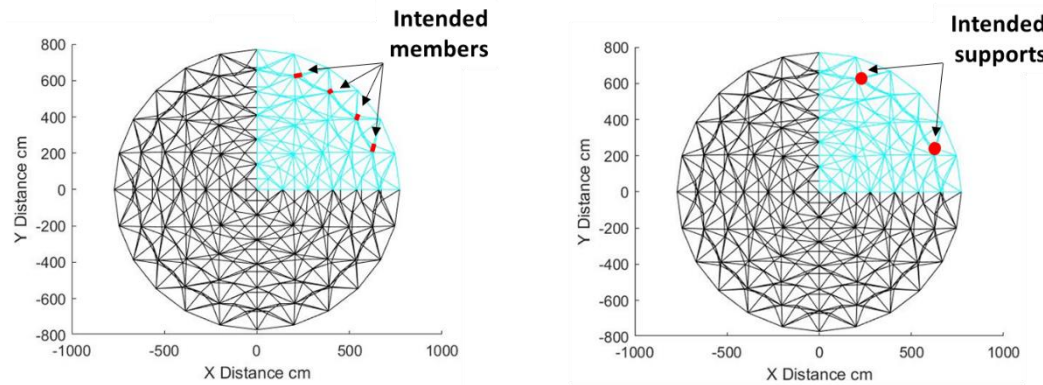
**Fig. 5.** Members and supports which their elimination cause progressive collapse at 140% of the gravity loads

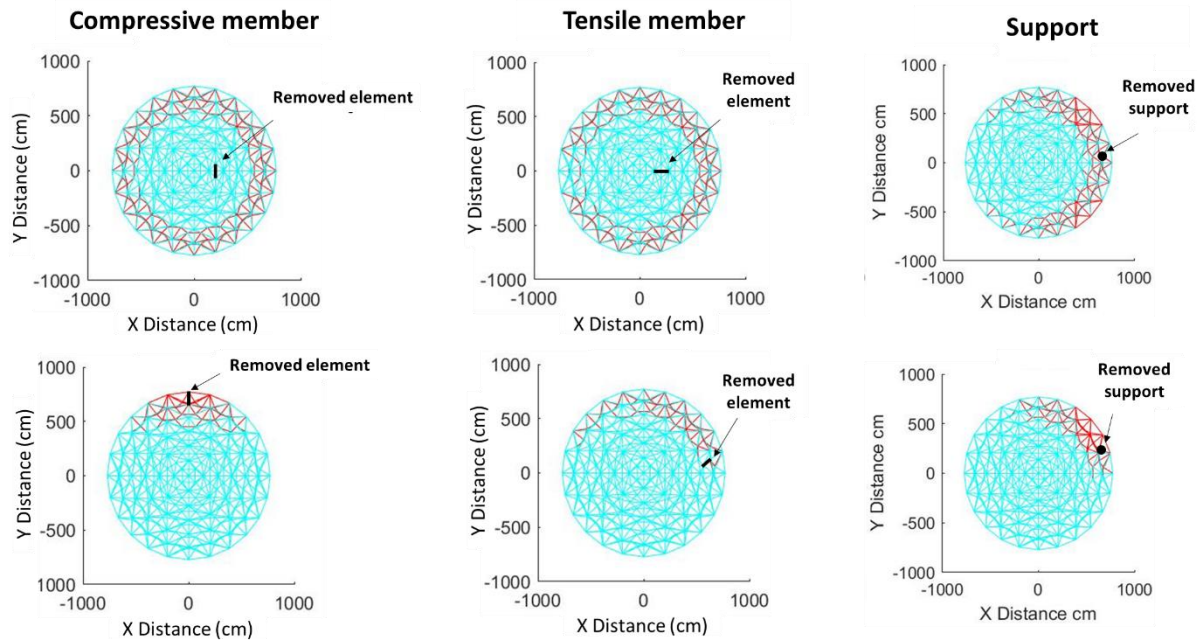
Fig. 6. Pattern of progressive collapse for elimination of compressive members, tensile members and supports

By applying 150% of the gravity load or more, the progressive collapse occurs by eliminating every member (compressive or tensile) or support of the structure. Fig. 6 displays Pattern of progressive collapse for elimination of compressive members, tensile members and support nodes. For compressive and tensile members, elimination of one central and one side member is displayed. According to the figure, the progressive collapse occurs in the outer ring of the dome where the members are attached to the support nodes. Also it can be seen that, the more closer the removed member is to the center of dome, the more extensive the propagation of progressive collapse will be.
