Erosion Risk Mapping Using CORINE Methodology for Goz Watershed in Kahramanmaras Region, Turkey

ABSTRACT

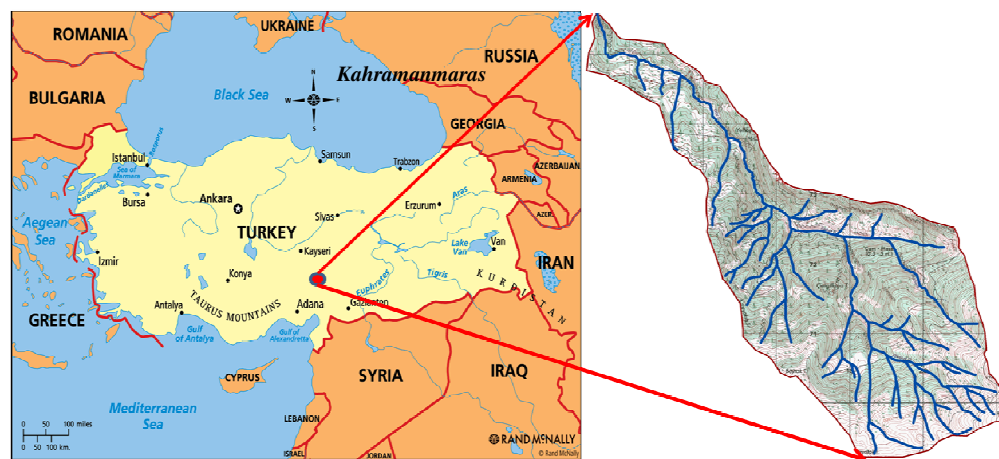
Figure 1. Goz Watershed of Menzelet Dam in Kahramanmaraş.

Goz Watershed, a sub-watershed of Menzelet Dam was selected as the study area. The watershed is 45 km away from the city of Kahramanmaras and has an area of 1,336.6 ha (Figure 1). It is located between the latitudes of 37° 39' 58" and 36° 40' 54" North, and the longitudes of 36° 54' 28" and 36° 57' 59" East. The average elevation and ground slope was 1,295 m and 38%, respectively.

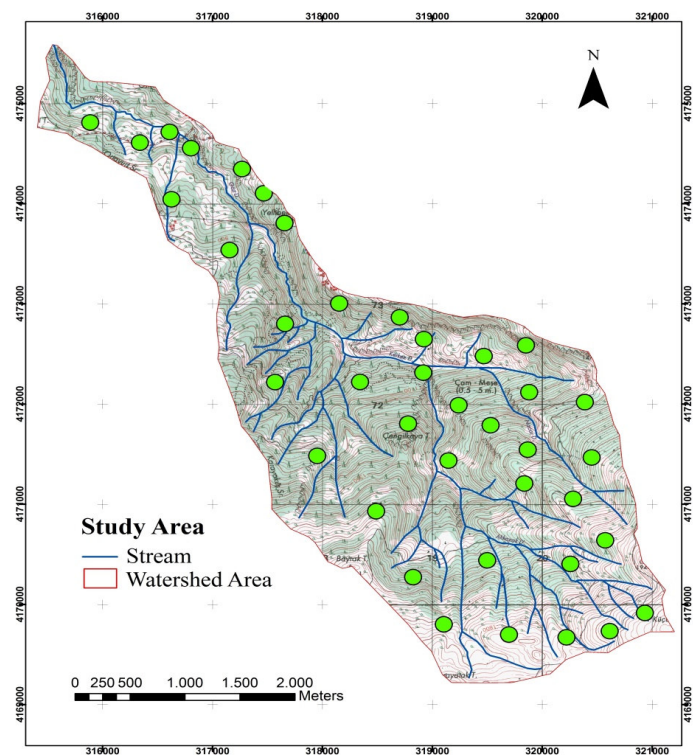
Figure 2. Soil sampling points in the study area.

Figure 2 indicates the soil sampling points in the study area. Then, only those soils that passed through a 2 mm sieve were evaluated in laboratory. Soil texture class map was interpolated with "Thiessen Polygon" for the whole watershed. Soil texture classification was made according to USDA texture classification (SSM, 1993).

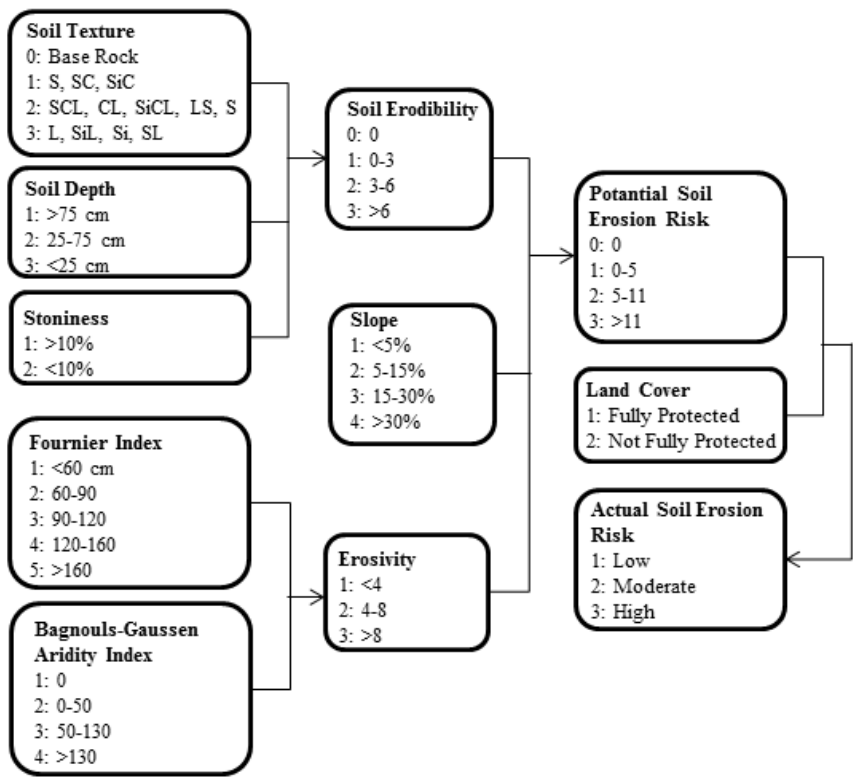
Figure 3. Flow diagram of the CORINE methodology (C: Clay; S: Sandy; Si: Silt, L: Loam).

In the CORINE methodology, soil texture was grouped into three classes including: Slightly erodible (1), Moderately erodible (2), and Highly erodible (3) (Figure 3). Soil maps were used in order to classify soil stoniness and soil depth, which are important indicators of erosion. The stoniness was classified as: Fully protected (1), and Not fully protected (2) soils, by considering the percentage surface cover of stones. The soil depth, which is the depth from the soil surface to the base of the soil profile, was classified as slightly erodible (>75 cm) (1), moderately erodible (25-75 cm) (2), and highly erodible (<25 cm) (3) soils. Finally, the soil erodibility index was calculated by multiplying these three soil factors (CORINE, 1992; Bayramin *et al.*, 2003; Aydın and Tecimen, 2010) and reclassified

Where, T_i is the mean temperature for the month, P_i is the total precipitation for month, and k_i is the proportion of the month during which $2T_i - P_i > 0$. The *BGI* was classified into: Humid (1), Moist (2), Dry (3), and Very dry (4). Finally, erosivity index was determined by multiplying Fournier and Bagnouls-Gausson aridity indices. The input data of precipitation and temperature were obtained from the nearest weather station in Kahramanmaraş for the period of 1985-2010. Finally, erosivity index was reclassified into: Low (1), Moderate (2), and High (3) (Figure 3).

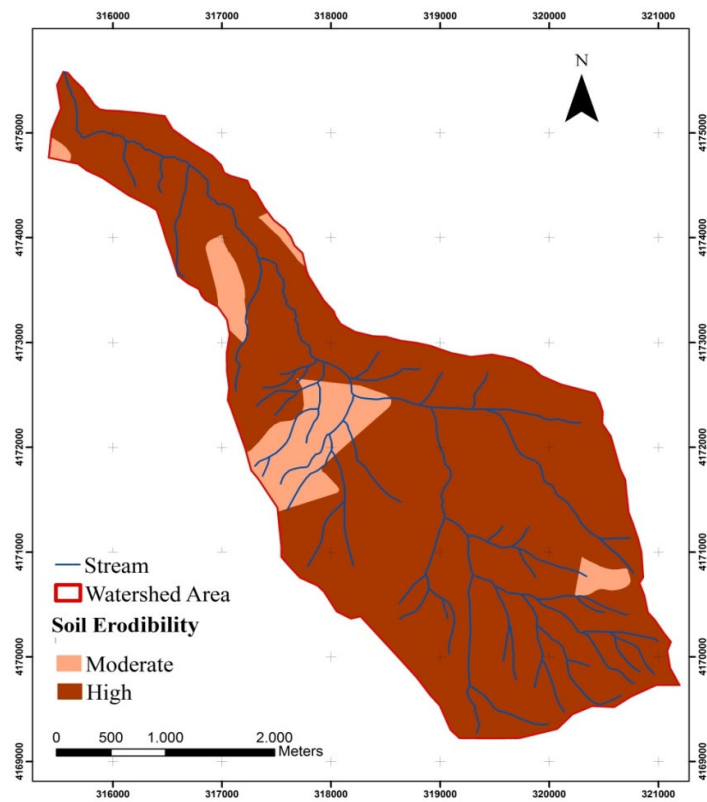
Figure 4. The soil erodibility map of the study area.

Based on soil texture, stoniness, and depth parameters, erodibility factor was moderate (3-6) in 9.5% (126.81 ha) of the total area while it was classified as high (> 6) in 90.5% (1207.98 ha) of the area. Thus, the soil in most parts of the study area was subject to erosion risk considering soil erodibility factor (Figure 4).

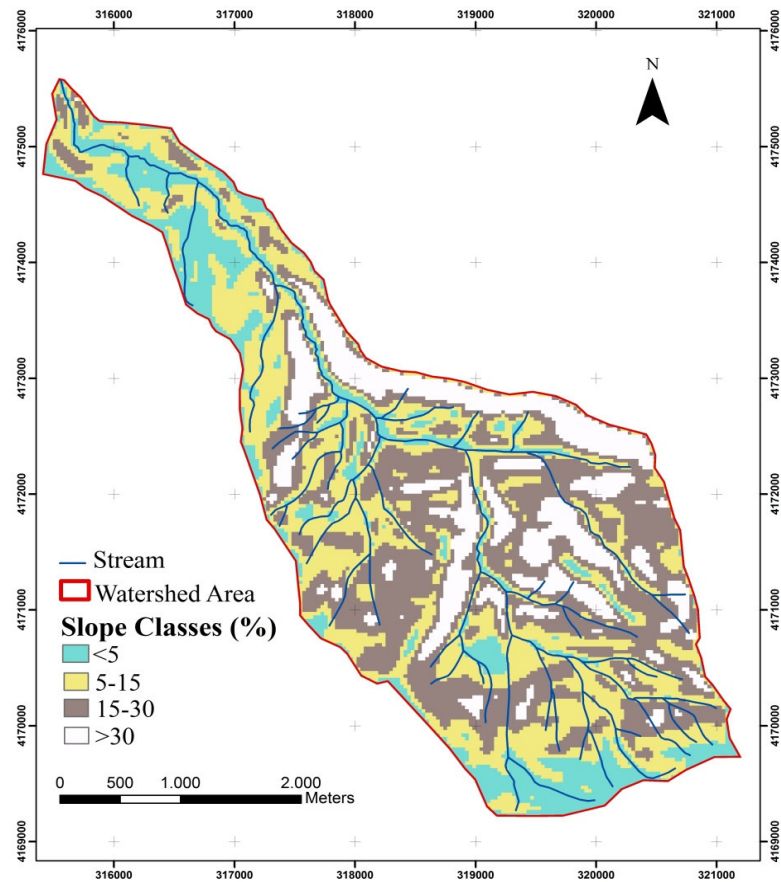
Figure 5. The slope classes map of the study area.

The topographic factors, especially ground slope, are important in terms of estimating erosion. The steep ground slope potentially accelerates the surface runoff, which dramatically increases erosion (Lal, 1994). The results indicated that the average slope in Goz Watershed was 38%. It was estimated that about 50.42% of the watershed was classified as steep and very steep areas, while the rest was on gentle slope (29.52%) and flat (20.06%) (Figure 5).

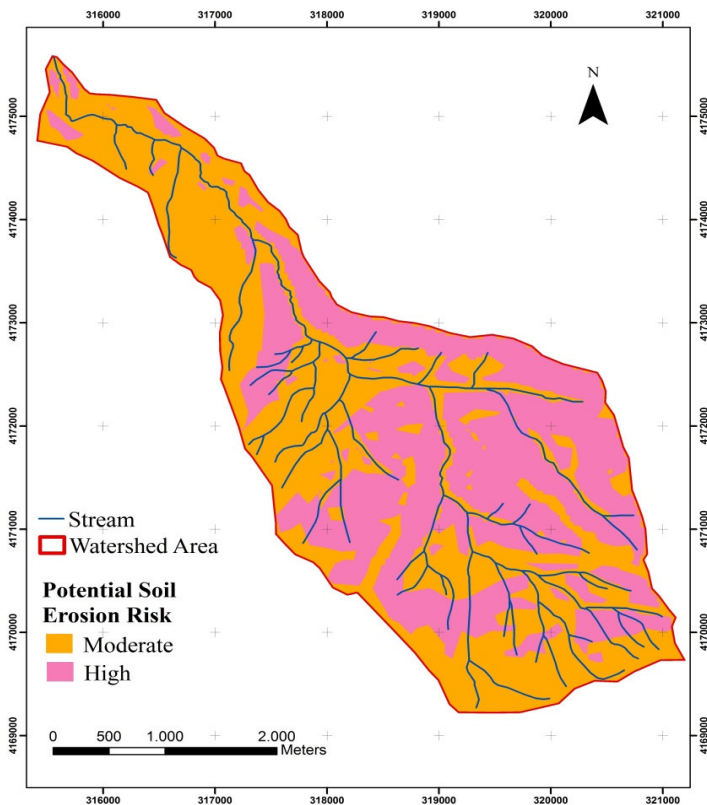
Figure 6. The potential erosion risk map of the study area.

The potential soil erosion risk of the study area was determined and then mapped (Figure 6). The potential erosion risk map indicated that the study area had 54.52% moderate and 45.48% high erosion risk levels. The actual erosion risk map was generated by overlaying potential erosion risk map and land cover map (Figure 7). Reliability of land cover data is very important in soil erosion models (Odoro-Afriye, 1996). The accuracy assessment of

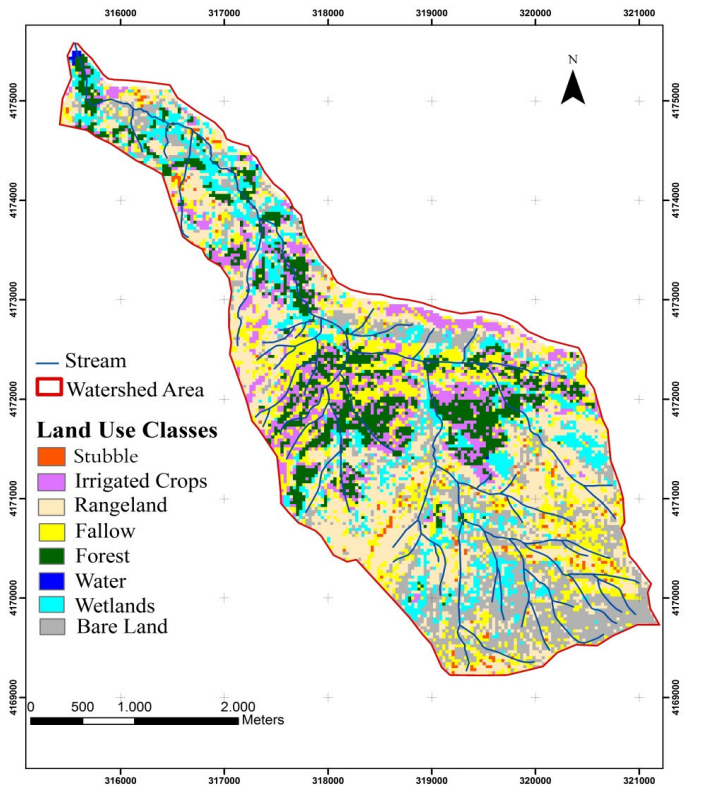
Figure 7. Land use map of the study area.

In the study area, forest was classified as fully protected (1), while the rest i.e. irrigated crops, stubble, fallow, wetlands, rangeland, and bare land were classified as not-fully protected (2). Land cover map indicated that the study area was 88.33% not-fully and 11.67 % was fully protected. Actual erosion risk map indicated that 11.97% of the study area had moderate risk, while 88.03% of the study area possesses high erosion risk (Figure 8).

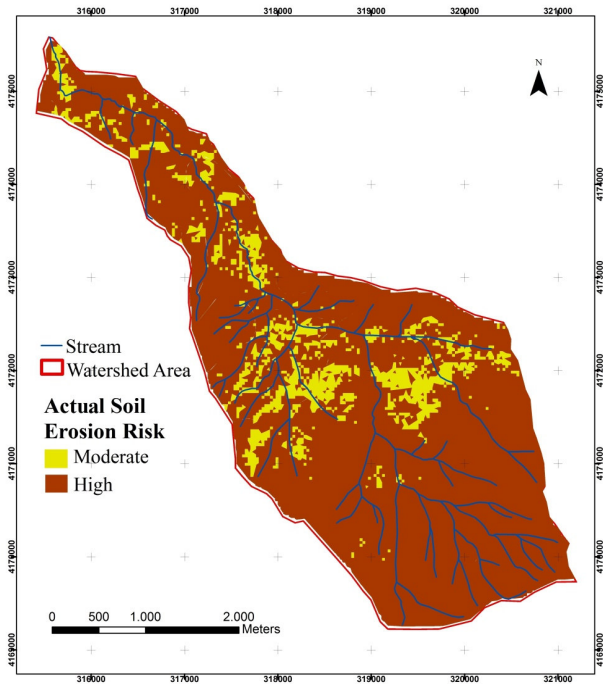
Figure 8. The actual erosion risk map of the study area.
