## THE INFLUENCE OF MORTAR HEAD JOINTS ON THE IN-PLANE AND OUT-OF-PLANE SEISMIC STRENGTH OF BRICK MASONRY WALLS\*

**Abstract**– A sound assessment of the in-plane shear and out-of-plane bending capacities of the load-bearing walls is imperative when conducting seismic assessment or seismic design of masonry buildings. The bulk of work on the subject so far has assumed uniform construction with the brick units connected to each other by mortar bed joints as well as head joints. However, in many construction practices, either for architectural purposes or for speeding up the construction process, the head joints are omitted. This omission may have a profound effect on the response and the strength capacities of the wall. In this paper, the results of a number of tests carried out on half-scale brick wall panels, having different material properties, with head joints and without head joints, are presented. The walls are subjected to in-plane shear, as well as out-of-plane bending pushover loads to failure and their load-displacement curves are established. Representing numerical models for the in-plane shear case are also analyzed and results are compared with those of the experiment

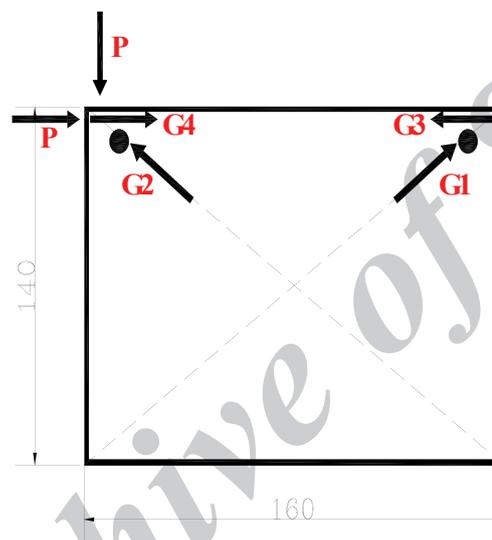
The test set-up used in this study (Fig. 1) conforms to one of a number of test set-ups presented by Mayes and Clough [23-24] in their state of the art reports regarding the in-plane shear tests on masonry walls. In this set-up, two hydraulic jacks, one placed horizontally and the other vertically at the loading end of the concrete beam which was constructed on the wall, simultaneously exert equal loads on that corner of the wall. The loading step in all four tests was set at 3.0 kN. This loading step corresponded to 2% of the estimated ultimate capacity of the strongest panel. Four mechanical dial gauges were used to record the displacements of the wall specimens in each loading step. The positions of these gauges are also shown in Fig. 1.

Fig. 1. Test setup for the in-plane shear loading of wall panels

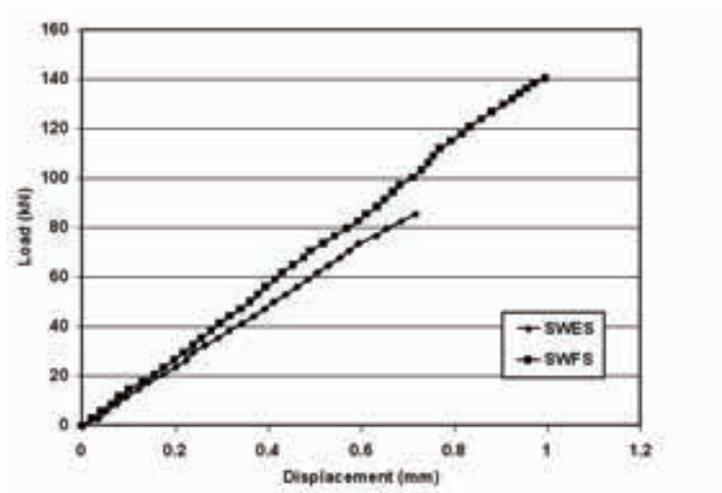
**Test of standard wall with head joints (SWFS):** Considering the material properties and method of construction, the ultimate shear capacity of this wall was estimated as 150kN. The force-displacement pushover curve obtained for the drift ( $G_3$ ) is plotted in Fig. 2. The force-displacement curve shown in Fig. 2 indicates a near linear response of the wall panel up to the 121 kN. A slight change in the slope of the curve beyond this load may correspond to the first cracking of the wall. However, during the test, no cracks became visible until the load of 140kN, at which the sudden and explosive failure of the wall panel occurred on the compression diagonal, (Fig. 3). The diagonal failure was primarily in the form of tensile failure of brick units and mortar joints with a major line crack and a number of smaller parallel cracks running through both materials. As it was expected, the brick-mortar bond slippage on the diagonal main crack was minimal. The drift measured at the load 121 kN is 0.83mm, giving a stiffness of 142 kN/mm.

Fig. 2. Pushover curves of the walls SWFS and SWES

**Test of standard wall without head joints (SWES):** The incremental pushover curve for drift measured for this wall during the in-plane shear test is plotted in Fig. 3. Similar to the response of the wall with head joints, an almost linear force-drift relation can be observed for this wall. The slope of the curve, however, changes markedly beyond 74 kN load, indicating some form of yielding of the wall panel. However, no cracking could be seen at this load. At 91.5 kN load, the failure of the wall occurred somewhat similar to that of the wall SWFS, with a sudden and explosive cracking on the compression diagonal (Fig. 4). The

The slope of the drift pushover curve, up to 74 kN provides a stiffness of 121 kN/mm for this wall. This stiffness is 15% less than the stiffness measured for the wall SWFS, indicating the stiffening effects of the head joints. By comparing the ultimate loads measured for the two walls, it becomes evident that the head joints had a 35% contribution to the in-plane shear capacity of the wall SWFS.

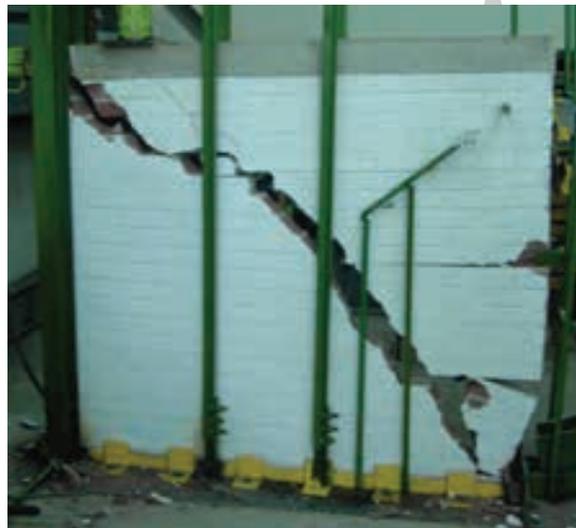
Fig. 3. Mode of failure of the wall SWFS

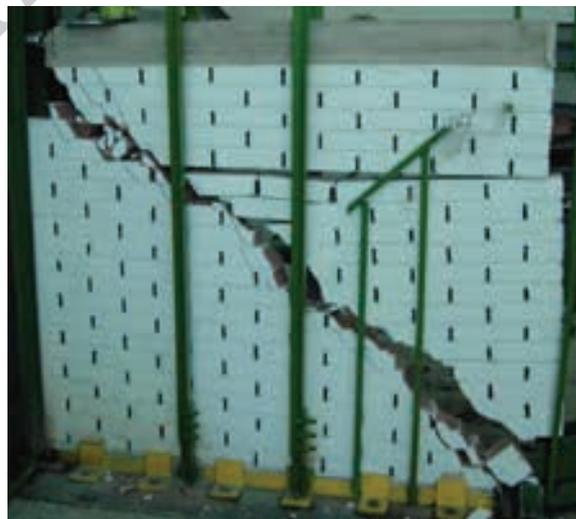
main form of failure was, however, parallel diagonal tensile cracks through the bricks and mortar joints with very small sections of bond slippage.

Fig. 4. Mode of failure of the wall SWES

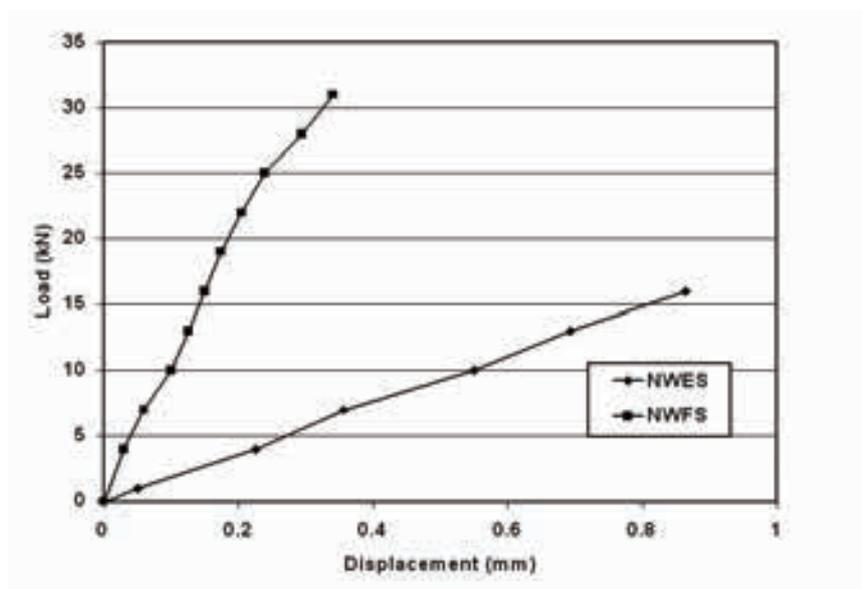
**Test of non-standard wall with head joints (NWFS):** The force-displacement curves for the non-standard wall with head joints (NWFS) are plotted in Fig. 5. The ultimate failure of the wall, at 31 kN load, was sudden. However, contrary to the failure of the standard walls it was not explosive. The main crack followed, more or less, the compression diagonal in a combination of horizontal and stepwise bond slippage (Fig. 6). The stiffness of this wall is calculated as 99 kN/mm.

Fig. 5. Pushover curves of the walls NWFS and NWES

**Test of non-standard wall without head joints (NWES):** The pushover force-displacement curve deduced from the test of this wall is shown in Fig. 5. The main crack in the form of a classic and clean stepwise bond failure on the compression diagonal appeared at the load of 16 kN (Fig. 7). With the application of further loads, a somewhat ductile failure continued with widening of the stepwise crack.

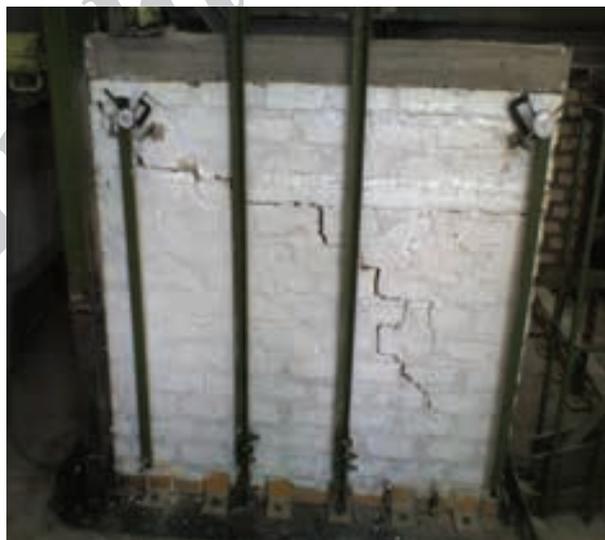
Fig. 6. Mode of failure of the wall NWFS

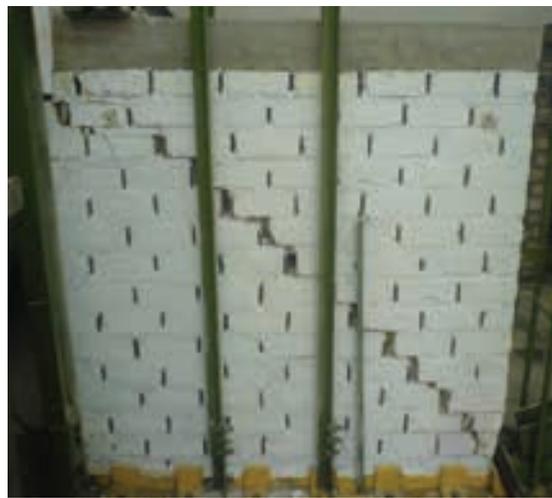
Fig. 7. Mode of failure of the wall NWES

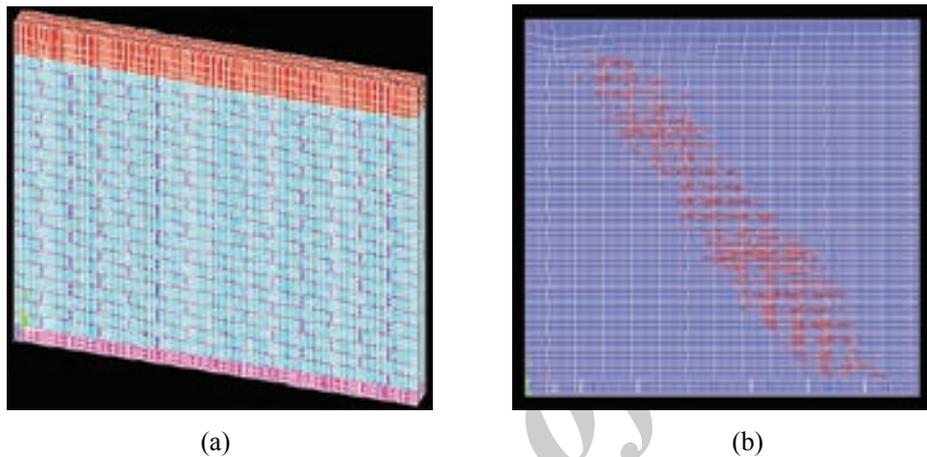
In forming the micro models for the standard walls, it was deemed unnecessary to use interface elements to represent the bond strength between bricks and mortar. This was because the experimental results suggested that due to the type of mortar used in, and the moisture curing of, the standard walls, the strength of the bond between brick units and mortar was sufficient not to warrant modelling the interface. A very fine mesh was used for the micro model of the standard wall with head joints (SWFS). The mesh is shown in Fig. 8a.

Fig. 8. Standard wall SWFS, (a) The FE mesh of the micro model, (b) ultimate crack pattern

The pushover curve, representing the relation between the incremental load and the corresponding in-plane drift for this wall is plotted next to the experimental curve in Fig. 9a. Close agreements could be seen between the two curves, numerical shear strength being around 9% less than the experimental capacity at a similarly reduced drift level. It shows a linear response of the wall up to the load 120kN. No cracking was seen in the results for this range. Beyond this load, the first cracks develop in the vicinity of the compression diagonal and rapidly spread to cover the entire compression diagonal zone (Fig. 8b). The spreading of the cracks can be deduced from the force-drift curve of Fig. 9a in the form of the change of the slope at the end of the curve. The shear stress distribution in the wall at the ultimate load corresponds well with both the numerical cracking zone and the experimental cracking pattern.

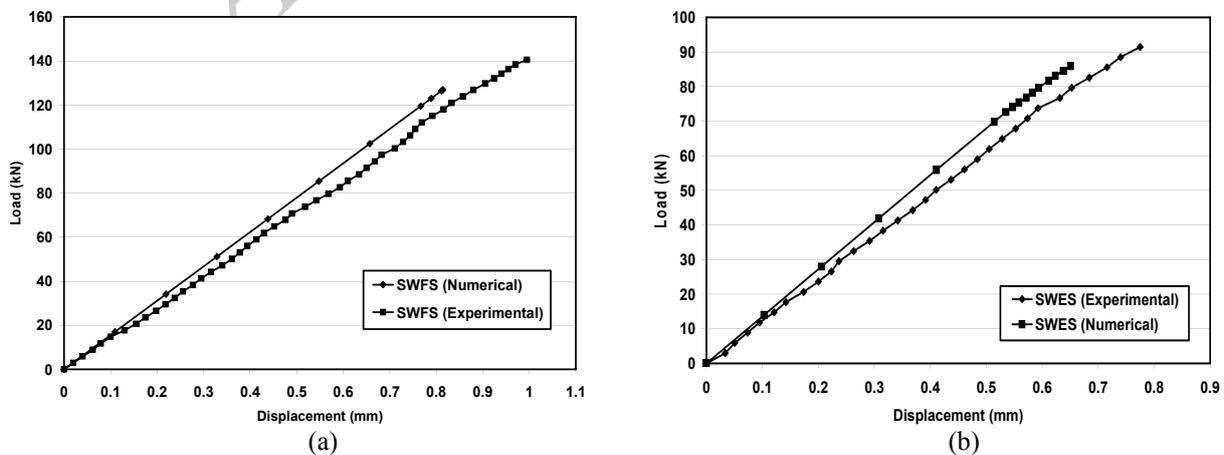
Fig. 9. Comparison between the pushover curves of the standard wall panels; (a) with head joints (SWFS) and (b) without head joints (SWES)

The nonlinear pushover analysis of the standard wall panel, SWES, was performed in a similar manner to the wall SWFS. The numerical pushover curve for this wall is plotted next to the experimental curve in Fig. 9b. Similar to the experimental response curve, the numerical curve shows a marked, albeit short, ductile zone. This indicates the dominance of the mortar bed joints in forming the response of the brickwork at failure. Formation of cracks could be seen to be different to that of the wall with head joints (SWFS). However, similar to wall SWFS, the numerical shear strength evaluated for this wall is also less than the experimental value, the difference being around 6%.

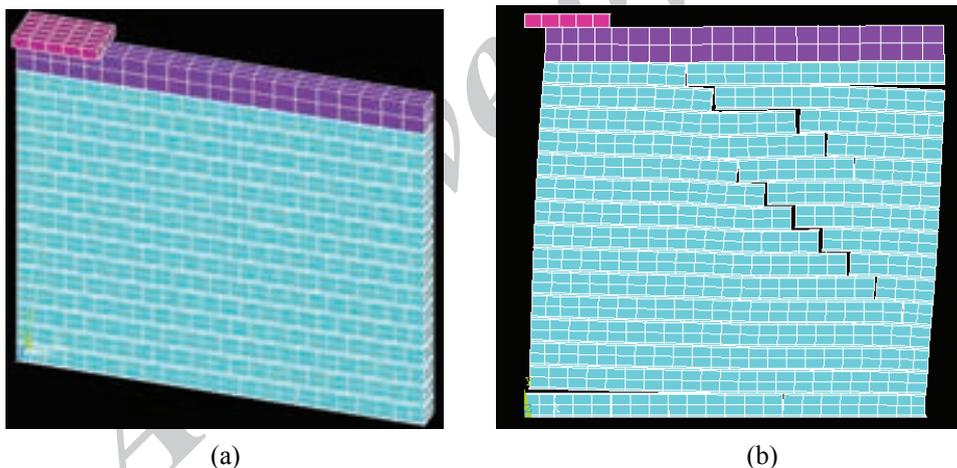
**Numerical analysis of non-standard wall panels:** A simplified micro model was developed to conduct nonlinear pushover analysis of the non-standard wall panels. This is because, unlike the standard walls, the response and the failure mode of the non-standard walls are dictated by the brick-mortar bond strength. To model the non-standard walls, therefore, a relatively fine micro model with interface elements was used. In this model, brick units together with half of their surrounding mortar are represented by a number of elements having identical material properties. Interface elements were used to join the brick-mortar elements at the middle of the mortar joints. The response of these elements is governed by Mohr-Columb criterion. The properties assumed for the elements, including the shear bond strength and friction coefficient, were deduced from the material tests (Table 1). The simplified micro model thus formed for the wall NWFS is shown in Fig. 10a. It should be noted that the equivalent brick-mortar elements are assumed to have linear responses. Considering the dominance of the bond strength, represented by the interface elements, on the shear response of these non-standard walls, such an approximation should not influence the results.

Fig. 10. Non-standard wall NWFS, (a) The FE mesh of the micro model, (b) ultimate crack pattern

The pushover curve evaluated for the wall NWFS using this numerical model is shown, superimposed on the experimental pushover curve for the same wall in Fig. 11a. The numerical curve follows a similar trend to the experimental curve up to a load of 25 kN, where the analysis stops as the ultimate wall capacity. This is 20% less than the experimental capacity. The relatively large discrepancy can be attributed to the variations in the material properties of the wall panel and the properties used for the numerical models obtained from material tests. The failure pattern for this wall, shown in Fig. 10.b, however, closely resembles the experimental failure pattern with initial horizontal cracking one brick layer below the concrete beam followed by the diagonal and horizontal bond slippage.

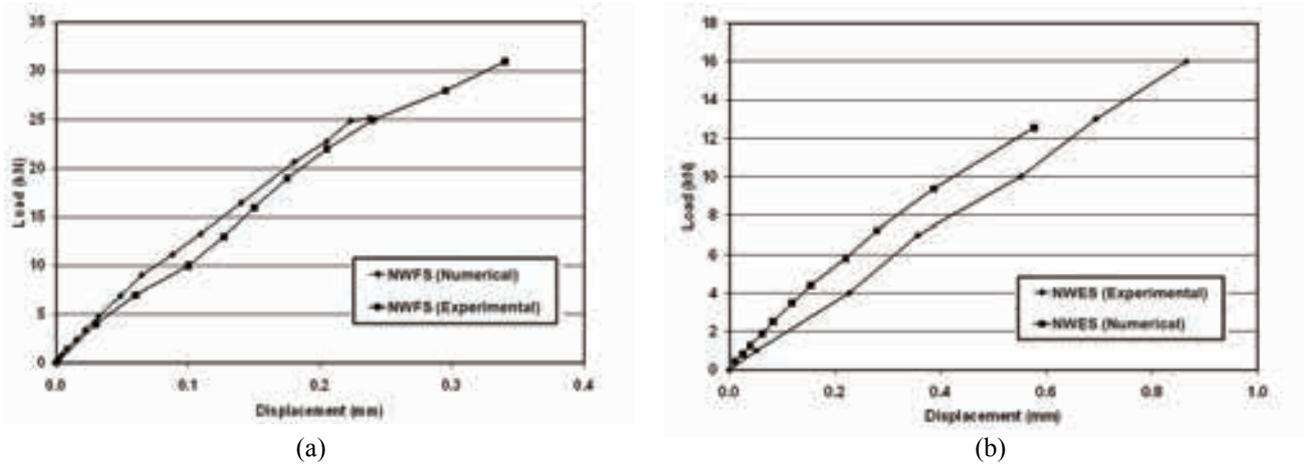
Fig. 11. Comparison between the pushover curves of the non-standard wall panels; (a) with head joints (NWFS) and (b) without head joints (NWES)

Similar behaviour could be seen when comparing the numerical pushover curve for the non-standard wall without the head joints with that obtained in the experiment (Fig. 11b). The numerical curve shows a stiffer response, giving an ultimate capacity of 12.6 kN, 11% less than the experimental capacity.

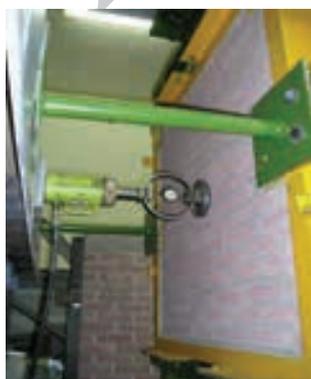
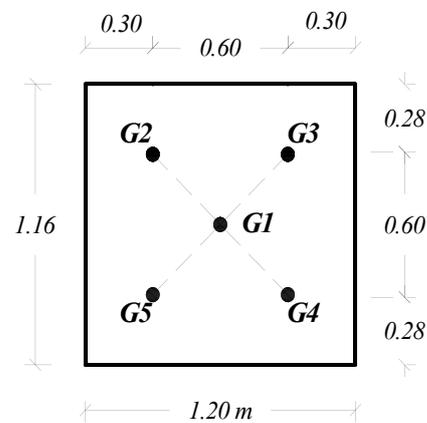
Similar to the in-plane shear investigations, four single-layer brick wall panels were constructed for the out-of-plane bending experiments. The wall panels for these tests were 120cm square. Of the four panels, two were made with standard materials and workmanship and two were constructed using non-standard materials and workmanship. Also, in each pair of the standard and non-standard panels, one panel was constructed with mortar head joints and another without the mortar head joints. The test set-up for the out-of-plane testing of the wall panels is shown in Fig. 12a. It consists of a loading frame, against which a horizontally placed hydraulic jack exerts the out-of-plane point load on the specimens. Five mechanical dial gauges were used to record the deflections of each specimen. The locations of these gauges are shown in Fig. 12b.

Fig. 12. (a) Test setup (b) position of mechanical gauges in the out-of-plane bending tests

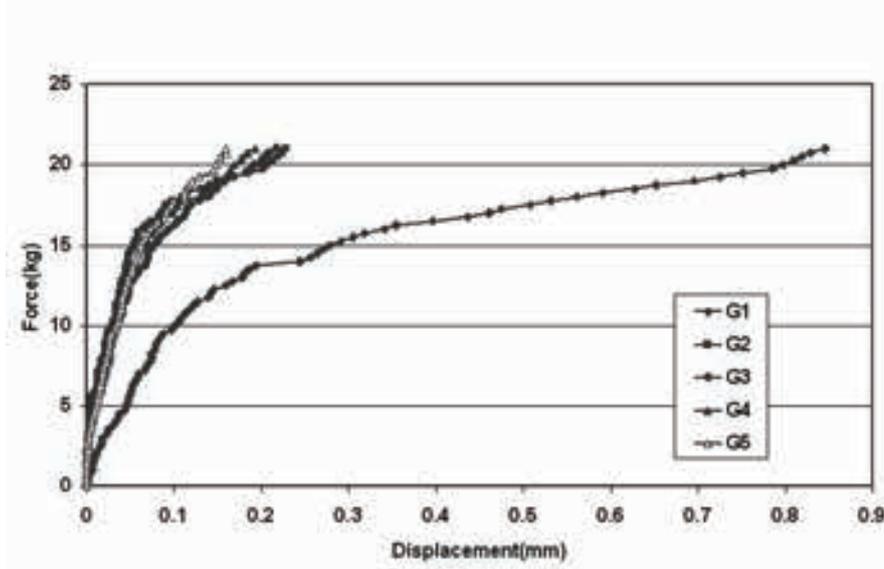
The out-of-plane incremental loading of the standard wall panels with head joints (SWFB) and without head joints (SWEB) was carried out in 0.25 kN steps and in each step, the corresponding displacements were recorded. The force-controlled pushover curves thus obtained for the test panel SWFB are plotted in Fig. 13. This figure indicates that the response of the panel with the head joints is linear throughout the panel up to a load of 14 kN; the linear stiffness being about 88.3 kN/mm using the displacements for the centre of the panel, (Fig. 13).

Fig. 13. Pushover curves of the wall SWFB

Figure 13 also indicates that the first crack occurred at the same load of 14 kN. The crack, however, did not become visible until the load reached the value of 17 kN. Contrary to the yield line theory prediction for isotropic materials, the first crack occurred almost vertically at the centre of the panel (Fig. 14). The formation of this crack reinforced the notion that the masonry wall is stiffness orthotropic. Following the reduction in the stiffness of the panel in the horizontal direction and the redistribution of stresses, the panel started to behave increasingly isotropic. The change from the orthotropic behaviour to isotropic performance was noted when at the ultimate load of 21 kN, simultaneous diagonal cracking, pertinent to an isotropic behaviour occurred (Fig. 14).

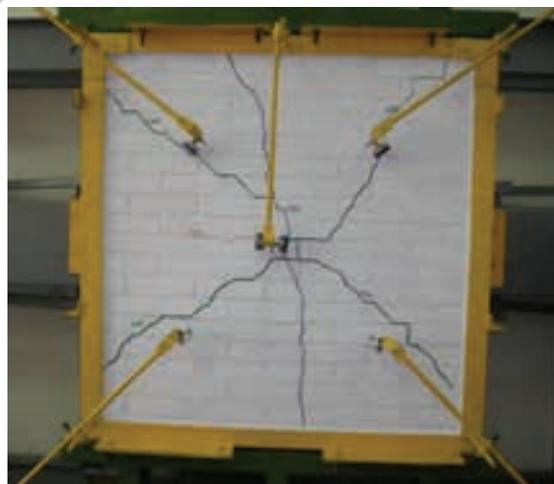
Fig. 14. Mode of failure of the wall SWFB

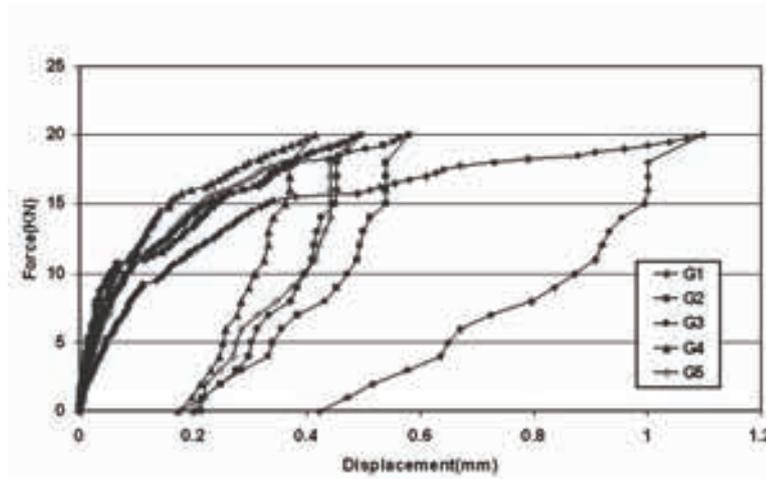
The pushover curves obtained for the SWEB panel are plotted in Fig. 15. The data for all five locations show that the first major change of slope occurred at 9.5 kN. The crack itself became visual at the load 10.7 kN in the form of a vertical crack running along the centre of the panel (Fig. 16). This crack was similar in position and orientation to the first crack that occurred in the sample SWFB. It did, however, occur at a load 32% less than the corresponding load in the sample SWFB. This indicates a considerable decrease in the out-of-plane capacity of the panel due to the omission of the head joints.

Fig. 15. Pushover curves of the wall SWEB

The occurrence of the vertical crack indicates that this panel also behaved initially orthotropic. The linear stiffness was about 82.6 kN/mm using the displacements for the centre of the panel. The force-deflection curves indicate a further softening of the panel at 15.5 kN. This softening became visible during the test at a load of 15.75 kN by the formation of a cross-diagonal crack (Fig. 16), similar to that which occurred in the panel SWFB at the higher load of 21 kN. Contrary to the behaviour of panel SWFB, which could not sustain further load beyond that point, the panel SWEB continued to carry further loads at higher deflections, indicating a substantial ductile performance. The load was increased to 20 kN, at which load was due to excess opening of the cracks. It was decided to discontinue loading up and to unload to obtain a complete half cycle (Fig. 15). Noting that the test procedure adopted here was force-controlled as opposed to displacement-controlled, the results of the post-peak unloading of the panel seen in Fig. 15

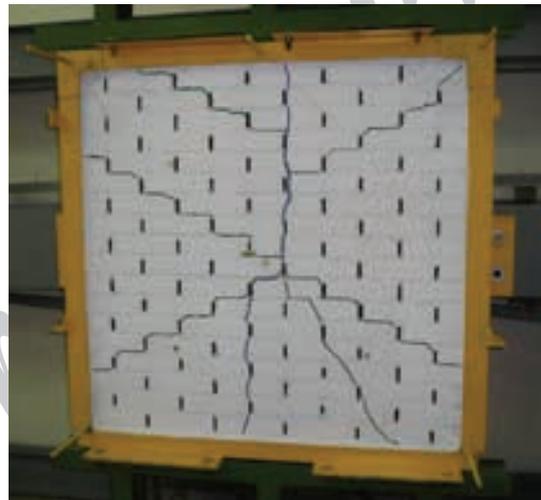
Fig. 16. Mode of failure of the wall SWEB

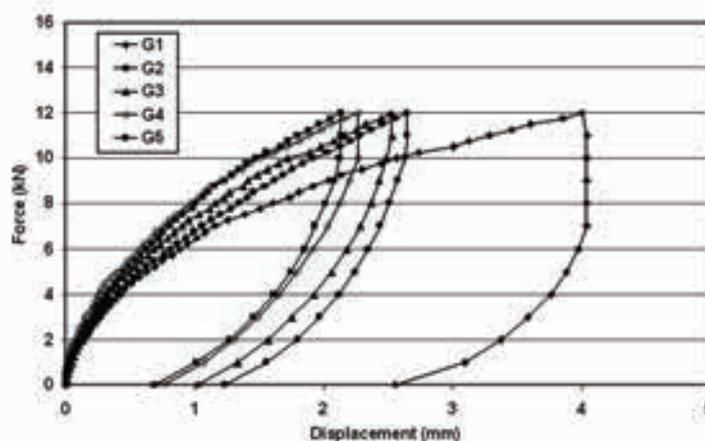
The out-of-plane loading of the non-standard wall panel with head joints (NWFB) was carried out at 0.25kN loading steps and at each step the wall displacements at the five locations shown in Fig. 8b were recorded. The load-displacement pushover curves for the five positions recorded are plotted in Fig. 17. Observations made during the test showed that the first cracks appeared in the wall at around 2.5 kN. These cracks were diagonal, following more or less the pattern indicated by the yield line theory of isotropic materials. The cracks also appeared exclusively on the joints between the bricks and mortar. This indicates the weak bond between the two materials. The cracks at 2.5 kN can also be deduced from the pushover curves of Fig. 17, at which the load change of the slope can be seen for all locations recorded. After that, a gradual decrease in the slope of the curves can be seen as the diagonal crack spread to cover the entire panel and a second set of diagonal cracks developed. Also, in line with an expected orthotropic response, a vertical line along the brick-mortar joints (Fig. 18) also appeared. The non-linear, somewhat ductile response of the panel continued, as the load increased to 12 kN. At this load, due to widening of the cracks it was decided to unload the frame and record the response to unloading.

Fig. 17. Pushover curves of the wall NWFB

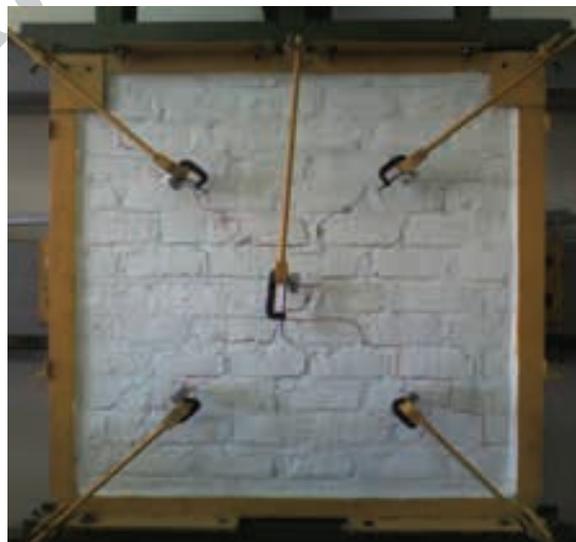
Fig. 18. Mode of failure of the wall NWFB

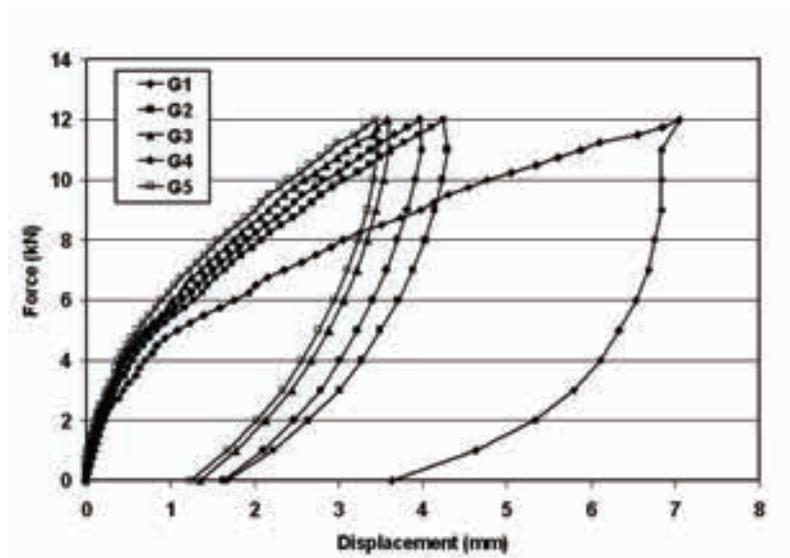
The out-of-plane loading of the non-standard wall panel without head joints (NWEB) was carried out in a similar manner to the previous tests. Figure 19 shows the force-displacement pushover curves for the five locations measured during the test. The loading was continued to the same level as the wall NWFB (12 kN), after which unloading was performed. The first softening of the wall appears to have occurred at the load of 1.75 kN. A second marked change of slope can be seen around 4.0 kN load, after which a gradual softening of the panel can be deduced from all five recording gauges. The failure pattern of this infill wall before unloading is shown in Fig. 20. By comparing the results of walls NWFB and NWEB, a marked decrease in the overall stiffness due to the omission of head joints can be seen. The test results are summarized in Table 3.

Fig. 19. Pushover curves of the wall NWEB

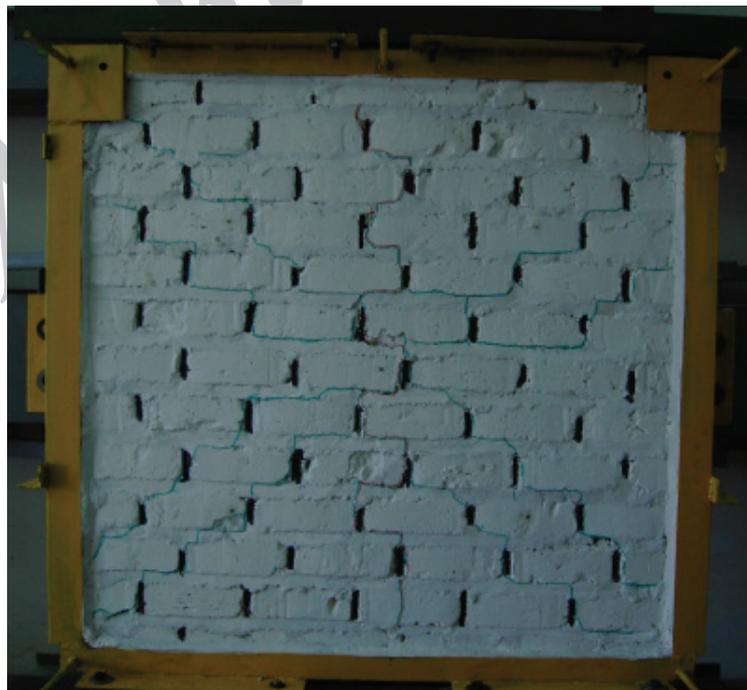
Fig. 20. Mode of failure of the wall NWEB
