Impact of fertilizer plant effluent on water quality

¹O. Obire; ¹A. Ogan; ²*R. N. Okigbo

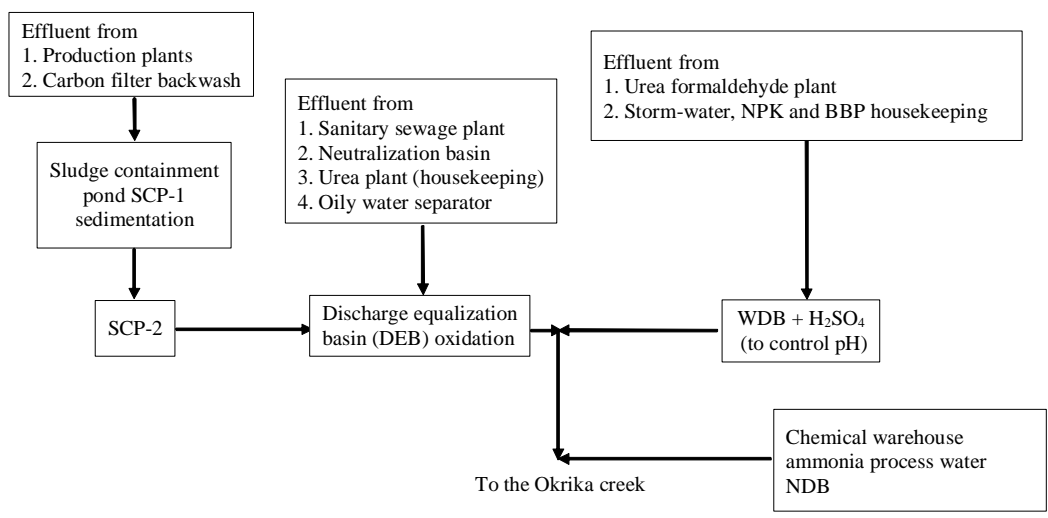
Fig. 1: Diagram of NAFCON effluent treatment and channelization into the Okrika creek

The study area from which the water samples were collected is the Okrika creek in Okrika Local Government area of Rivers State, which lies in the coastal fringes of Niger Delta (Fig. 1). It stretches from the NAFCON jetty through the Okrika jetty. The Okrika creek is bounded on its eastern bank by the NAFCON complex (in Onne, Eleme Local Government Area), the Okochiri community (in Okrika Local Government Area) and mangrove plants of different species and on the West by sand deposit from the dredged Okrika creek and different species of mangrove plants. The Okrika creek is confined in the salt water swamp zone and is influenced by tidal fluxes. The flow of the Okrika creek is only slightly swift and bidirectional. The creek is characterized by tall mangrove plants of different species having tangled mass stems and aerial roots of about 20-60 ft tall. The vegetation mostly consists of red mangrove. Frequent precipitation is a common occurrence in the study area and in rivers state as a whole. During the study period, i.e. 1998, the time lag of May to September was considered as the rainy season, while the dry season included the period of October to December when sampling ended. The control creek (Ikpukulubie creek) was chosen due to its relative distance from the Okrika creek and the NAFCON effluent outfall (Fig. 1). It is situated at the coastal fringes of the core south of Port Harcourt. Its vegetation is essentially the same as that of the Okrika creek. It has a fishing settlement and a rapidly

Based on the peculiarities and features observed around the study area, four sampling stations were established along the Okrika creek (Fig. 1). The sampling stations were chosen 50 m. from the banks of the creek and 100 m apart from each other.

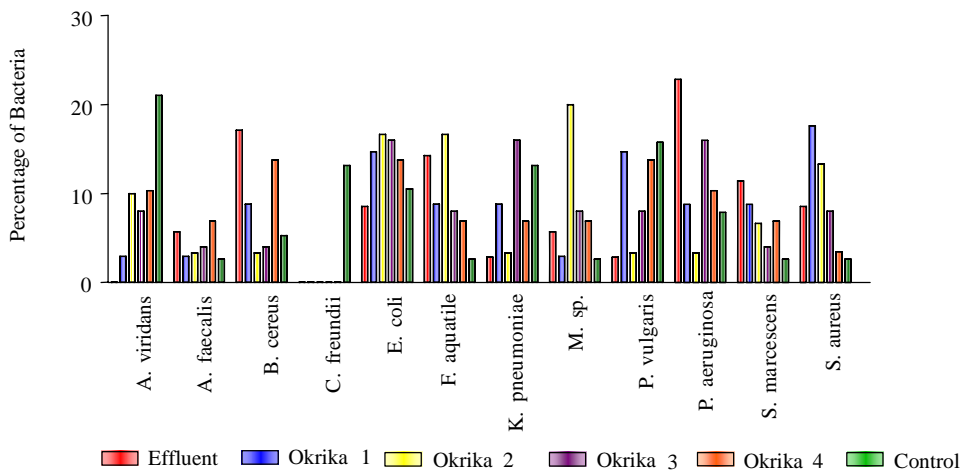
Fig. 2: Occurrence and abundance (%) of representative bacterial isolates of the NAFCON outfall effluent, the Okrika creek and the control creek

The occurrence and abundance (%) of representative bacteria isolated from the NAFCON outfall effluent, the Okrika creek and the control creek are as presented in Fig. 2. All of the bacterial types were isolated from the control creek, whereas *Citrobacter freundii* was not isolated from the NAFCON outfall effluent and from the Okrika creek. *Aerococcus viridans* was also from the control creek and Okrika creek but from the NAFCON outfall effluent. With the exception for *Aerococcus viridans* and *Citrobacter freundii*, all of the bacterial types isolated in this investigation occurred in the NAFCON outfall effluent. It could be affirmed that the outfall effluent exerted a bactericidal effect on *Aerococcus viridans* and *Citrobacter freundii*; it had an inhibitory effect on *Aerococcus viridans*, *Bacillus cereus*, *Klebsiella pneumoniae* and *Proteus vulgaris* and exerted an enrichment effect on *Alcaligenes faecalis*, *Bacillus*
