Treatment of a Bilateral Sacral Insufficiency Fracture with CT-Guided Balloon Sacroplasty

Christopher Wilhelm Ludtke^{1,*}; Christian Wissgott¹; Reimer Andresen¹

¹Institute of Diagnostic and Interventional Radiology/Neuroradiology, West kustenklinikum Heide, Academic Teaching Hospital of the Universities of Kiel, Lubeck and Hamburg, Heide, Germany

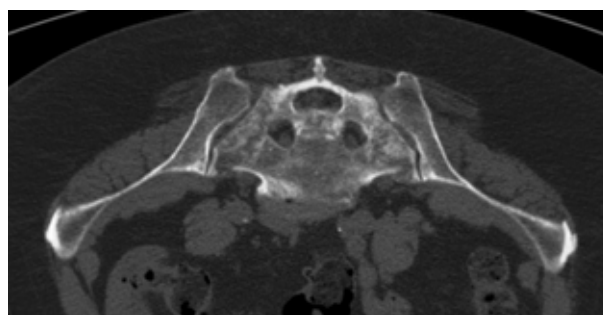
a renal cell carcinoma of the right kidney. Despite sufficient pain treatment and accompanying physiotherapy, the patient's mobility was severely restricted by pain at the time of presentation. The patient rated her pain as 9 on a visual analogue scale (VAS) with 10 as the maximum value. Osteoporosis was also suspected and confirmed by bone density measurement, so therapy with bisphosphonates was started in accordance with the guidelines (5). In the preinterventional CT of the pelvis and abdomen, a bilateral fracture line running sagittally through the lateral mass of the sacrum could be seen (Figure 1).

On the left, the fracture line traverses the transforaminal zone at the level of the second sacral vertebra. Both in this examination and in an additionally performed

Figure 1. Thin-sliced preinterventional CT (prone position and mirrored afterwards). Extensive fractured bone mass between the sacral foramina and the iliosacral joint

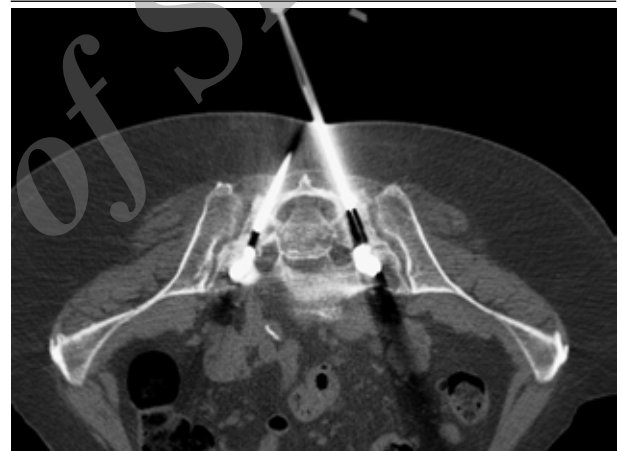
Figure 4. Single-slice CT image during balloon dilatation in the fracture zones of the os sacrum

They were inflated and deflated stepwise from the central to peripheral under CT monitoring by means of single slice images (Figure 4). Cement (polymethyl methacrylate, PMMA) application was then performed in the previously prepared hollow space using the low-pressure method under CT monitoring (Figure 5). The final check by thin-slice spiral-CT of the pelvis showed sufficient distribution of the cement, without leakage into

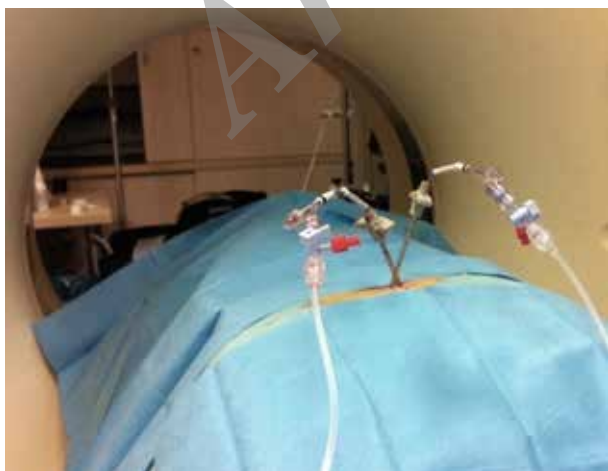
Figure 2. Patient positioning in the gantry with the inserted hollow needles and the connected balloon catheter system

MRI, no metastases of the suspected renal carcinoma were observed in the areas of the body examined. The morphology of the sacral fracture was also most consistent with an insufficiency fracture. In order to enable the further therapy of the renal tumor and to achieve sufficient pain reduction, in an interdisciplinary tumor conference, it was initially decided to treat the sacral fracture by CT-assisted balloon sacroplasty. In order to avoid further fracturing and prolonged hospitalization of the patient, we decided on simultaneous treatment of the bilateral fractures. In addition, a biopsy was to be taken for histopathological analysis for definitive exclusion of metastasis. The intervention was performed under intubation anesthesia and anesthesiological monitoring. The patient was placed in the prone position in the CT scan machine. As is routine practice, a single-shot antibiotic was administered (cefazoline 2 g IV). The short axis of the sacrum was selected as the entry plane. Access to the fracture zones was established from dorsal to ventral by two Kirschner wires, which can be directed and angulated easily without causing further damage in the osteoporotic bone. Along the Kirschner wires, two hollow needles were then placed in the fracture zone. The desired position was observed by single slice CT-images. To begin with, the bone biopsy was performed via the hollow needles. The balloon catheters (Kyphon®, Medtronic, 20 mm length) were then inserted (Figures 2 and 3).

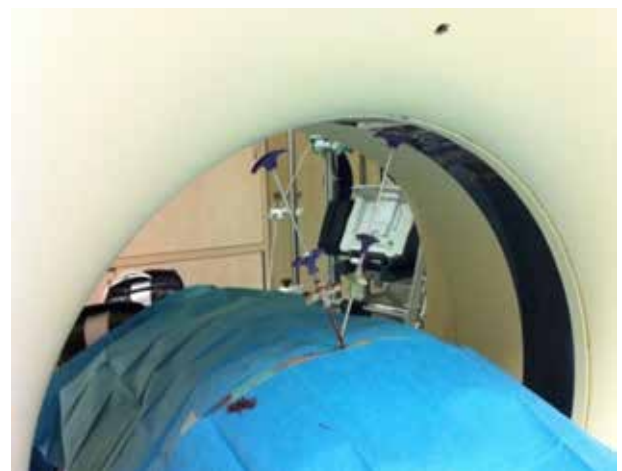
Figure 5. Evaluation of correct needle position after insertion of the cement applicator system

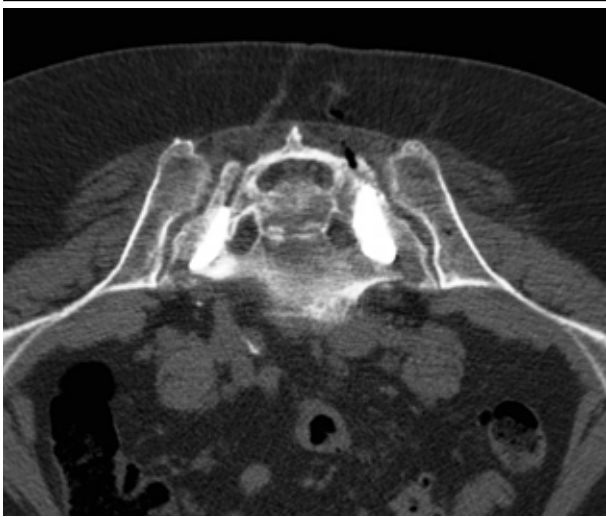
Figure 6. Final examination with thin-sliced CT images to check the correct position and sufficient cement distribution in the mean fracture zones

the neural foramina, the iliosacral joint or the visceral surface of the sacrum (Figures 6 and 7). In our institution, the cement distribution is usually observed by plain radiography (not shown) to have an initial image for potential follow-up examinations. Two days post-intervention, a pain reduction to VAS 3 was observed (Figure 8). The samples taken during the intervention showed no evidence of malignancy. The patient's previous pain-related restriction of mobility and her general condition improved markedly thereafter, so that the planned oncological therapy, including nephrectomy could be started.

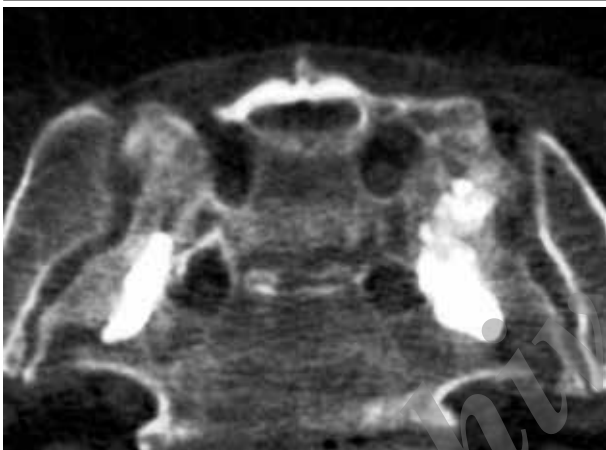
Figure 7. Enlarged and angled post-processed image. No cement leakages were detected.

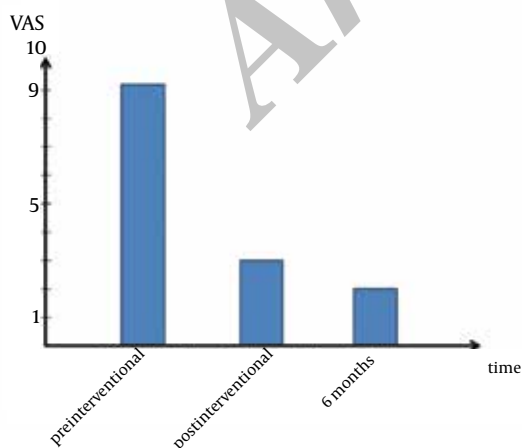
Figure 8. Development of the fracture-related pain on a visual analogue scale (no pain = 0, maximum pain = 10) in the so far observed period.

Percutaneous balloon sacroplasty already showed a marked reduction in pain and increased mobility in patients with insufficiency fractures in the first case reports published (6). By using balloon catheters and CT assistance, a controlled and reliable cement application can be achieved, so that cement leakages and neurological complications can be largely prevented. The compaction of the fractured and destroyed bone and the subsequent sealing with cement increases the stability of the posterior pelvis above all in the area of the neural foramina and appears to be the most important mechanism for prompt reduction of pain. In the meantime, the reliability and effectiveness of balloon sacroplasty in patients with insufficiency fractures has also been shown in a larger patient population (4). Apart from the general risk of anesthesia, and the potential risk of cement leakage into the neural foramina or the surrounding presacral soft-tissue structures, the case reports and studies published to date have not revealed any specific risks of this therapy. In a recent study, common sacroplasty in the vertebroplasty technique (sacrovertebroplasty) showed cement leakage rates of 27% into the fracture gap, which could potentially affect the lumbar nerve roots (7). Due to the use of balloons forming a pre-sized hole and compacting the fracture lines, the rate of leakage into the fracture gap is probably lower in balloon sacroplasty (4). Nevertheless, the patient has to be informed about the risk of neurological impairments before intervention. To prevent any kind of cement leakage, it is important to choose the right strategy for the intervention regarding the access (long- or short-axis), the exact positioning of the balloon and the amount of cement. In the short-axis technique, it is sufficient to use single slice CT-images; whereas, in long-axis access an additional plain radiography using a c-arm turned out to be useful in our experience (4). As a result of the bilateral simultaneous and thus definitive treatment of the fractures, hospitalization of the patient can be kept to a minimum and any other therapies planned are not unnecessarily delayed. As interventional and minimally-invasive pain therapy, balloon sacroplasty also represents a promising treatment option for complex insufficiency fractures or malignant primary diseases within the context of multidisciplinary concepts. In addition, case reports have also shown the successful treatment of pathological fractures of the sacrum by means of CT-assisted balloon sacroplasty (8, 9). Thus, the indication for CT-assisted sacroplasty is not limited by metastatic infiltration that cannot be ultimately ruled out preinterventionally, as in our case. As a result of the greatest possible reduction in incapacitating pain, the planned nephrectomy could be performed promptly and without complications. At present, around 6 months after the intervention, the patient reports intermittent pain with a maximum severity of VAS 2 (Figure 8).
