Original Article

Effects of continuous irrigation at room temperature or +4°C on the cyclic fatigue resistance of K3XF instruments

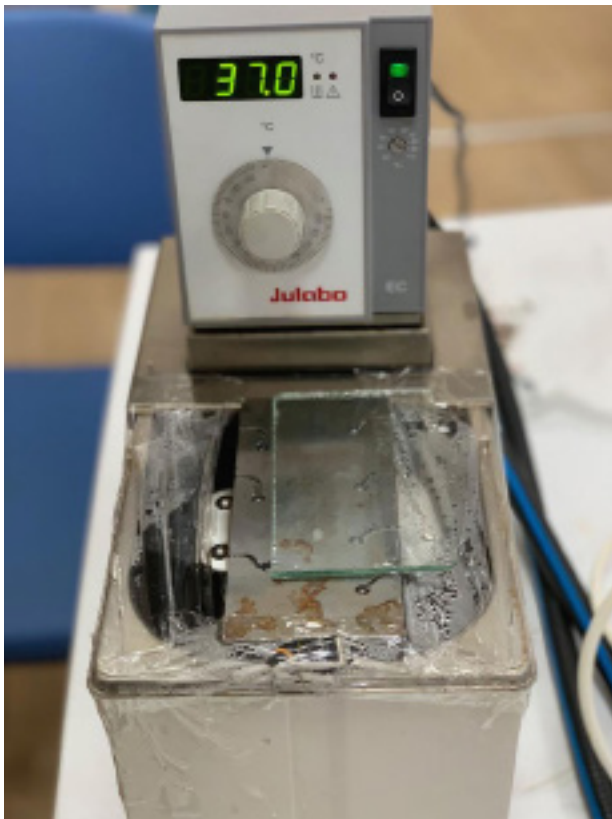
Figure 1. Experimental design.

The files were rotated within a tapered artificial root canal with a coronal and an apical curvature (double curvature). The coronal curvature's angle was 60° , and its radius was 5 mm. The apical curvature's angle was 70° , and its radius was 2 mm. The artificial root canal's length was 21 mm. The files were rotated using a torque-controlled endodontic motor (VDW Silver; VDW, Munich, Germany) according to the manufacturer's instructions at 350 rpm and 150 g-cm torque. The handpiece was fixed during the test. The curvatures were located 7 and 12 mm from the tip of the instrument. The test was performed in a water bath (Julabo, Seelbach, Germany) at $37 \pm 1^\circ\text{C}$.¹⁸ Cyclic fatigue test was started after the artificial canal temperature was confirmed using a thermocouple (Figure 1). Instruments' slipping out was prevented by covering the artificial canal with glass.

Continuous irrigation with saline solution at +4°C: K3XF instruments were operated under continuous irrigation with saline solution at +4°C. Saline was placed in a refrigerator for one day. In this group, the injectors were also placed in the refrigerator. During the experiment, to prevent the saline solution from heating, the injectors were stored in a container with dry ice (Elabscience Biotechnology Co. Ltd, Wuhan, China).

In the irrigation groups, the irrigation needle was placed in the coronal part of the stainless steel canal, and irrigation was performed at a constant speed of 10 mL/min. The time when the file was fractured
